*WW1&2 consent application*

# *Appendix B*

## **Soil type assessment of soils at Woldwide 1 & 2 dairy farms**

Investigation of cracking soils: Heddon Bush, January 2018.  
Michael Killick, Technical Specialist (Soils and Groundwater Quantity)

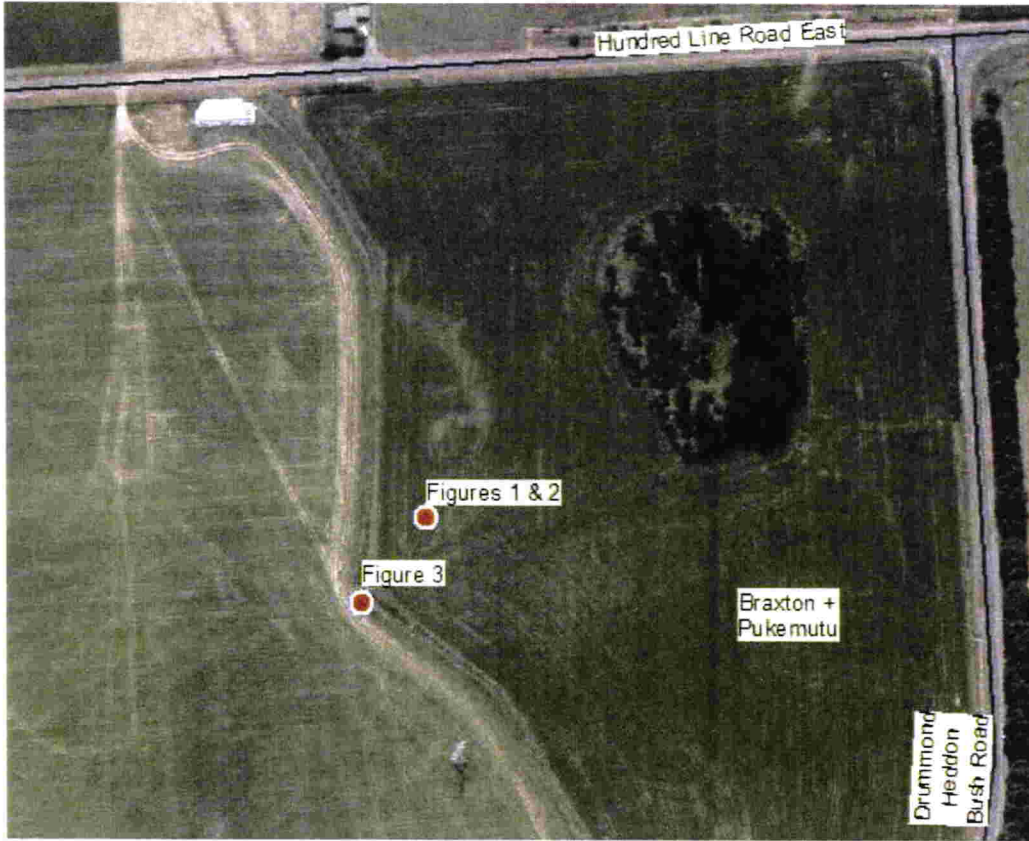
Figure 4. Site 1 locations.

A shallow hole (~15cm deep) at the site showed the soil was friable with many small to medium well-formed peds. A creek on the west side of the paddock which is a small tributary of Middle Creek was dry at the culvert where the bed was a metre or so below ground level. Site 1 was described by Abe as wet in winter with areas of standing water, the effects of which could still be observed in the dry conditions of our visit (re-sowing with new pasture had been prevented in one place due to previous muddy conditions). See figures 1-5.

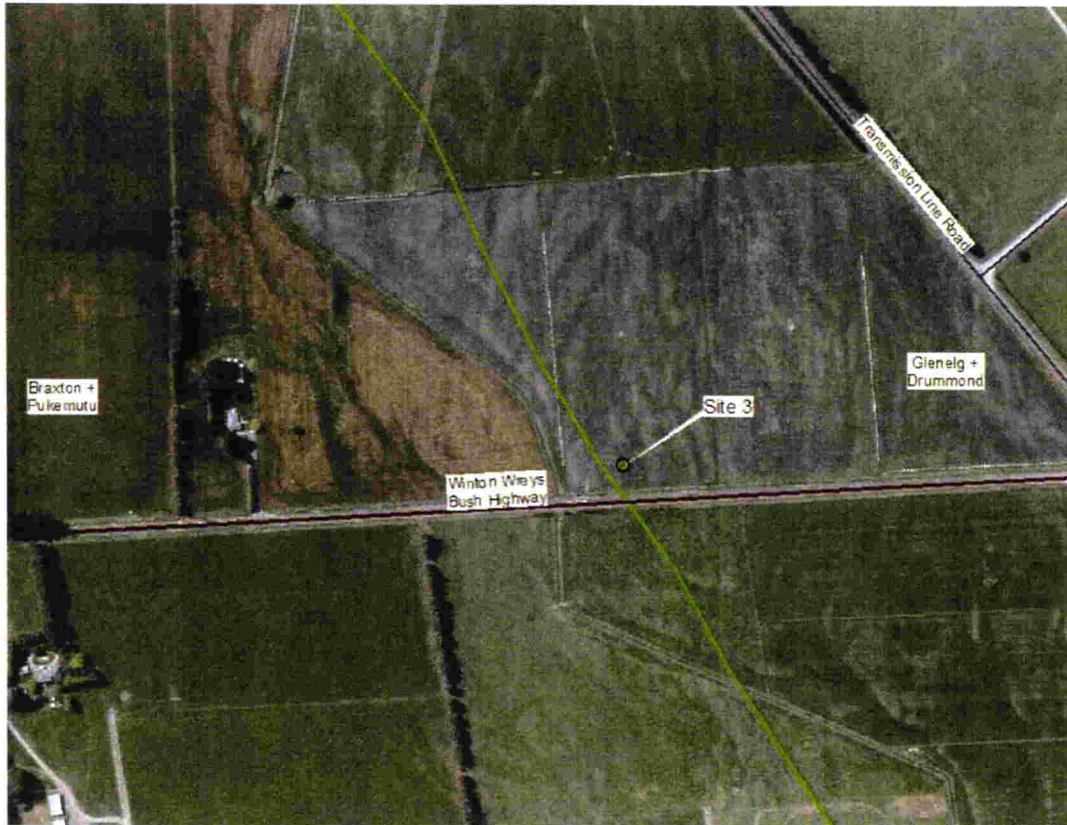
Figure 7. Site 3 location.

We walked a transect of approximately 50m at a third site ('Site 3', Figure 7) mapped as Glenelg + Drummond soils (close to the boundary of Braxton + Pukemutu soils). Cracks in this soil were observed at a density of at least one in the region of each stride i.e.  $1/m^2$ . The cracks were smaller than at Site 1, 2-4mm wide and less than 100mm long (see Figure 6). A hole dug to about 15cm depth at this site brought up two large stones (~90mm) and a number of small stones. A steel ruler was inserted easily into a crack to a depth of ~20cm, but could be inserted with similar ease to similar depth in soil without cracks at the site. (The depth of the cracks could not otherwise be ascertained as it was not visible from the surface and the soil structure and cracks collapsed easily with digging.)

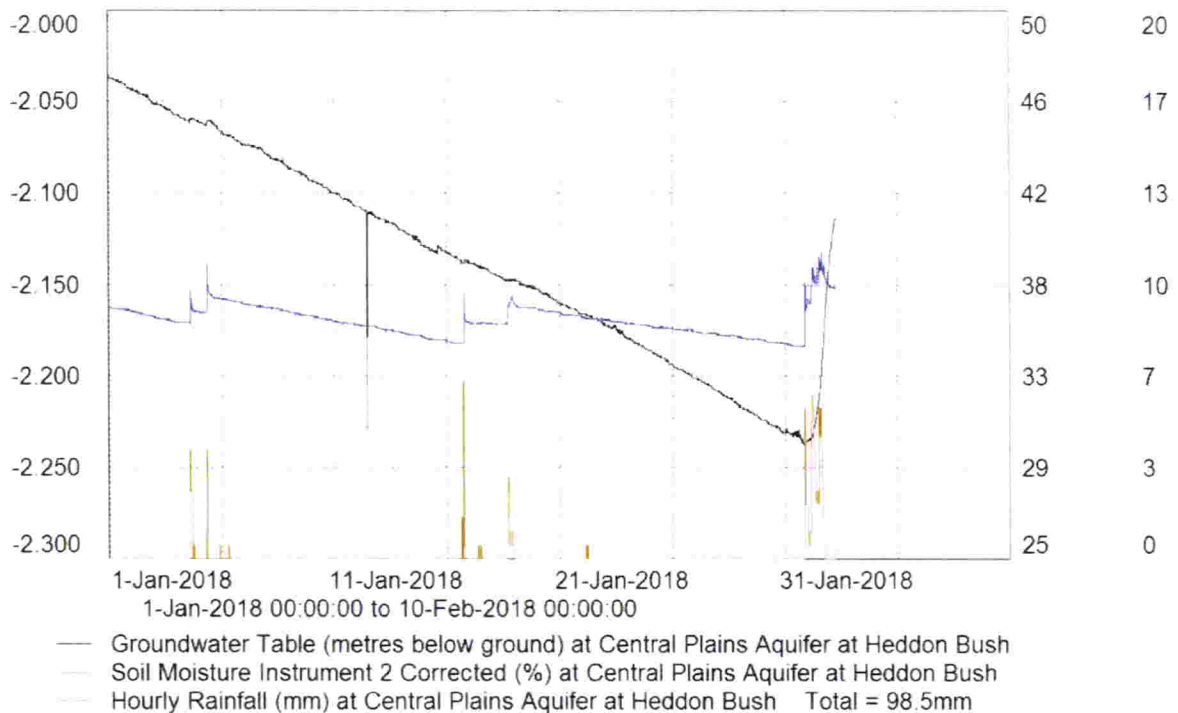
Figure 8. Groundwater level, soil moisture and rainfall at the Environment Southland Heddon Bush monitoring site.

At the Environment Southland site, Central Plains Aquifer at Heddon Bush, about 2.7 km from Site 1, rise in the groundwater level in the 6m deep bore occurred within 12 hours of the onset of rainfall. The location of this site is mapped as Braxton and Pukemutu soils but it was found at installation to be stony, so the site description was changed to Glenelg soils. Earlier, lesser rainfall events in January had little effect on groundwater level. See Figure 8.
