Woldwide One Limited (APP-20171445) Request for Further Information Response

This assessment has been prepared to address the issues raised in Environment Southland's Request for Further Information letter dated 8th September 2017.

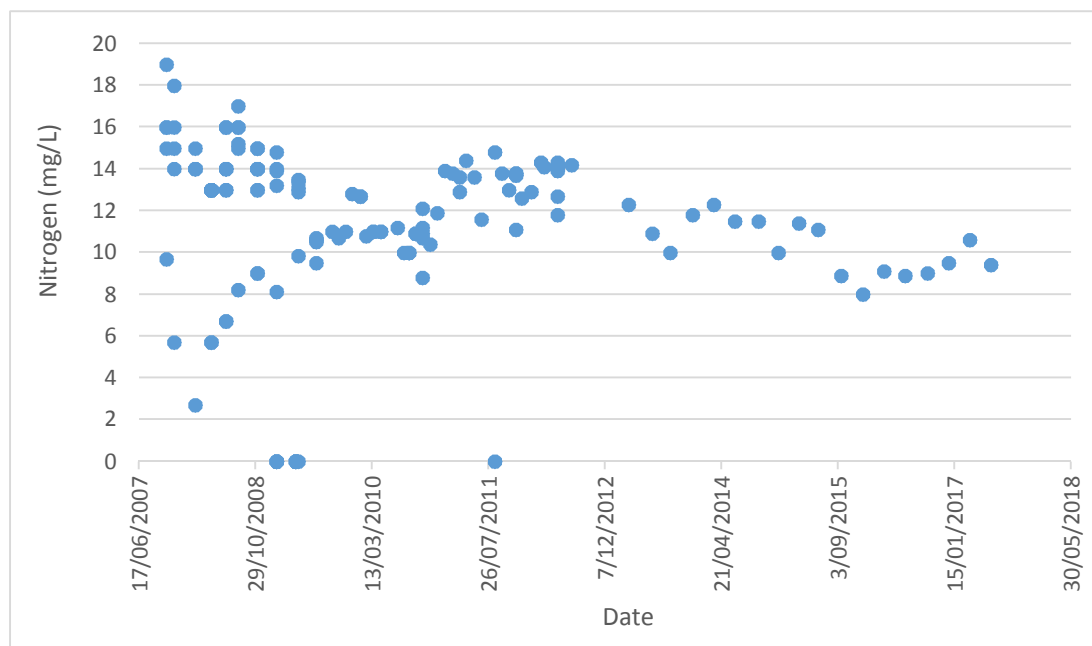
Figure 1 shows the Nitrogen results for bore E45/0330 from October 2007 to present. The results indicate there is no apparent trend and that the nitrogen levels in bore E45/0330 are relatively high however they do not appear to have increased with the development of farm land to dairying in the Waimatuku and Central Plains catchments over the previous 10 years.

Figure 1: Nitrogen (Nitrate-Nitrite) results from bore E45/0330 (2007-present)

The nitrogen results in both bores E45/0330 and E45/0010 indicate that the water is currently within the drinking water quality standard (11.3 mg/L).

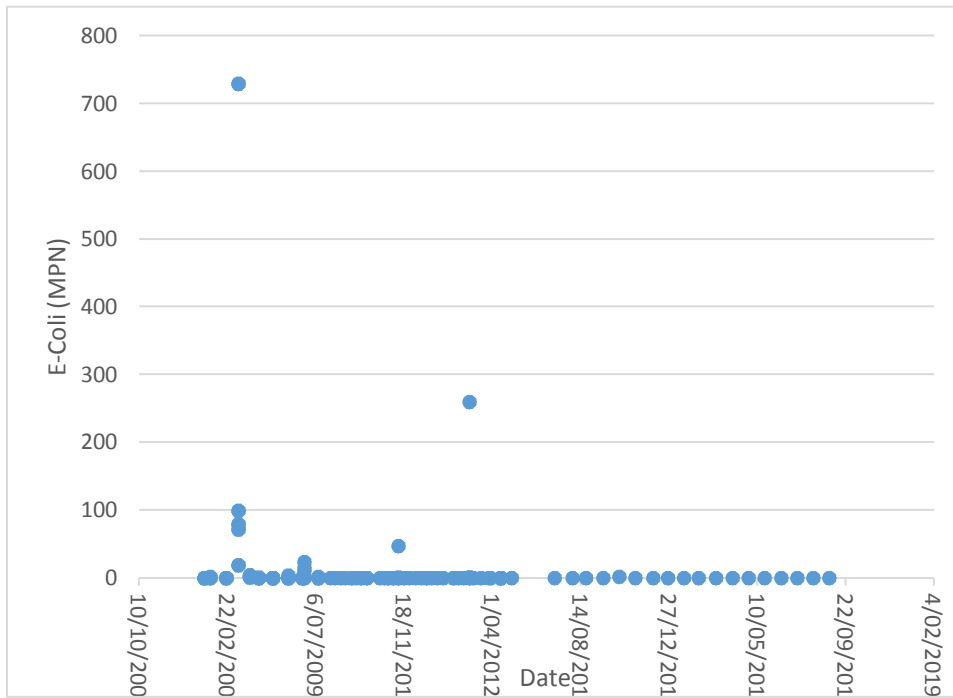
Figure 2 shows the E-Coli results for bore E45/0330 from September 2007 to present. The results indicate there is no apparent trend and that the E-Coli levels in bore E45/0330 are low and do not appear to have increased with the development of farm land to dairying in the Waimatuku and Central Plains catchments over the previous 10 years.

Figure 2: E-Coli results from bore E45/0330 (2007-present)

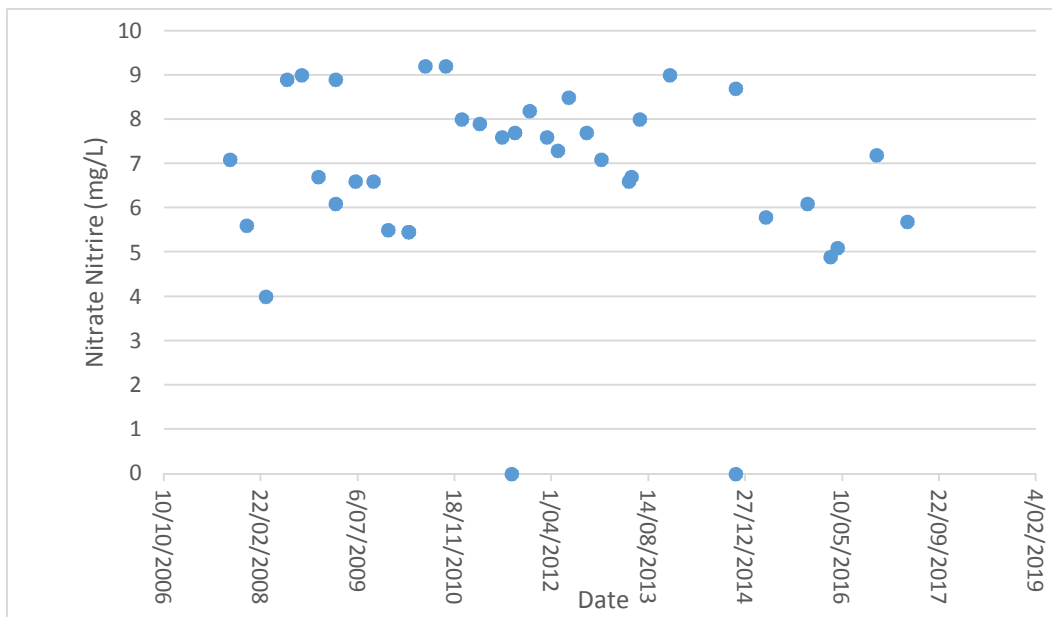
Figure 3 shows the Nitrogen results for bore E45/0010 from September 2007 to present. The results indicate there is no apparent trend and that the nitrogen levels in bore E45/0010 are relatively high however they do not appear to have increased with the development of farm land to dairying in the Waimatuku and Central Plains catchments over the previous 10 years.

Figure 3: Nitrogen (Nitrate-Nitrite) results from bore E45/0010 (2007-present)

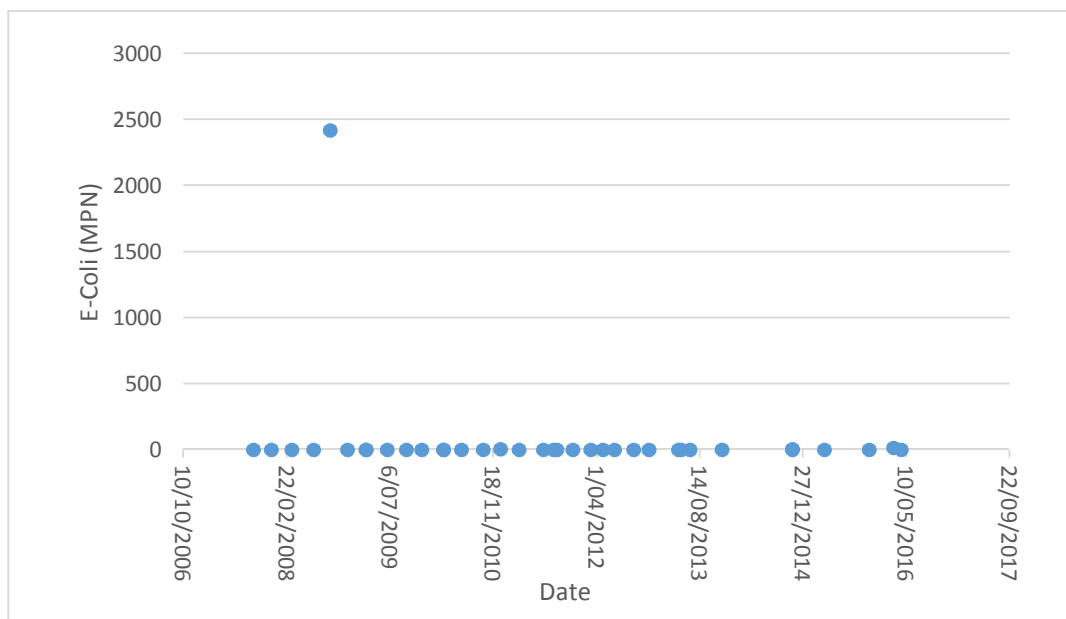
Figure 4 shows the E-Coli results for bore E45/0330 from September 2007 to present. The results indicate there is no apparent trend and that the E-Coli levels in bore E45/0330 are low and do not appear to have increased with the development of farm land to dairying in the Waimatuku and Central Plains catchments over the previous 10 years.

Figure 4: E-Coli results from bore E45/0010 (2007-present)
