### Submission on a publically notified application concerning resource consent under section 96, Resource Management Act 1991

### Assessment of potential effects on groundwater quality on Heddon Bush School water supply bore

Worldwide One Limited, a dairy farm located at 104 Shaws Trees Road, Heddon Bush (Figure 1), currently holds a consent (301663) to discharge dairy effluent from a maximum of 540 cows. Worldwide One is seeking consent to discharge dairy effluent from 800 cows (an increase of 48%) and increase the groundwater take from a maximum of 60m<sup>3</sup>/day to 91 m<sup>3</sup>/day.

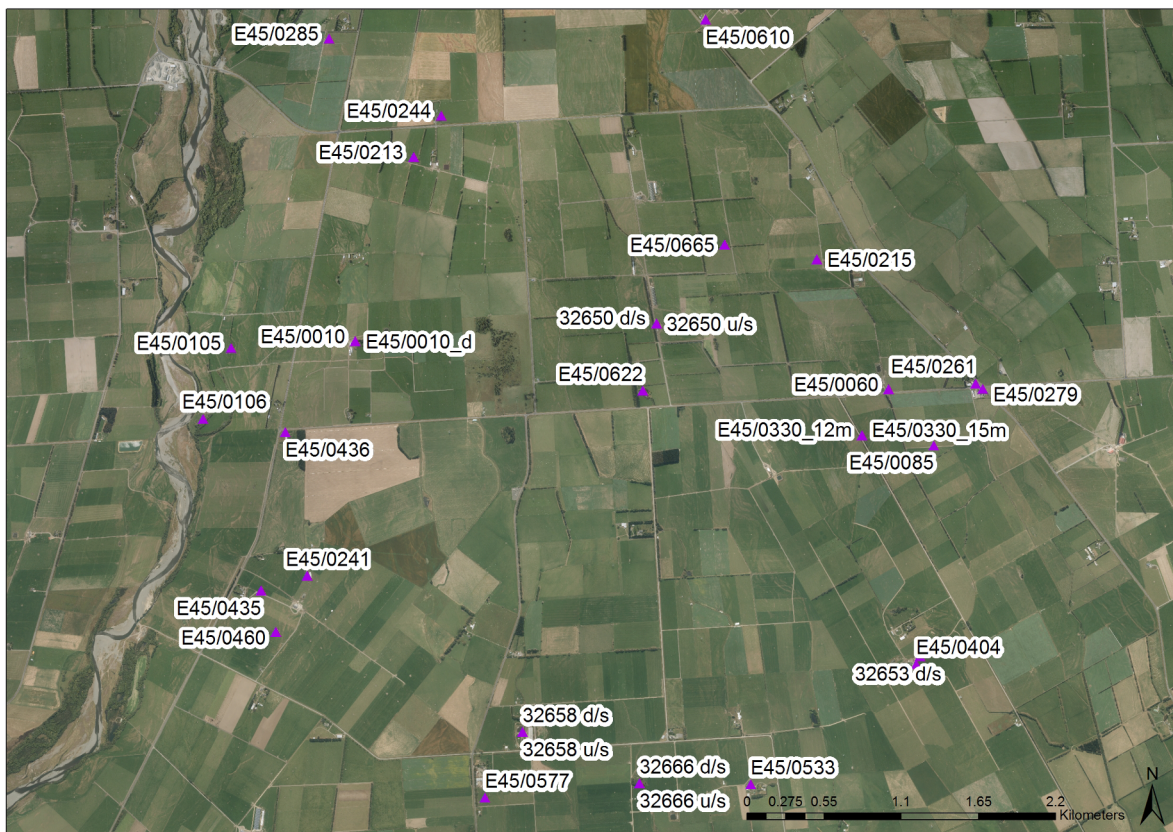
Figure 2: Water quality data map (data obtained from Environment Southland)

Very limited (2010 - 2011) water quality data (surface and groundwater) are available from Environment Southland database in bores within ~700m of the Heddon Bush School (Figure 2). Nitrogen concentrations (<3 mg/L) were measured both at surface water and groundwater samples (Table 2).

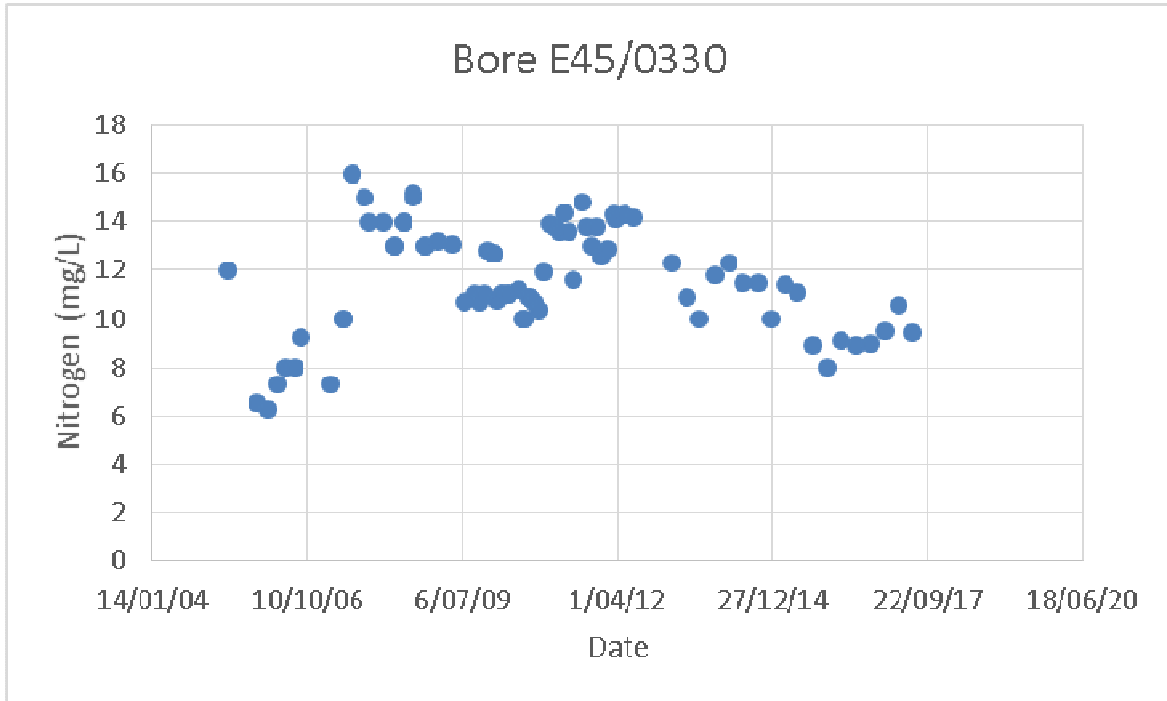
Figure 3: Nitrogen (Nitrate – Nitrite) Concentrations in bore E45/0330 (2004 – 2017)

Groundwater quality testing undertaken in samples from bores within ~2.5km of the farm show elevated nitrogen concentrations (average values range from 3.83 mg/L -15.8mg/L). Long term groundwater quality data are limited. In the vicinity of the Worldwide One property there are three bores with relatively recent groundwater quality data. E45/0330 is approximately 300m south, E45/0010 approximately 1200m west and E45/0435 is approximately 2000m south east of the Woldwide One property (Figure 2). Nitrogen concentration data from those bores are presented in figures 3, 4 and 5 (data obtained from Environment Southland).

In all three bores the data indicate there is no apparent trend on nitrogen concentrations over the years and the nitrogen concentrations are close and have exceeded the Maximum Accepted Value for Nitrogen (11.3mg/L) in Drinking Water Standards for New Zealand (DWSNZ) in the past.

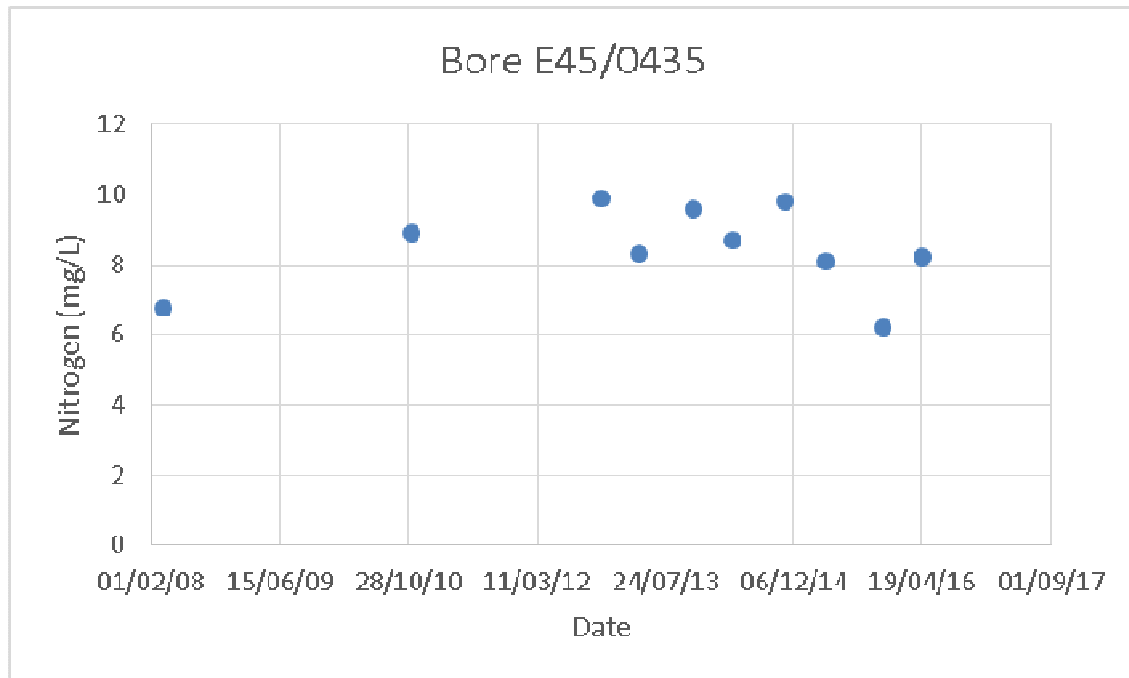
Figure 5: Nitrogen (Nitrate – Nitrite) Concentrations in bore E45/435 (2008 – 2017)
