Water quality assessments

**Woldwide One Limited and
Woldwide Two Limited
&
Woldwide Four Limited and
Woldwide Five Limited**

Reference: 19180

Date: 26 August 2019

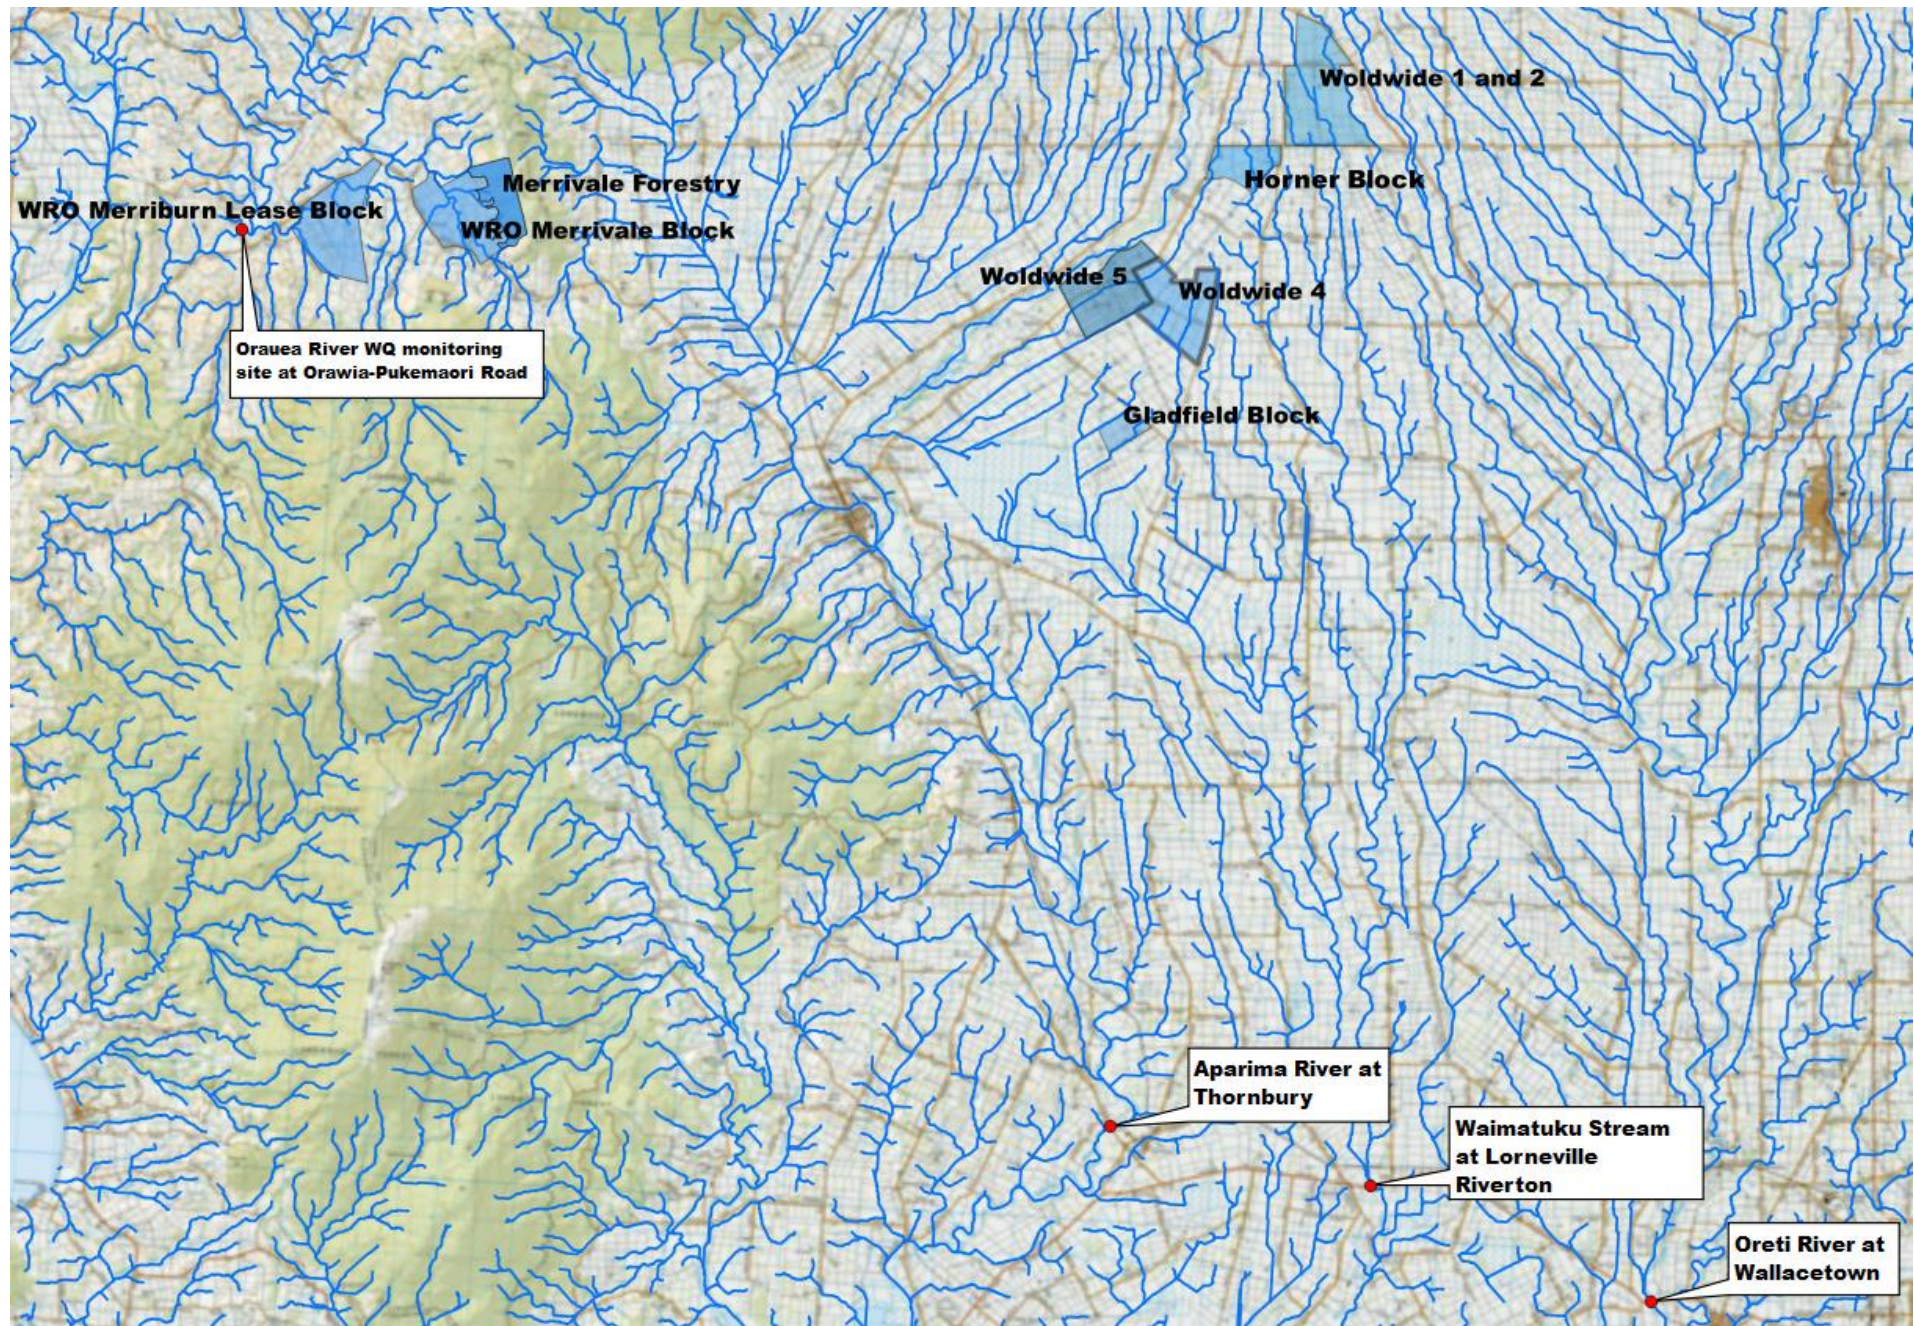
Figure 1: Location of all properties and catchments above the Orauea River, Aparima River, Waimatuku Stream and Oreti River monitoring sites

- 3.1 The WW1&2 dairy platforms and the Horner Block (HB) are spread across the catchments of the Aparima River, the Waimatuku Stream and the Oreti River as indicated in Figure 1. There are long-term water quality monitoring sites for these rivers at Thornbury, near Waimatuku and Wallacetown respectively.
- 3.2 The WW4&5 dairy platforms and the Gladfield Block are further south and east from the WW1&2 blocks and are spread across the Aparima River and Waimatuku Stream catchments, with the majority of WW5 in the Aparima River catchment.
- 3.3 The surface water catchments are illustrated in figures 1 & 2 together with the Environment Southland GIS system's approximate catchment boundaries.
- 3.4 The runoff blocks are in the catchment of the Orauea River and there is a long-term water quality monitoring site at the Orawia Pukemaori Road, as indicated in more detail in Figure 3.

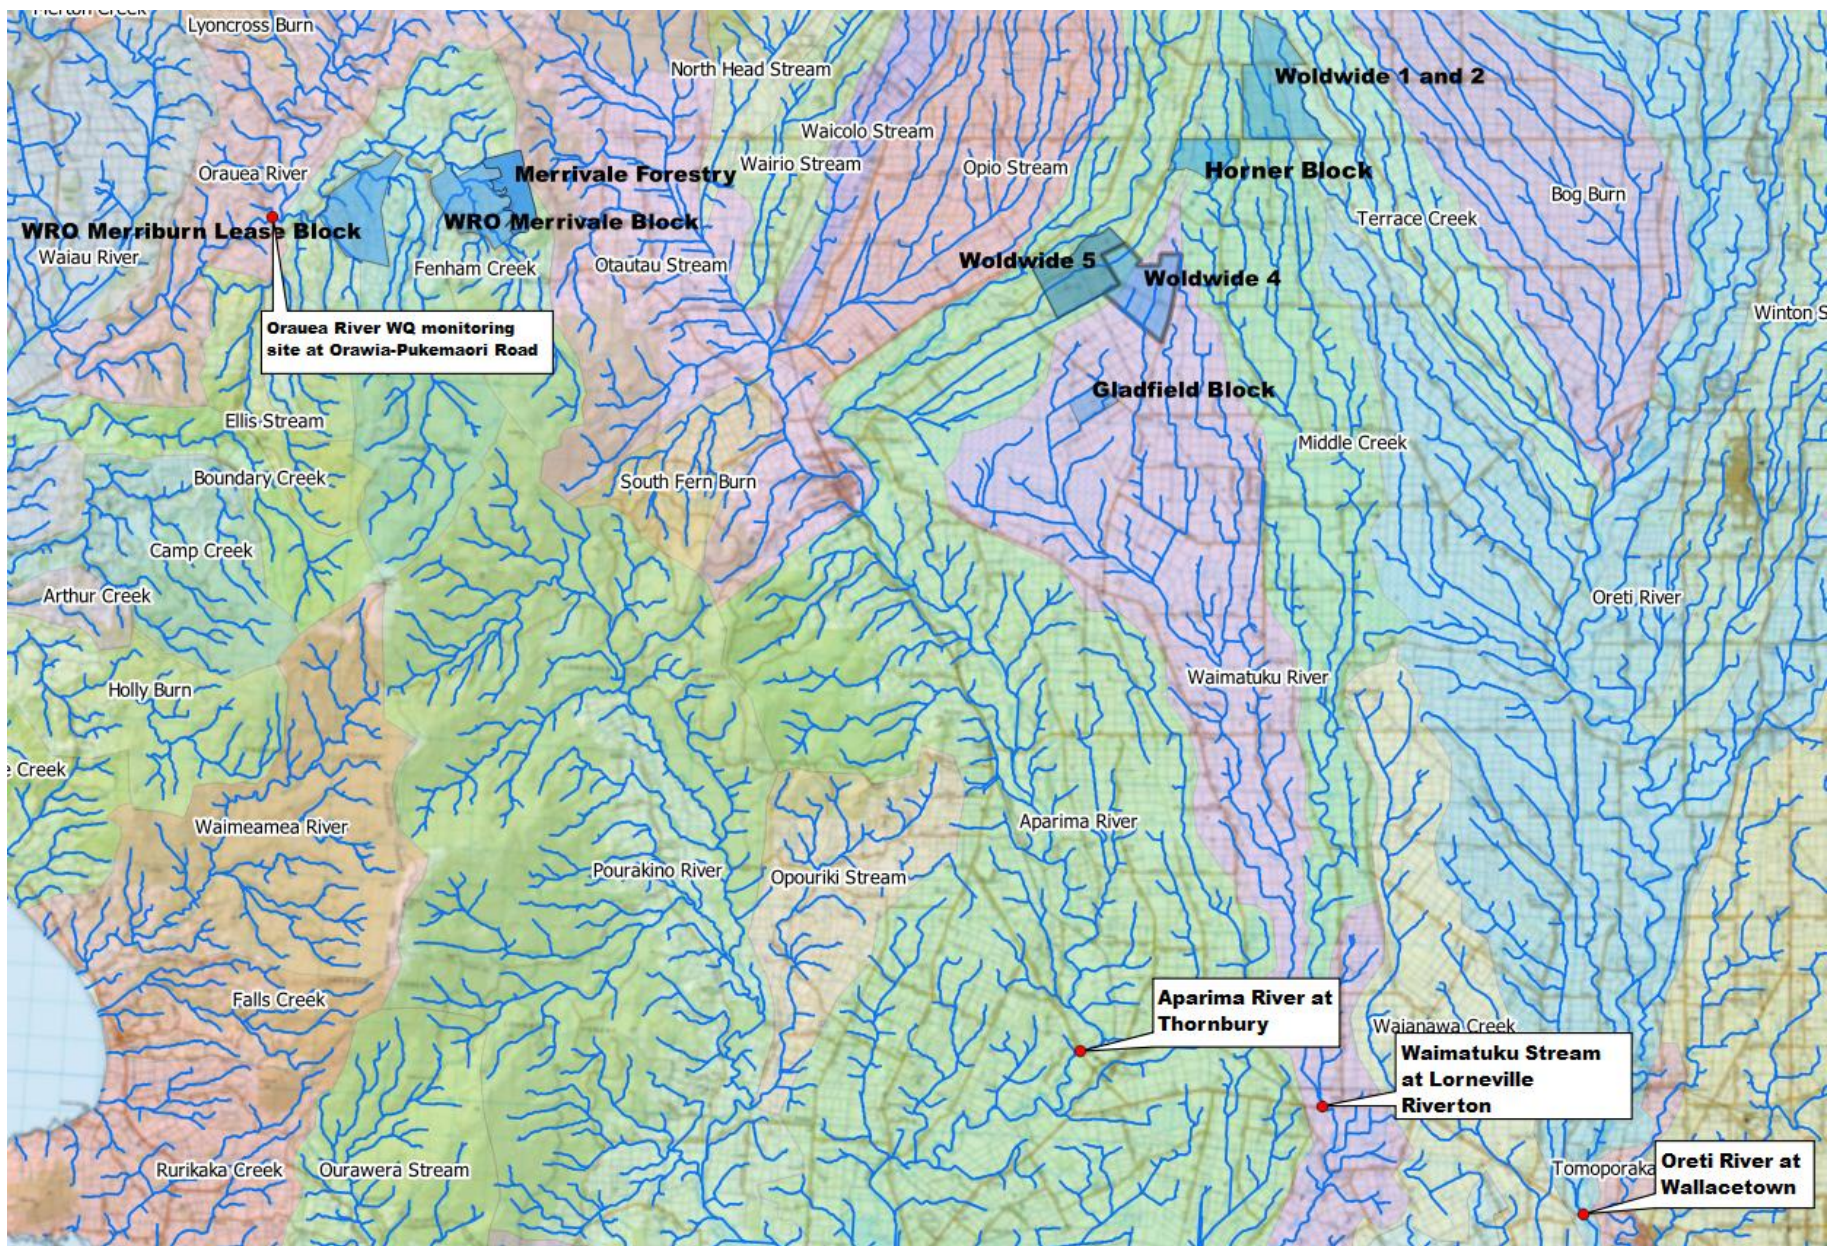
Figure 2: Location of properties and catchment above the Aparima River and Waimatuku Stream river monitoring sites, shaded areas showing Environment Southland GIS surface catchment areas

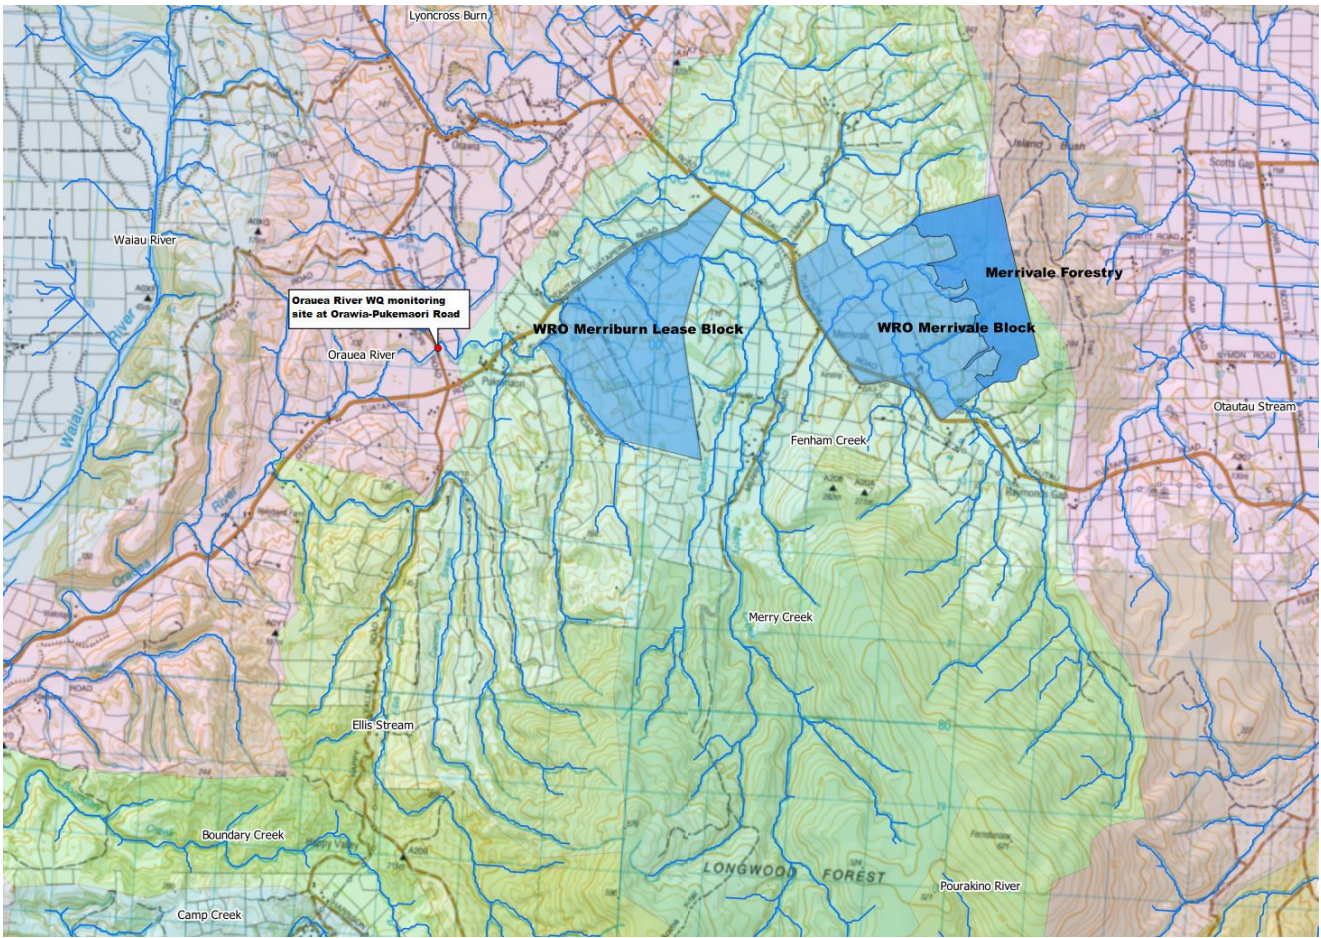
Figure 3: Location of the WRO properties and catchment above the Orauea River monitoring site, shaded areas showing Environment Southland GIS surface catchment areas

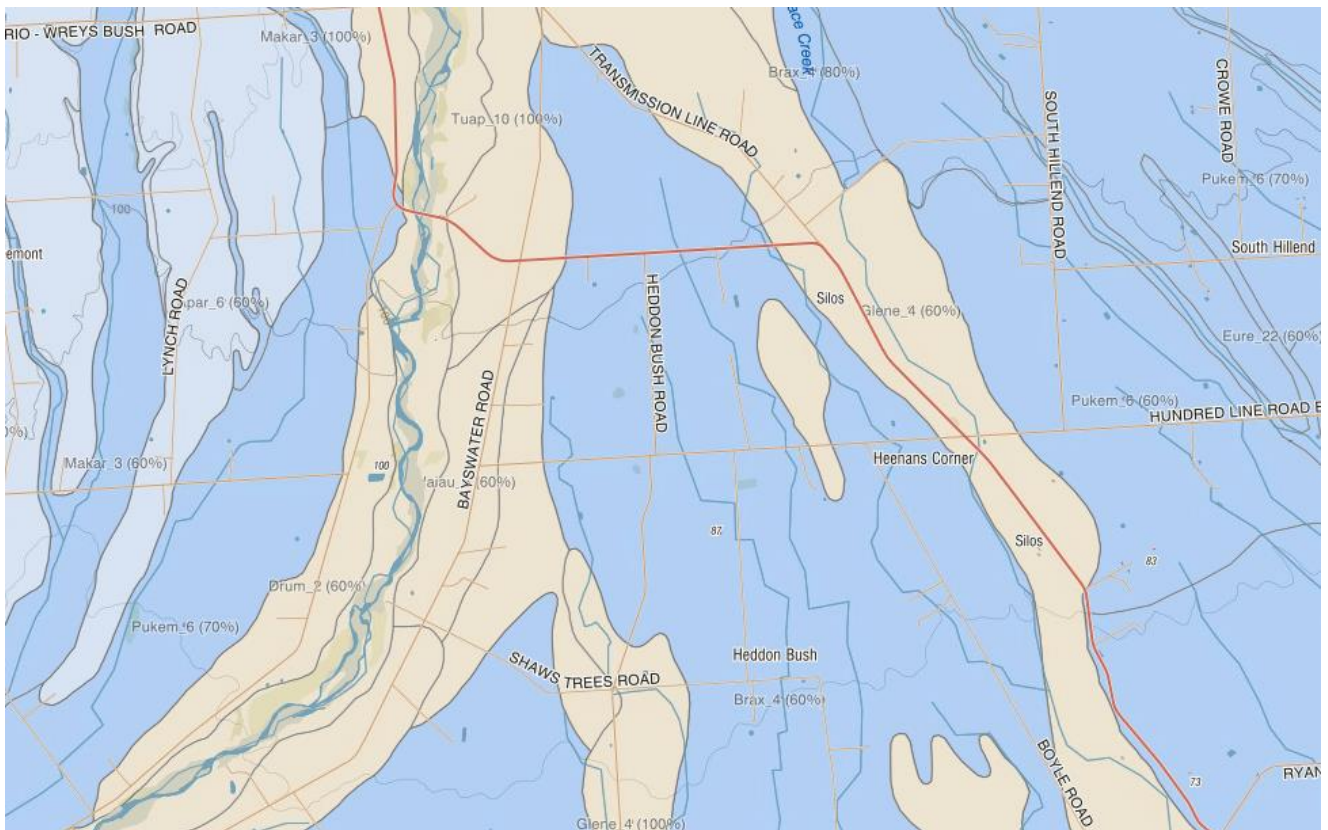
Figure 4: S-map representation of soils in the area of the dairy platforms and the Horner Block (blue = heavy poorly drained soils, cream/yellow = relatively shallow well-drained soils)

3.5 The land use in the catchments is predominantly sheep and beef, dairying and some grain growing. The primary AEE summarises the results of on-site soil investigations. In addition to these assessments, the Landcare Research S-map database¹ has been assessed and supports the conclusions that the WW1&2& HB properties have both deep poorly drained soils (Braxton) and shallow well-drained soils (Glenelg). This is illustrated in Figure 4 and the primary AEEs have a more detailed discussion on the results of a field investigation of soil characteristics and the implications of soils for contaminant loss to water. The WW5 land has a greater proportion on the well-drained soils.

3.6 The heavier soils provide for significant run-off during rainfall events and artificial drainage provides an important transport route. The free-draining soils provide a primary contaminant transport route to groundwater.

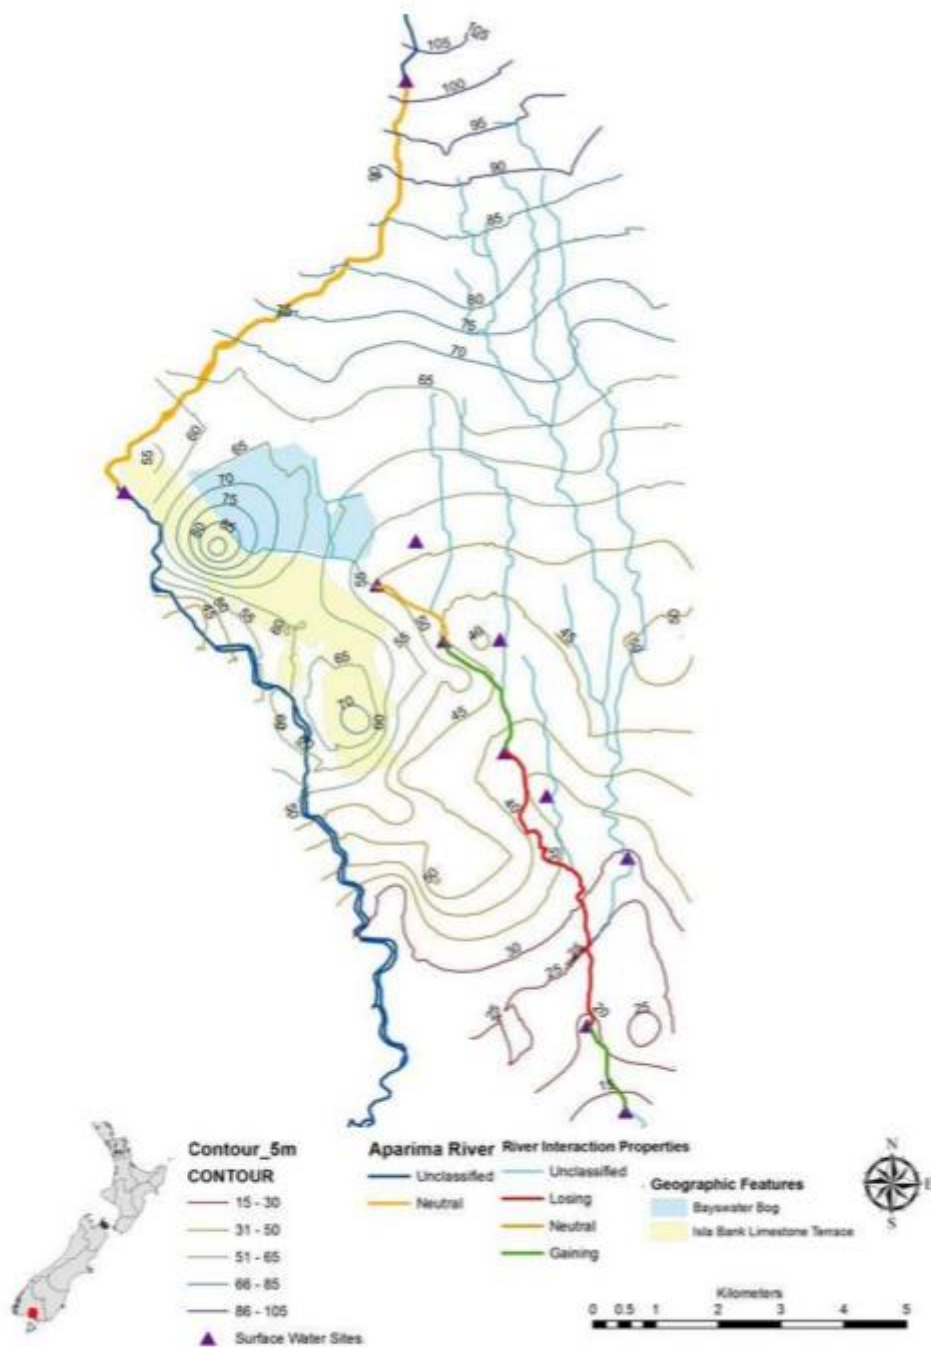
Figure 5: Piezometric contour diagram from Hitchcock thesis showing groundwater flow direction and some stream sections losing/gaining flows to/from groundwater

3.8 There is little piezometric contour information available for the wider area with the exception of an MSc thesis³ undertaken in the upper catchment of the Waimatuku Stream. A figure from that thesis helps to clarify the direction of groundwater flow in the upper reaches of the Waimatuku Stream and is reproduced as Figure 5.

3.9 This groundwater contour information strongly indicates that groundwater flow direction is generally southerly and depending on groundwater levels would recharge tributaries of the Waimatuku Stream, Aparima River and Oreti River depending on location. Some drainage water will enter groundwater and recharge surface waters some distance down-gradient and some

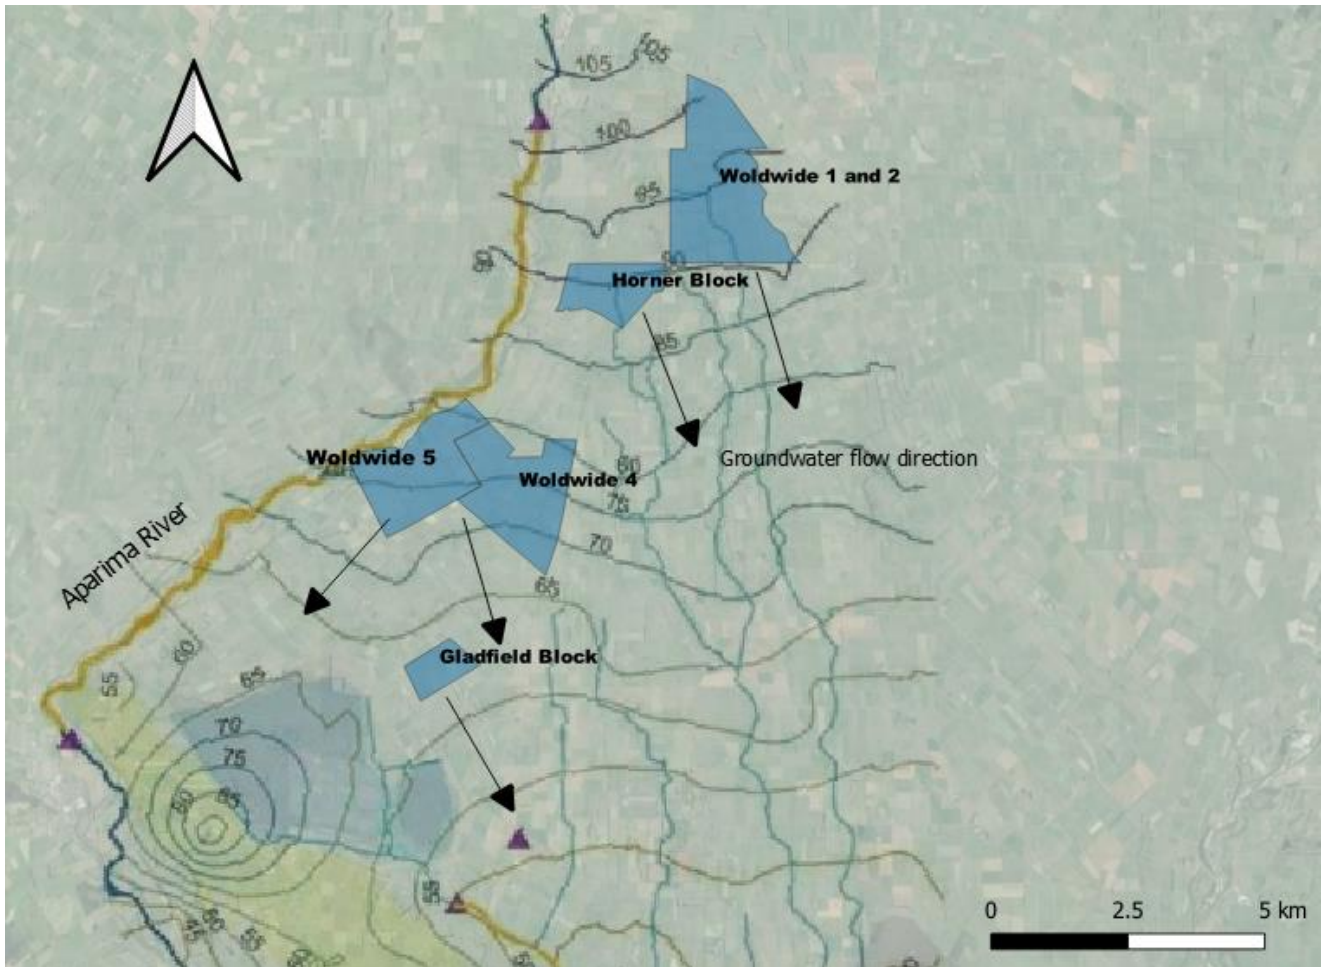
Figure 6: Piezometric contour diagram from Hitchcock thesis georeferenced showing groundwater flow paths relative the location of Woldwide properties

3.10 To assist in identifying the direction of groundwater flow relative to each of the properties the diagram from Ms Hitchcock's thesis has been georeferenced to Google earth and the location of the Woldwide properties to more clearly indicate the direction of groundwater flow relative to the properties. This is illustrated in the following figure.

7.14 The groundwater contour mapping illustrated in Figure 6 strongly indicates that the majority of groundwater that receives drainage from the WW1&2 and Horner Block properties will move in a southerly direction and is likely to eventually recharge the Waimatuku Stream further down the catchment. Nitrogen loading reductions will contribute to a very small loading to groundwater that moves down-gradient in the Waimatuku catchment.

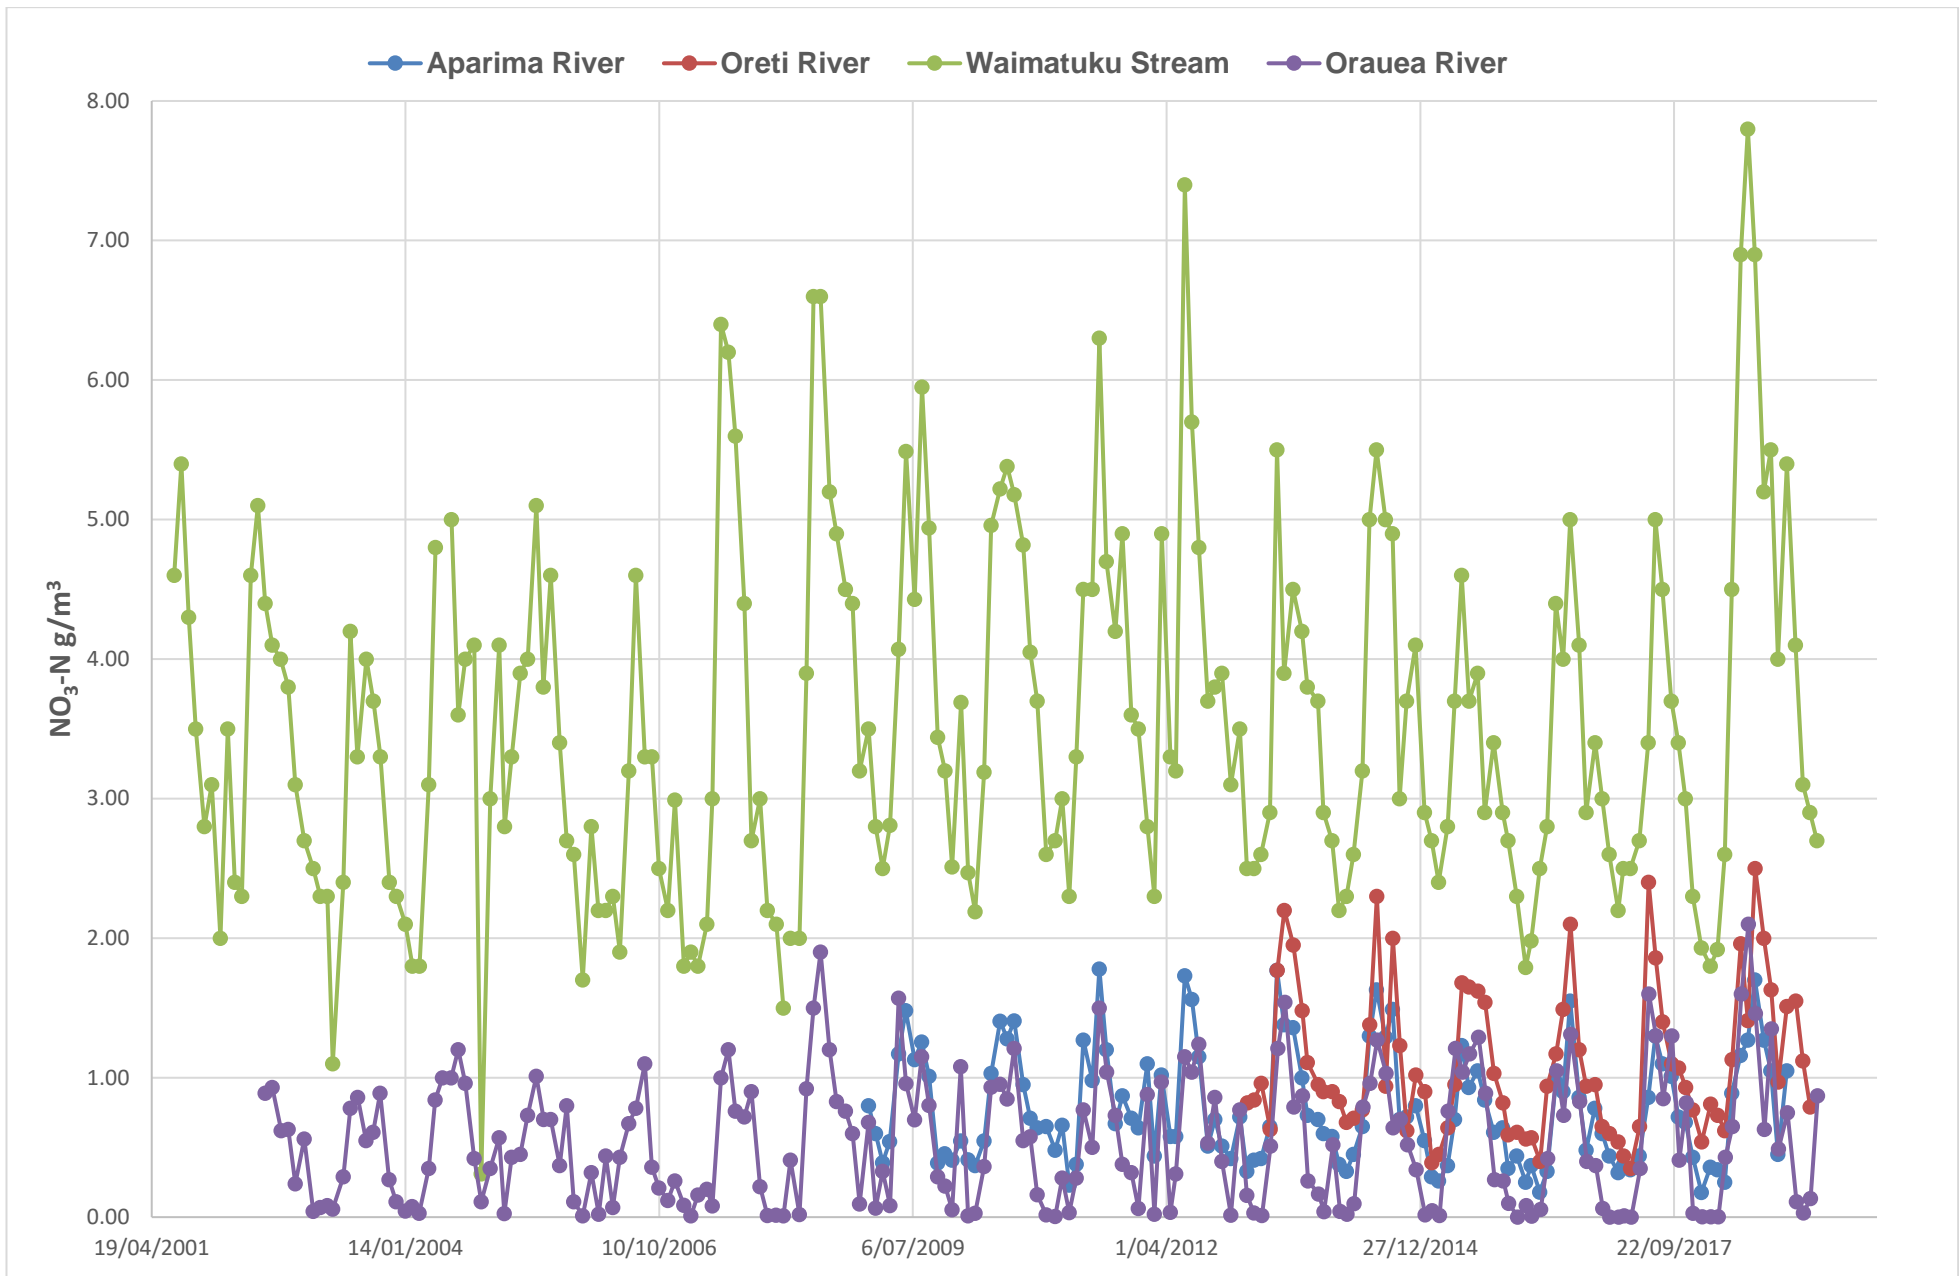
Figure 7 Total oxidised nitrogen changes over the last ~20 years in the four rivers/streams

5.12 An example of the differences in water quality and the nature of the annual changes in nutrient concentrations is illustrated in the following diagram that compares the changes in total oxidised nitrogen in the four rivers over recent years.

- 5.13 The nitrate nitrogen data illustrate the annual rise and fall in nitrate nitrogen concentrations that happens; generally during/after the winter period when surplus nitrogen in the soil profile drains through to groundwater and then moves through to surface water. In addition, the data highlights the significantly higher nitrate nitrogen concentrations in the Waimatuku Stream with annual winter high concentrations recently peaking at 7.8 g/m³.

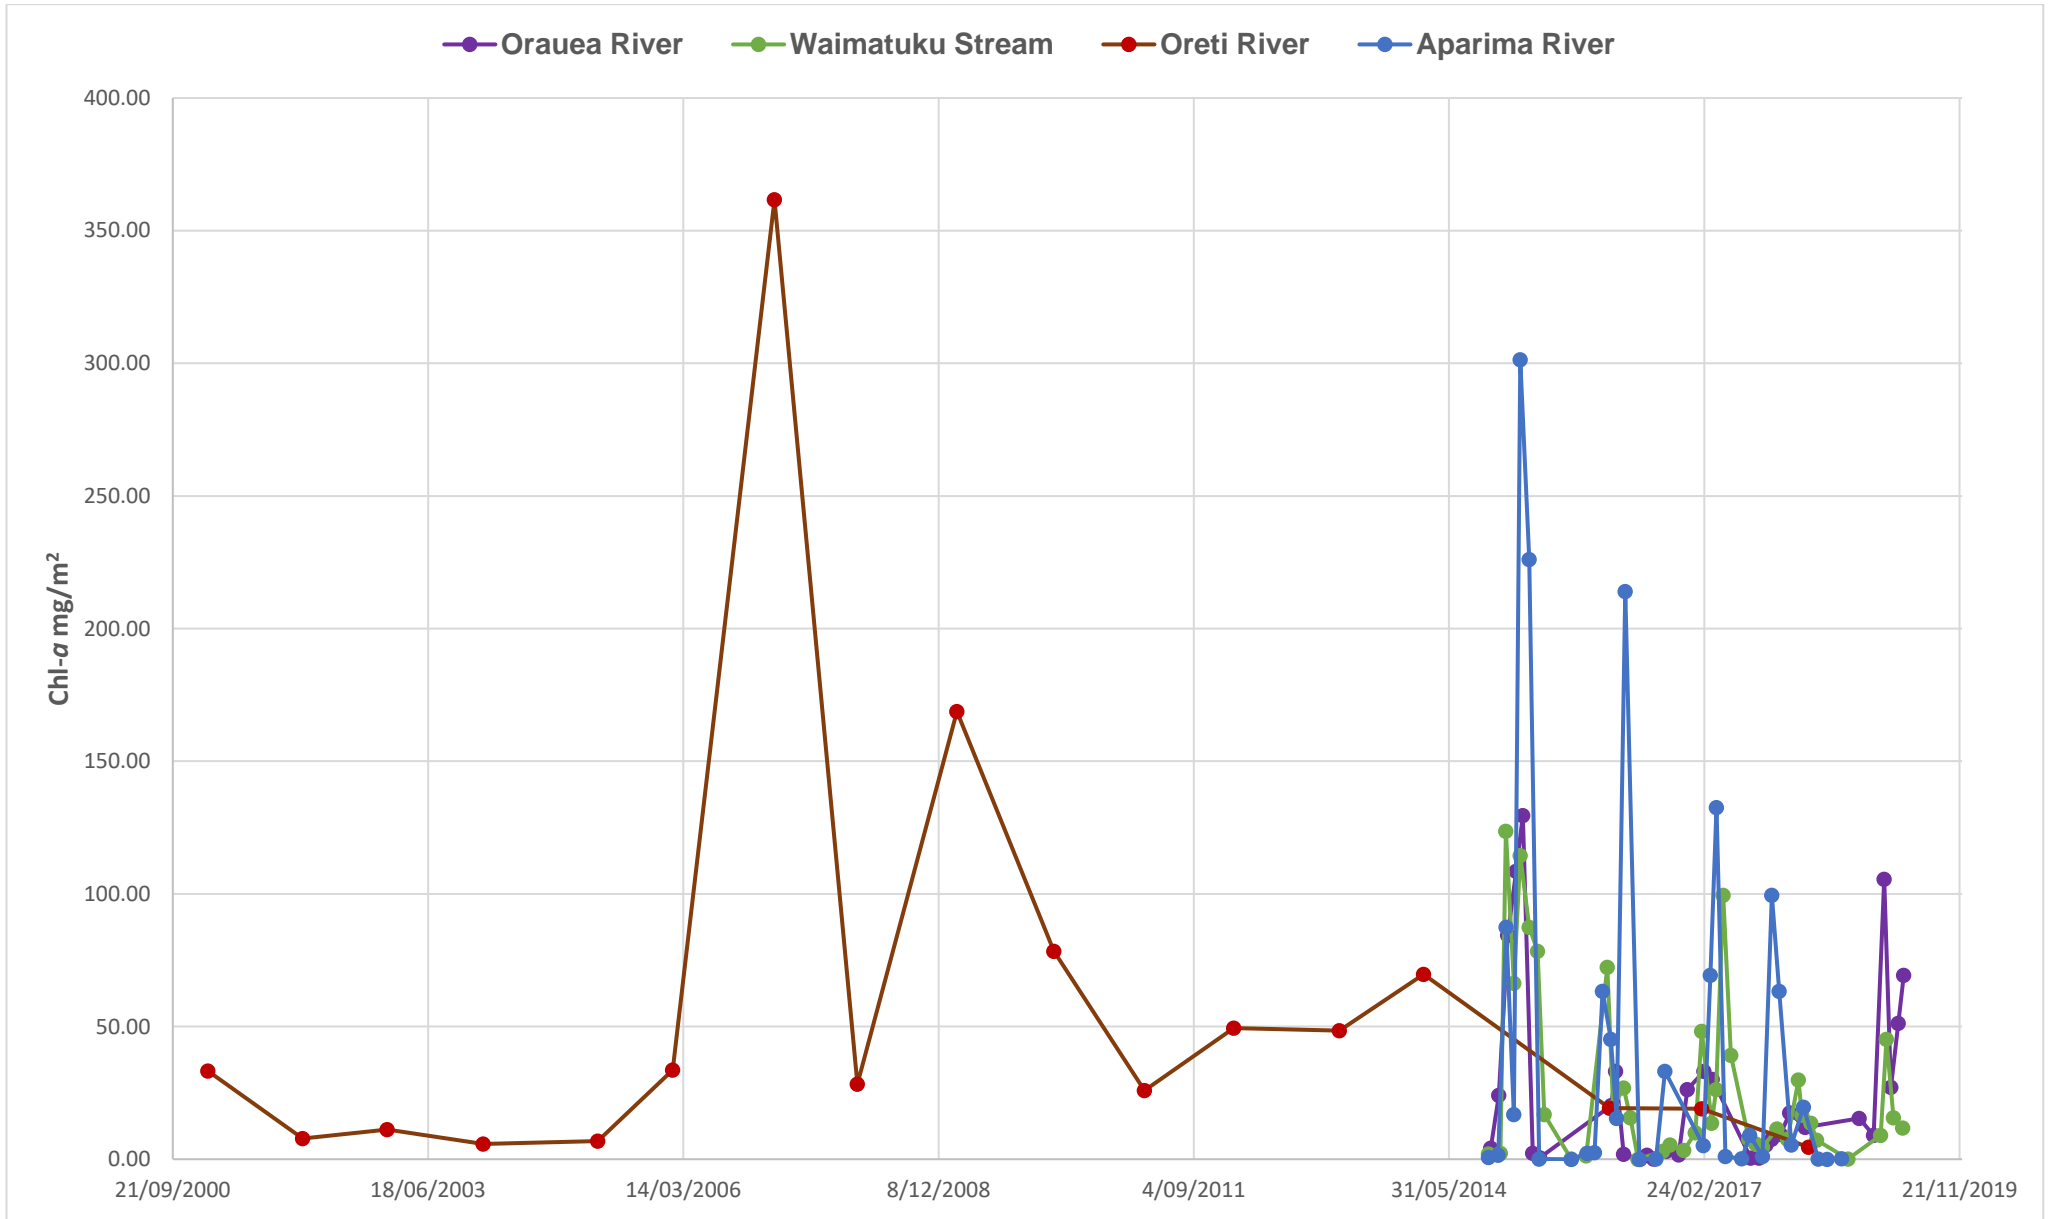
Figure 8: Periphyton chlorophyll-a biomass at four sites on the four rivers/streams

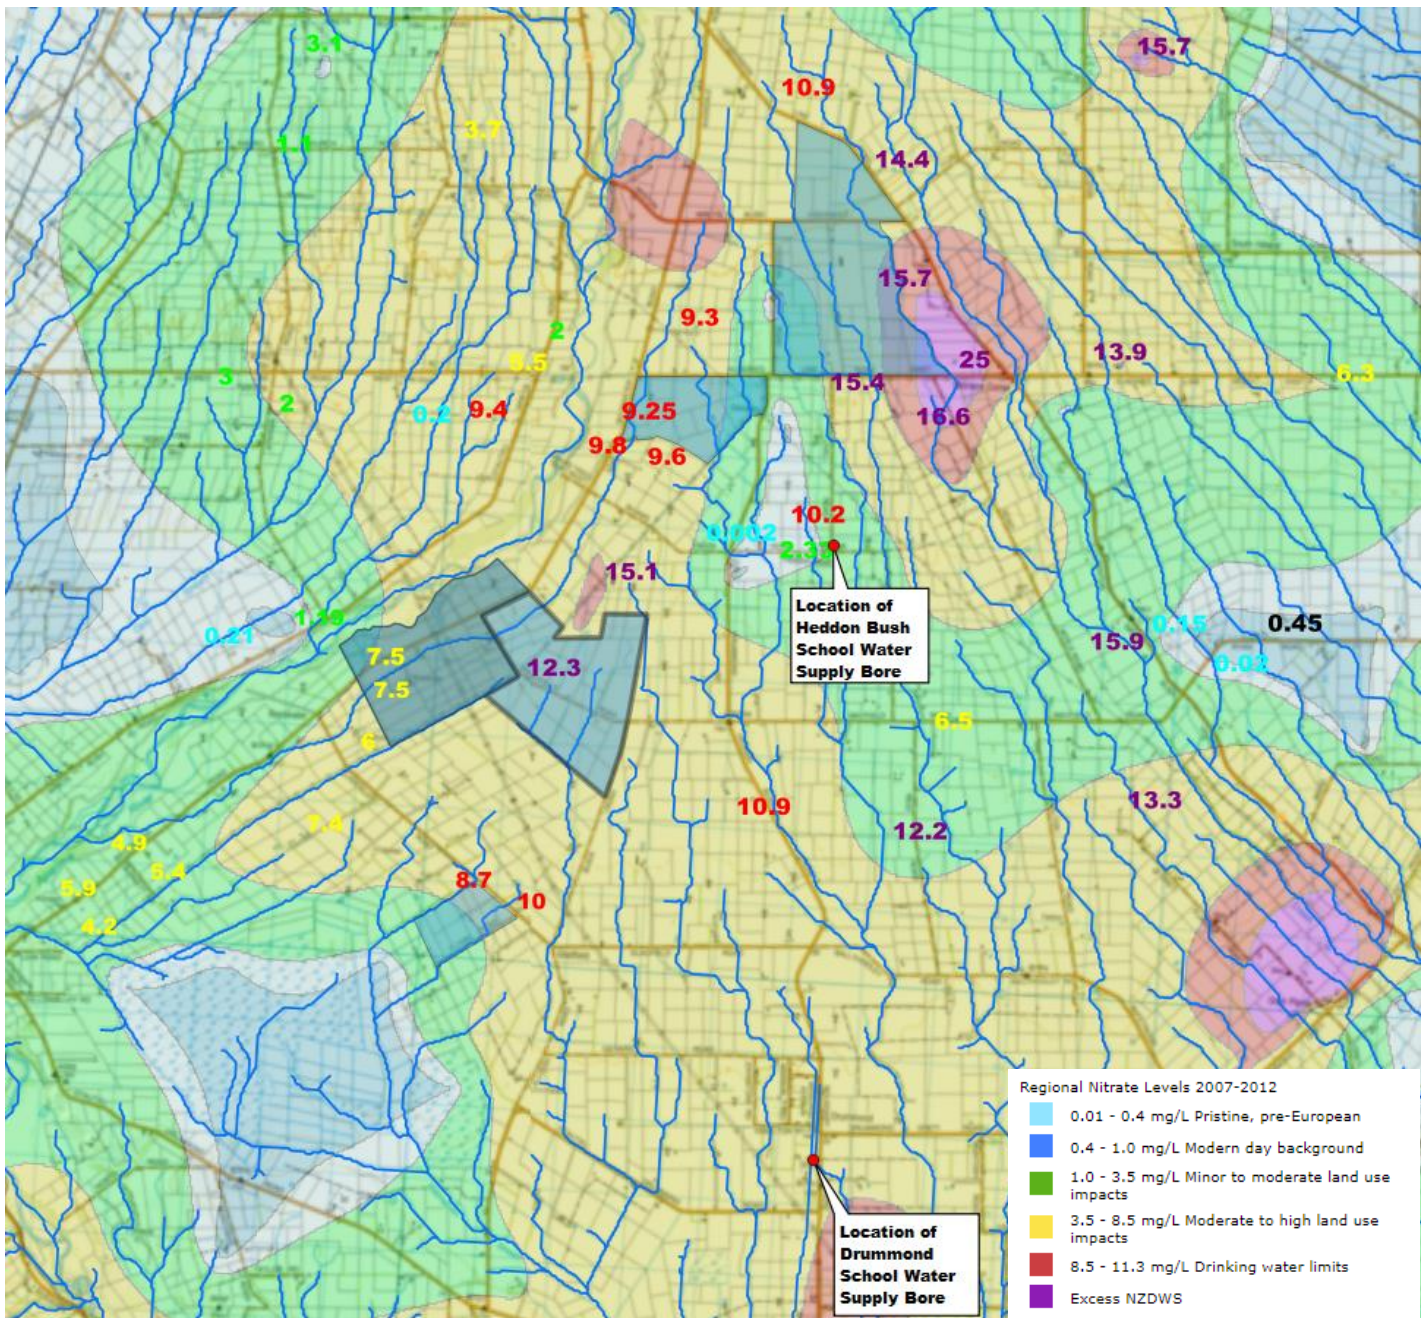
Figure 9: Environment Southland groundwater nitrate nitrogen concentration contour estimates for the period 2007 – 2012 with location of property overlaid, and more recent peak nitrate nitrogen results

- 5.26 Interpretation of the contour data should be done with great care because there are a limited number of results that have been used as the basis for developing these groundwater quality contours, and the source data includes results from a very wide range of bores. Many of these bores, particularly those that have been installed in recent years as a requirement of resource consent conditions are relatively shallow (<8 m depth) and some do not appear to have been installed with appropriate well head protection (in spite of bore land use consent conditions apparently requiring compliance with NZS 4411:2001 (Environmental standard for drilling of soil and rock)).

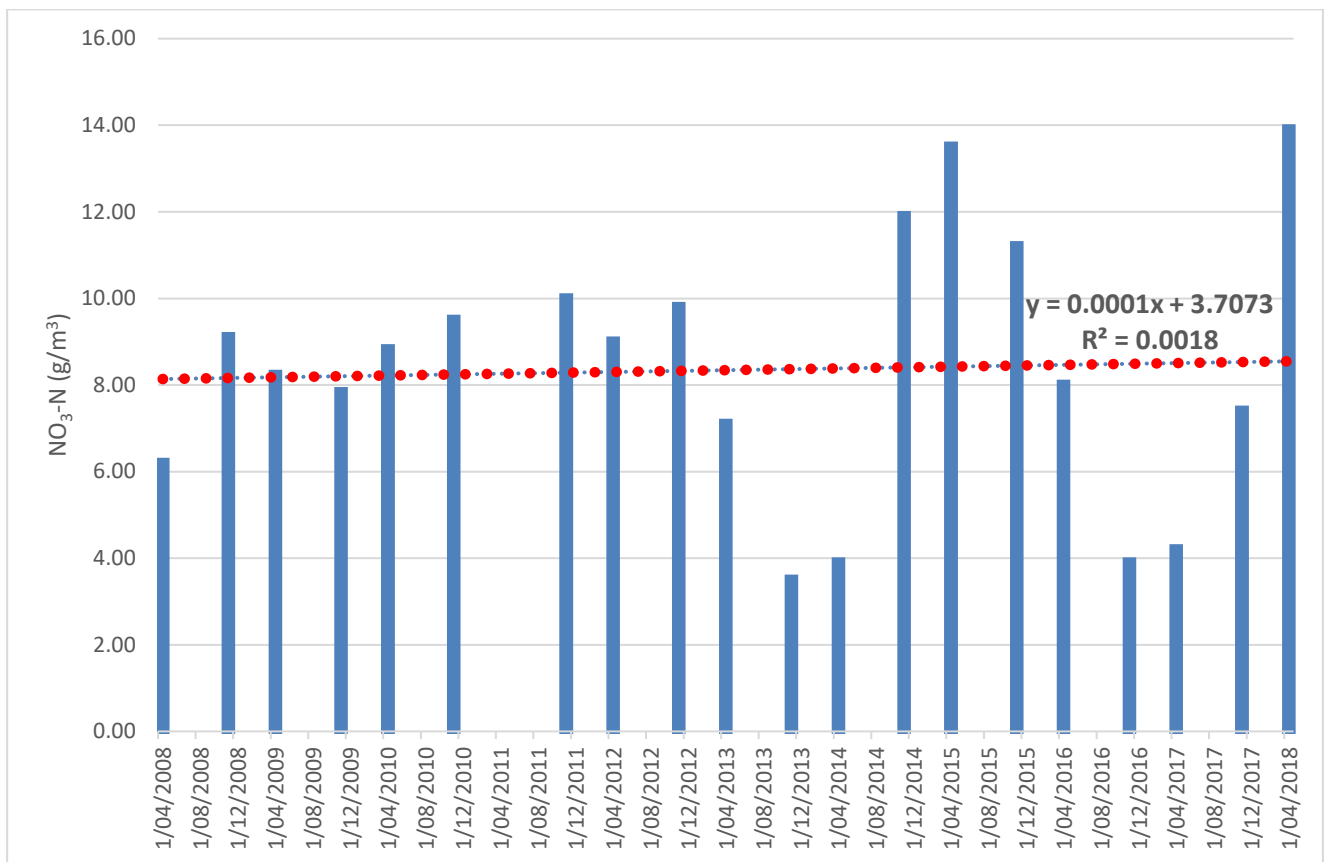
Figure 10: Nitrate nitrogen concentrations in groundwater from bore E45/0081, 2008-2018 (showing as a purple '13.9' east of the property in Figure 9)

5.32 The results from this bore (E45/0081, Figure 13) indicate some significant variability over time that may reflect real changes in regional groundwater quality, for example, the responses to increased drainage after a winter period with significant drainage and the possible decrease in nitrate nitrogen in response to the relatively dry period in 2017, with a significant increase in very recent years that possibly reflects an increase in drainage. However, the use code for the bore is noted in the Environment Southland system as a groundwater quality monitoring which is likely to indicate that it has been established to monitor the localised effects of dairy shed effluent disposal rather than regional groundwater quality. The low R² value of 0.0018 and the obvious peaks and troughs indicate that an overall trend is not obvious.

5.33 This bore was included in the observational assessment and was identified as having poor wellhead protection, close to contaminant sources, surface water flow path and stock access, indicating a potential for localised groundwater contamination via the bore.

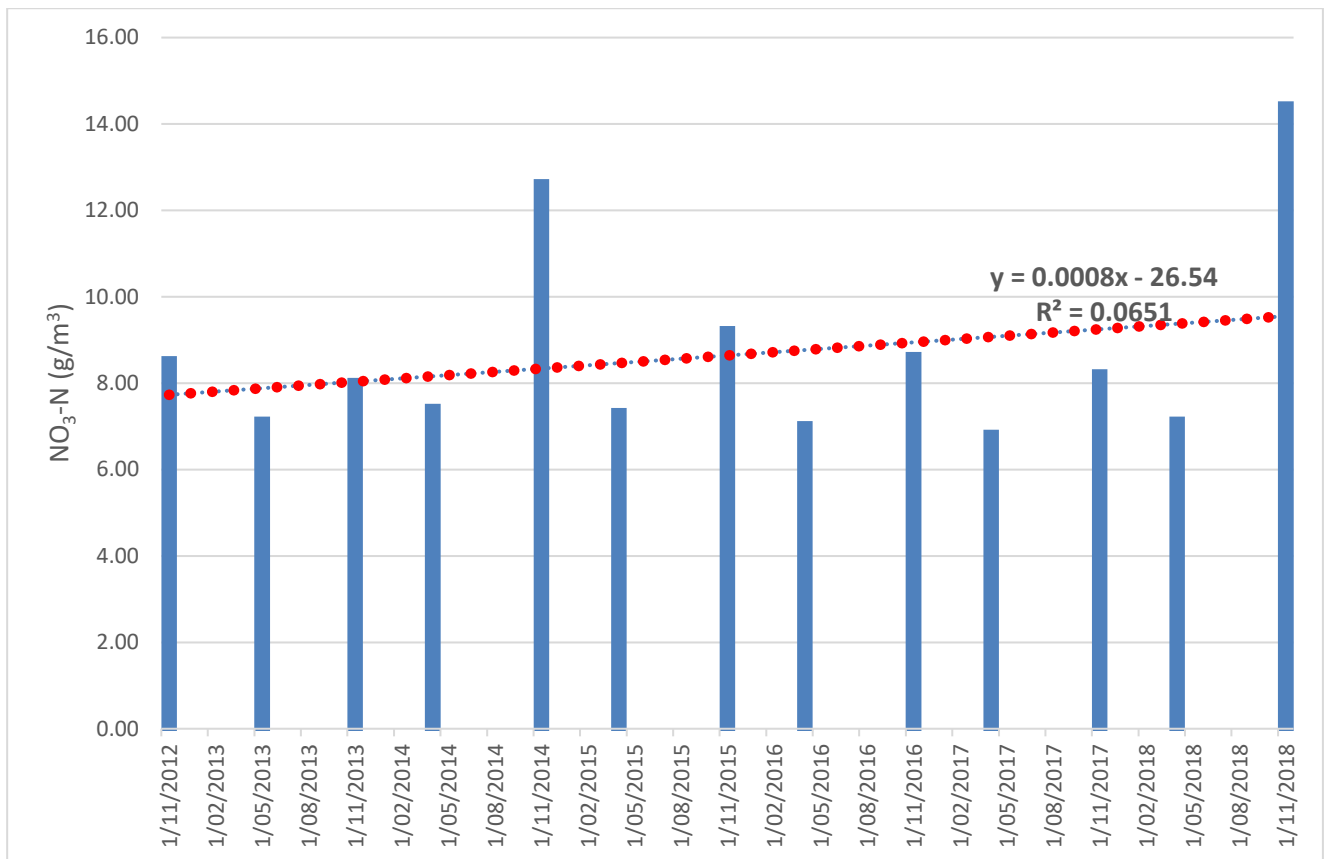
Figure 11: Nitrate nitrogen concentrations in groundwater from bore E45/0610, 2009-2018 (showing as a purple '14.4' north east of the property in Figure 9)

5.34 The data from bore E45/0610 potentially indicate similar summer and winter lows and highs in nitrate nitrogen concentrations. There is an apparent small increasing trend but the very low R² value indicates that there is little confidence that this indicates a real trend in groundwater nitrate nitrogen concentrations.

5.35 The use code for this bore is noted as dairy use rather than groundwater quality monitoring so it is less likely that groundwater from this bore is directly influenced by dairy shed effluent discharges. This bore was not inspected as part of the bore observation assessment.

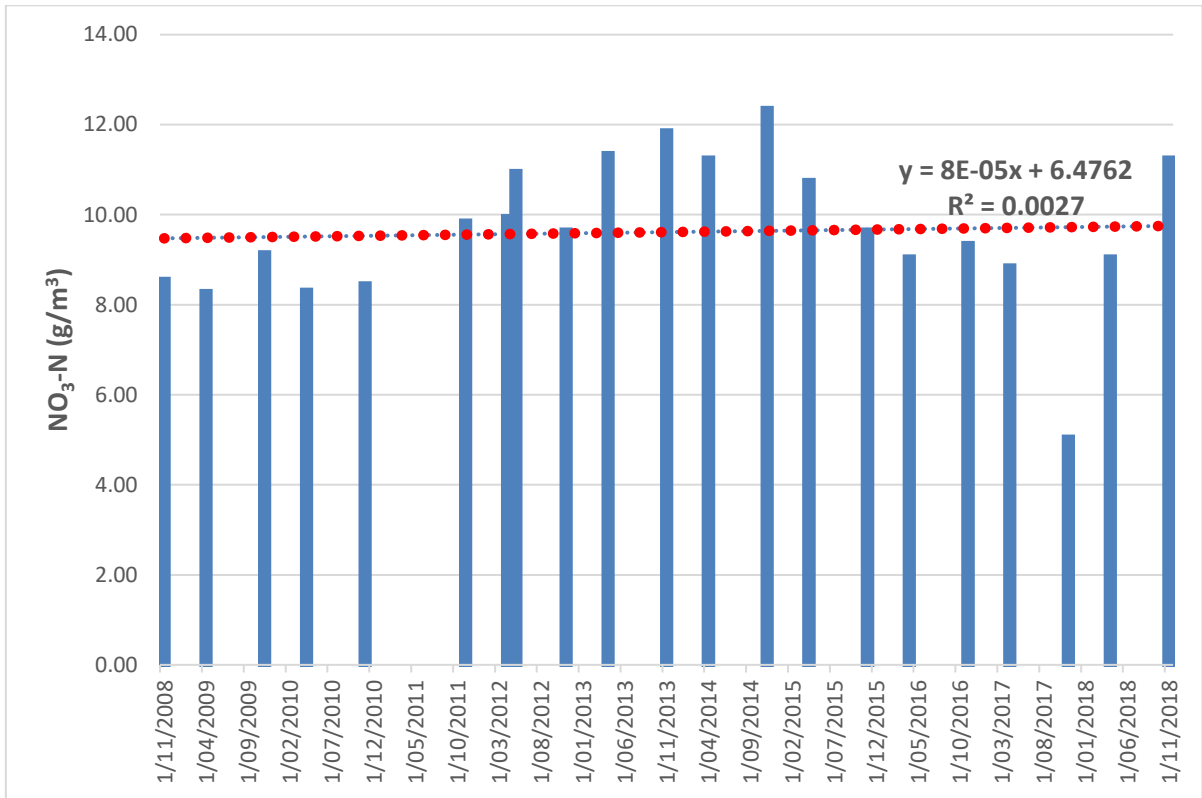
Figure 12: Nitrate nitrogen concentrations in groundwater from bore E45/0458, 2008-2018 (showing as a purple '12.3' south west of the property in Figure 9)

5.36 The results from bore E45/0458 down-gradient from the Horner block are illustrated in the following figure. However, as noted for bore E45/0081, the use code for this bore is also noted in the Environment Southland system as a groundwater quality monitoring which is likely to indicate that it has been established to monitor the localised effects of dairy shed

effluent disposal rather than regional groundwater quality. This bore was not inspected as part of the bore observation assessment.
