Water quality assessments

**Woldwide One Limited and
Woldwide Two Limited
&
Woldwide Four Limited and
Woldwide Five Limited**

Reference: 19180

Date: 26 August 2019

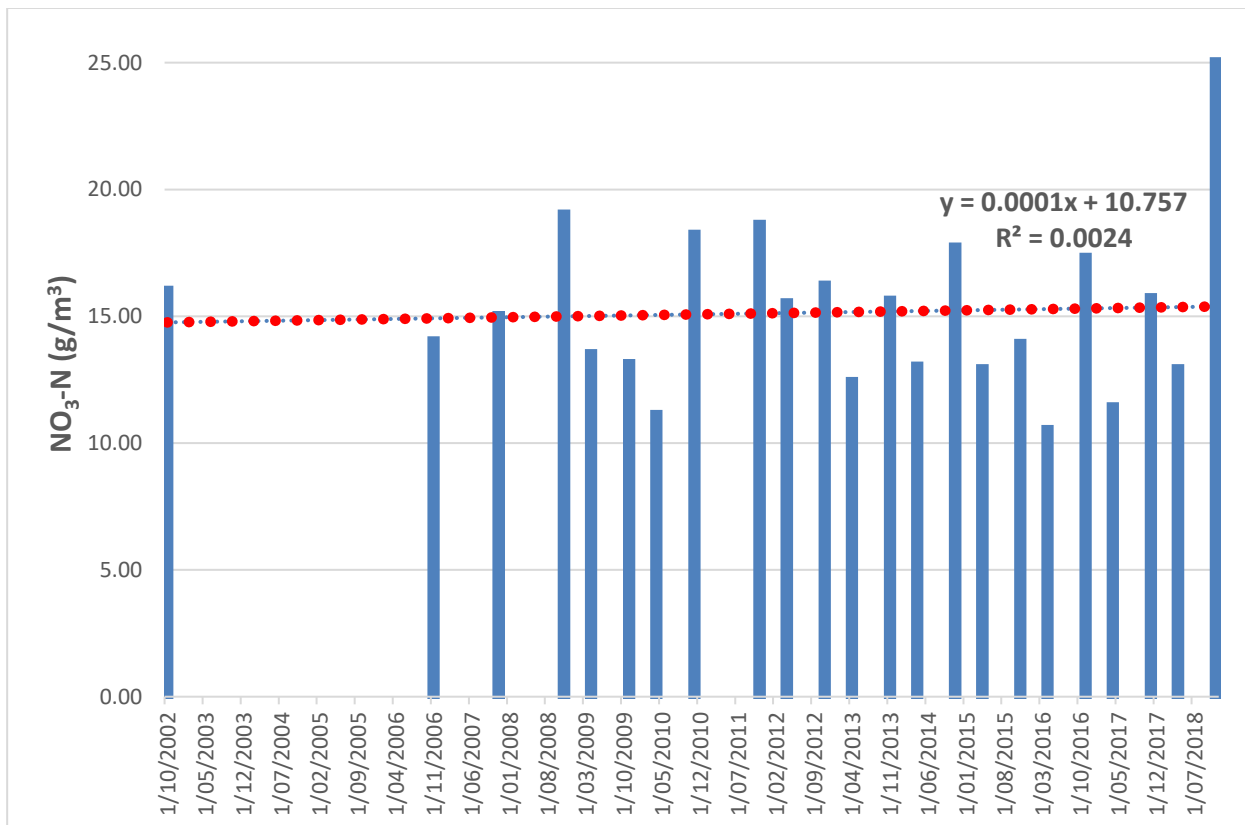
Figure 13: Nitrate nitrogen concentrations in groundwater from bore E45/0060, 2002-2018 (showing as a purple '25' south east of the property in Figure 9)

- 5.37 The very high concentrations found in groundwater from bore E45/0060 are likely to be related to the proximity to a dairy shed and effluent pond immediately upgradient from the bore of unverified depth. These concentrations are consistently high but with some peaks indicating a possible local source of contamination.

- 5.38 This bore was included in the observational assessment and was identified as having poor wellhead protection, close to contaminant sources, surface water flow path and close but not immediate stock access, indicating a potential for localised groundwater contamination via the bore.

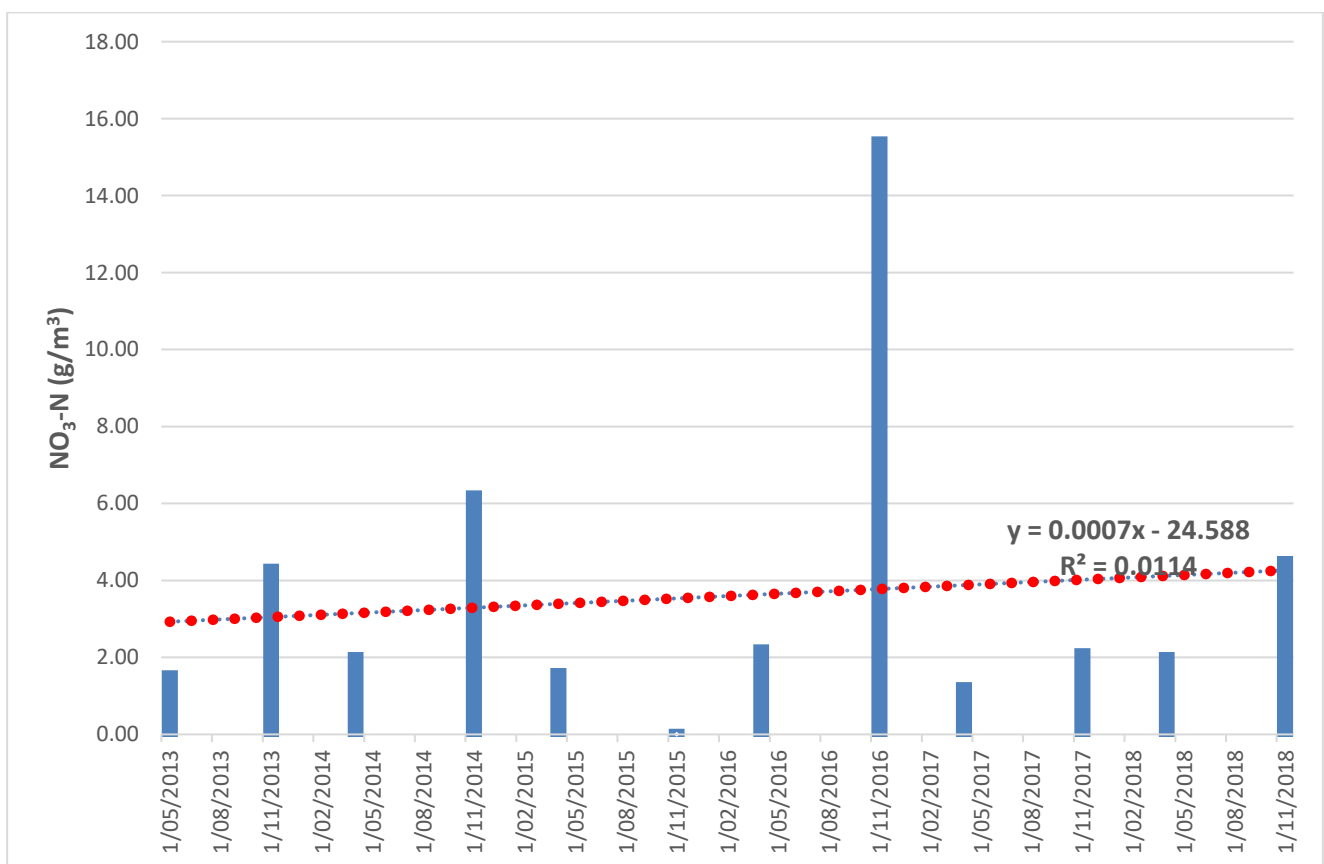
Figure 14: Nitrate nitrogen concentrations in groundwater from bore E45/0622, 2013-2018 (showing as a purple '15.4' south of the property in Figure 9)

- 5.39 The potential limitations of some of the groundwater data are particularly apparent from the results of sampling from bore E45/0622 which is referred to in the main AEE. The results for this bore from 2013 to 2018 are illustrated below. The peak nitrate nitrogen result for 2016 appears to highlight the pitfalls with very shallow (3 m deep, unverified) well/bore without adequate wellhead protection for groundwater quality monitoring. The peak is highly unlikely to represent the quality of the underlying groundwater which is more likely to be represented by the other results that appear to range between 2 – 6 g/m³ of nitrate nitrogen.

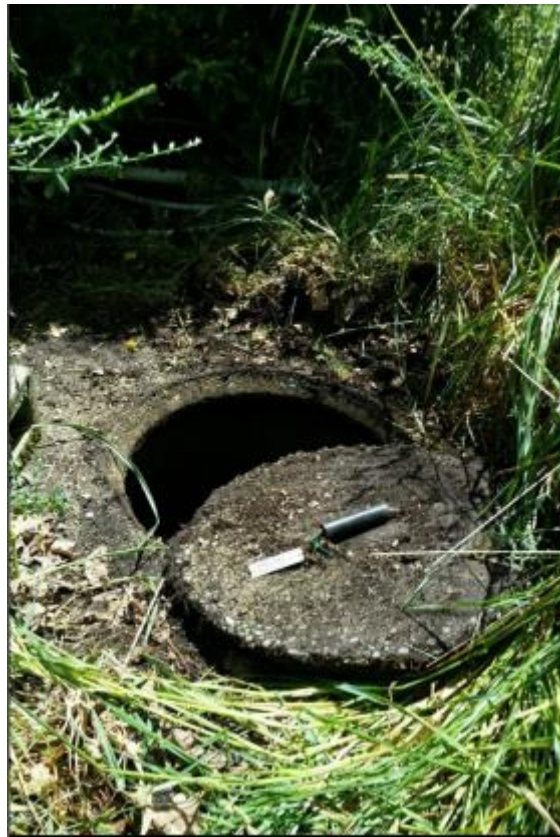
Figure 15: Bore E45/0622 in early 2019, showing the lack of wellhead protection and potential for surface water runoff entry

5.40 Bore E45/0622 is scheduled to be modified in late August/early September to raise the well significantly above ground level and a concrete apron will also be installed to ensure that this well meets the requirements of NZS 4411:2001.

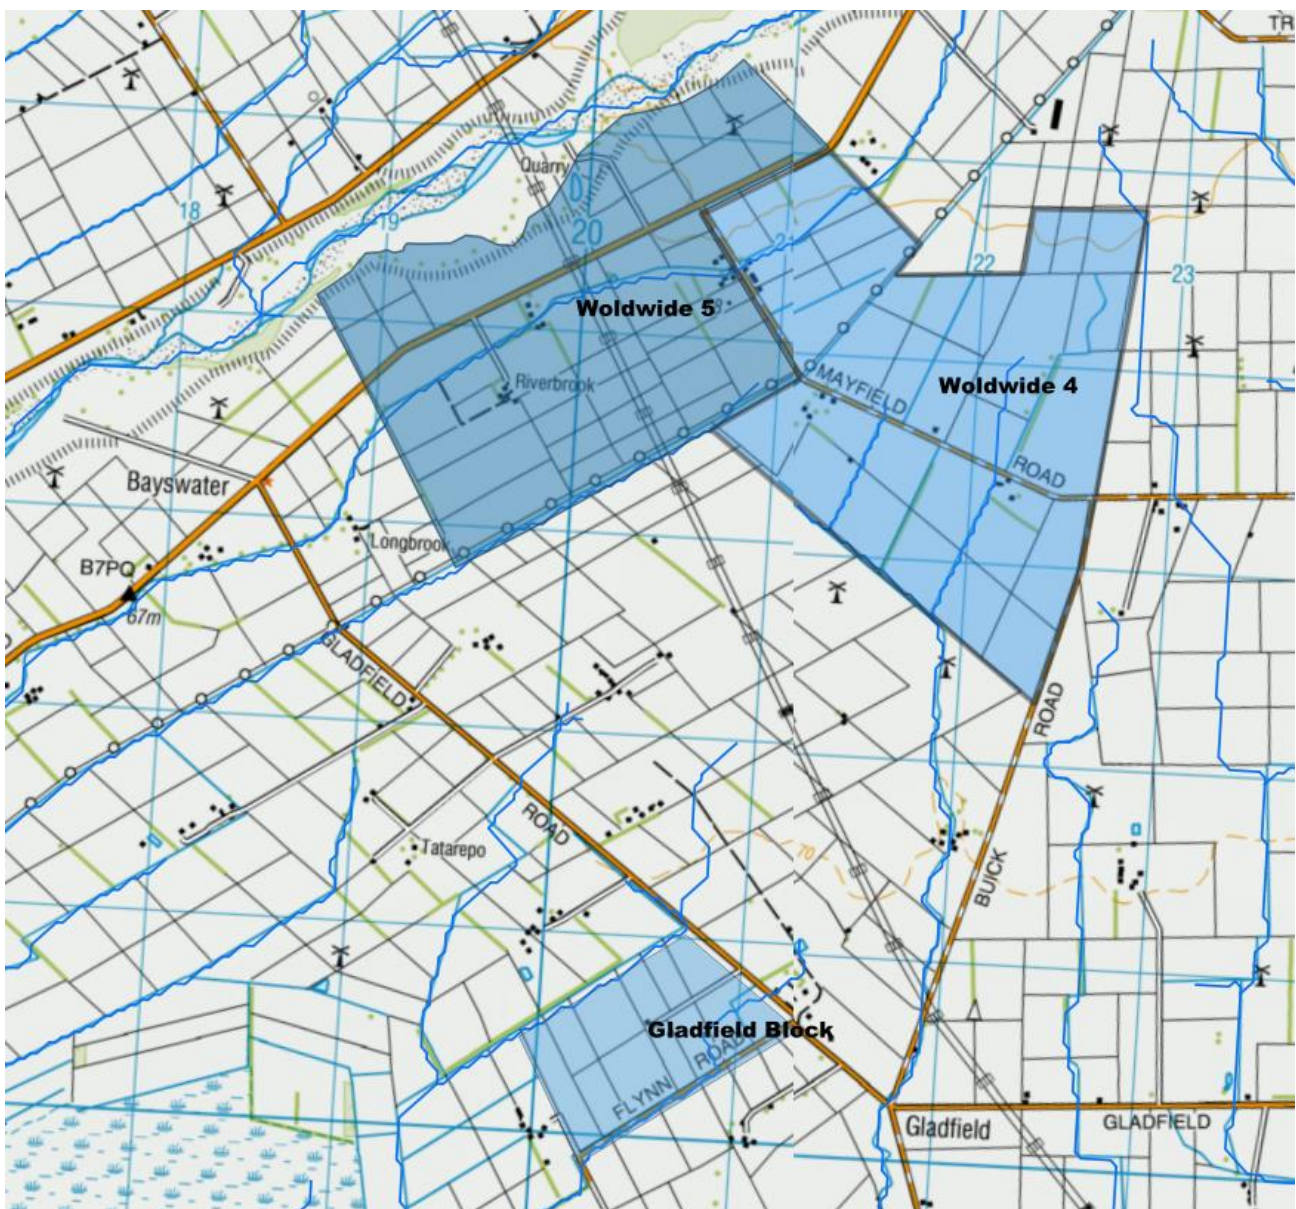
Figure 17: Woldwide 4 & 5 and the Gladfield Block and key streams/drains

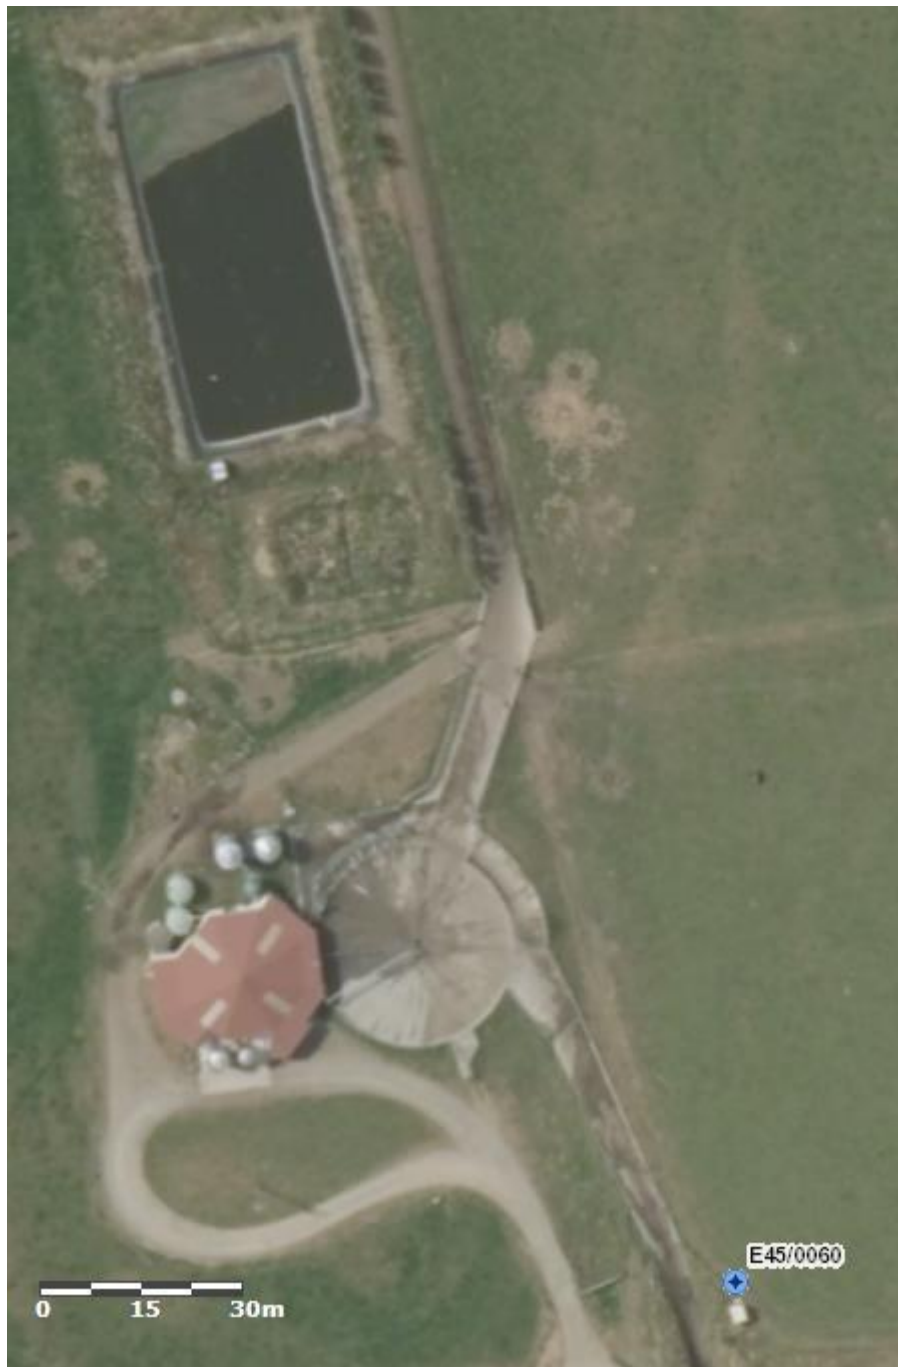
Figure 18: Location of monitoring bore E45/0060 relative to adjacent contamination sources

- 9.3 As noted earlier in this report, some groundwater quality results may not accurately indicate regional groundwater quality and in some locations groundwater quality is likely to be affected by contaminated surface water entering groundwater because of poor well head protection and proximity to contaminant sources. For example, bore E45/0060 was inspected as part of the survey of six bores. The location of this bore is illustrated in the following figure.

9.4 Bore E45/0060 is located extremely close to a dairy shed and associated lane and underpass, the wellhead protection is poor and there is a surface water flow path to the well. The results of sampling of this well are illustrated in Figure 11 and indicate that the results are likely to have been affected by these factors.

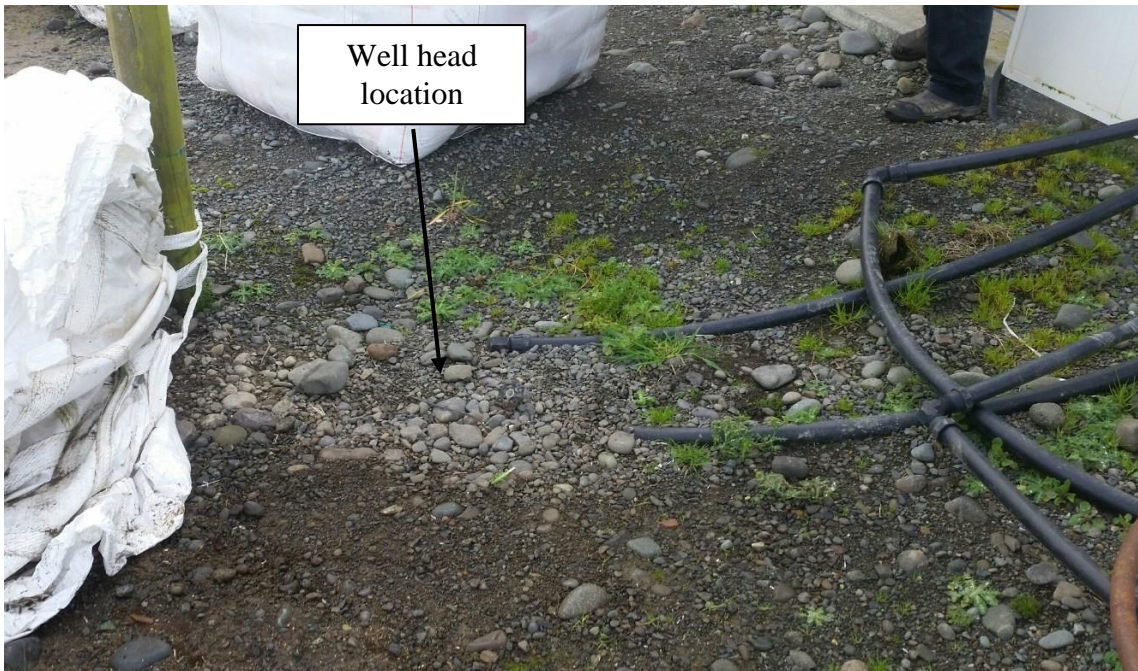
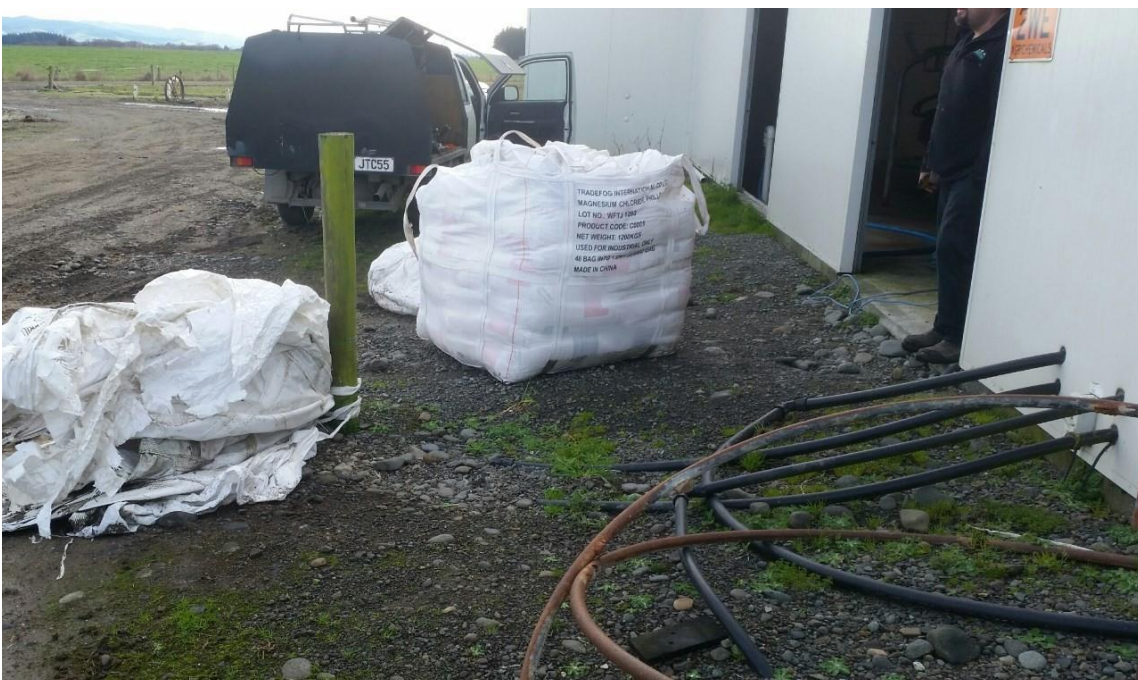
- Primary Use; Dairy
- Well head protection; Poor
- Proximity to contaminate sources; Close <200 m – Dairy Shed, Stock Lanes, Septic system
- Surface water flow path; Possible route to well
- Stock access; No
- Distance to surface water way; Close <100 m
- Suitability for groundwater monitoring; Low

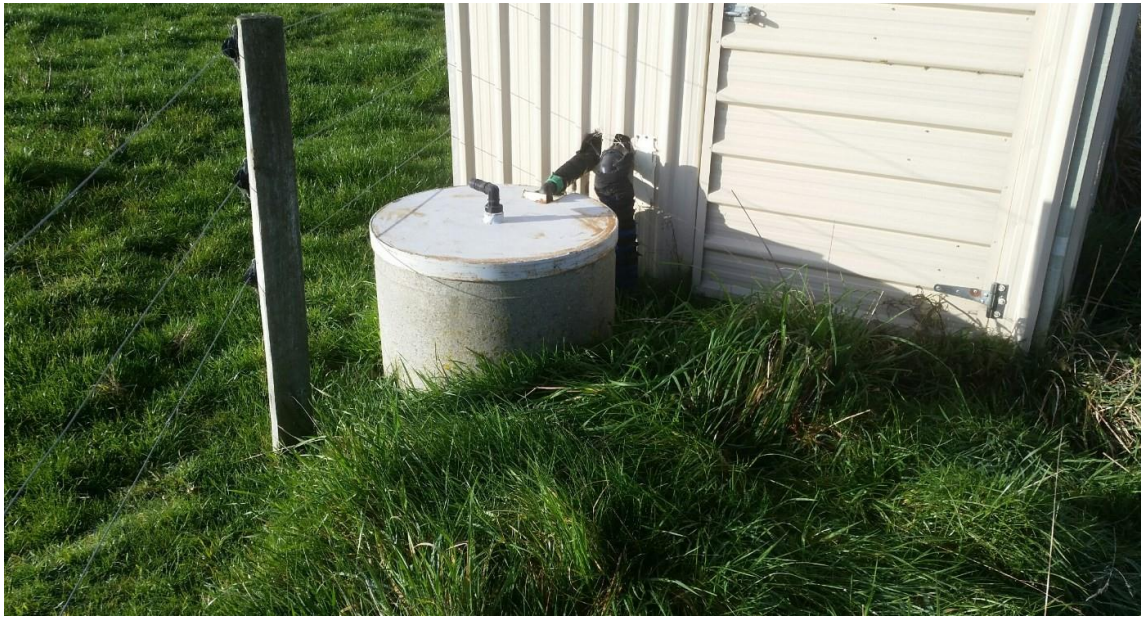
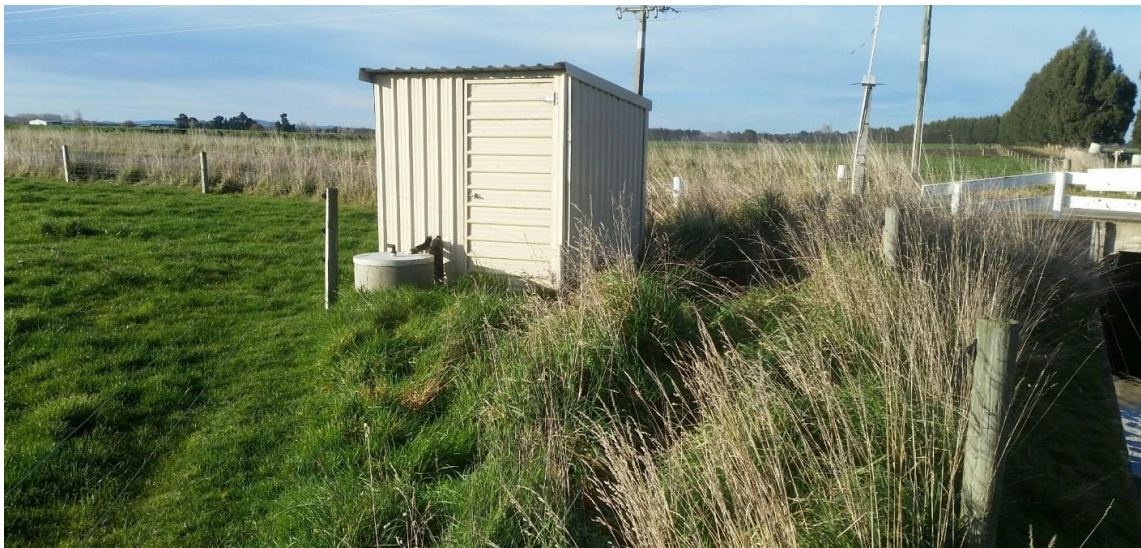
Well E45/XXXX: A well adjacent to a pump shed and 6 m from a stock underpass

- Primary Use; Dairy
- Well head protection; Poor
- Proximity to contaminate sources; Close <200 m – Dairy Shed, Stock Lanes, Underpass
- Surface water flow path; Clear route to well
- Stock access; No, however stock can access within 1 m of the well.
- Distance to surface water way; Close <100 m
- Suitability for groundwater monitoring; Low

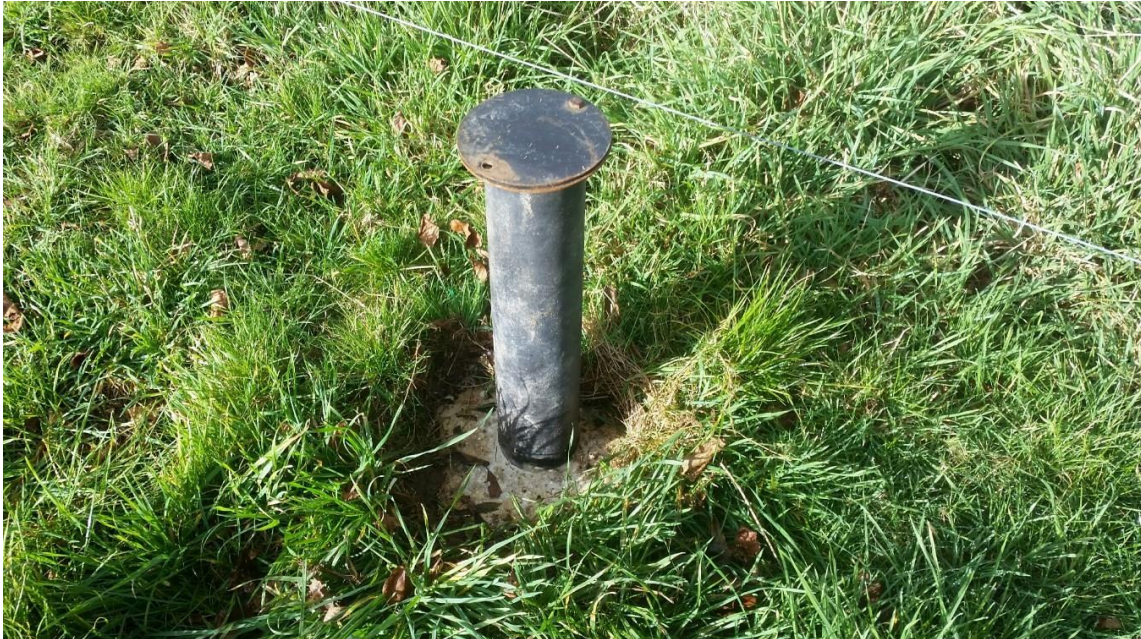
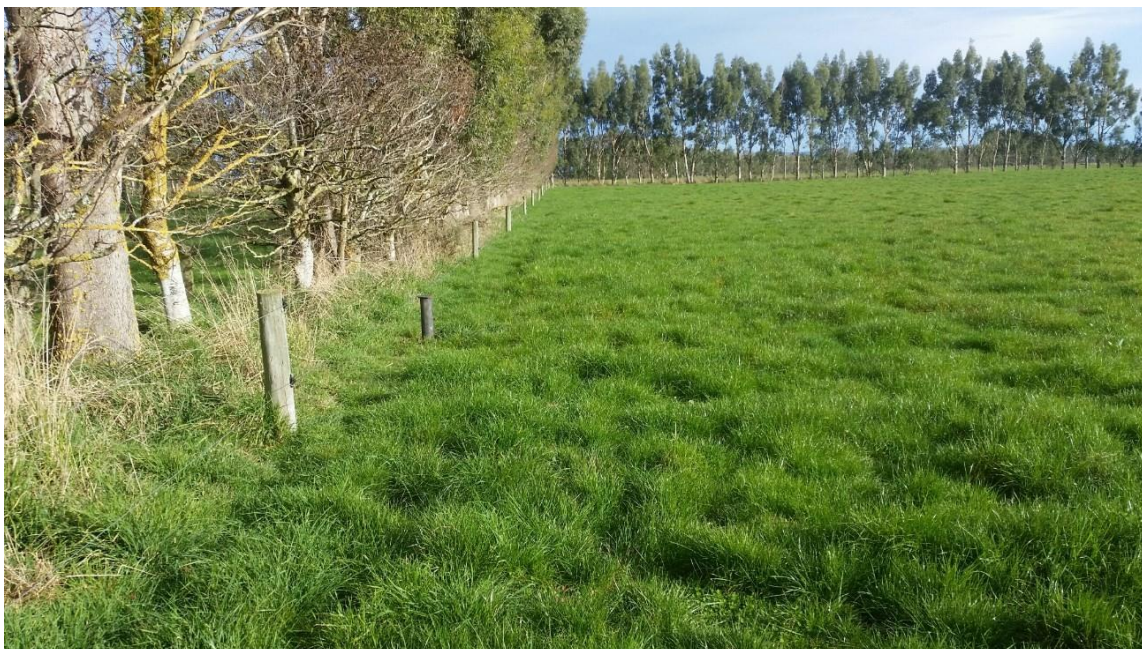
Well E45/XXXX: A bore adjacent to a shelter belt within a paddock

- Primary Use; Environment Southland Ground Water Monitoring
- Well head protection; Moderate
- Proximity to contaminate sources; Close <200 m – Shelter Belt/Stock Camp, Stock Lane, Water Trough
- Surface water flow path; No likely route to well
- Stock access; Yes
- Distance to surface water way; Moderate 100 m - 500 m
- Suitability for groundwater monitoring; Medium

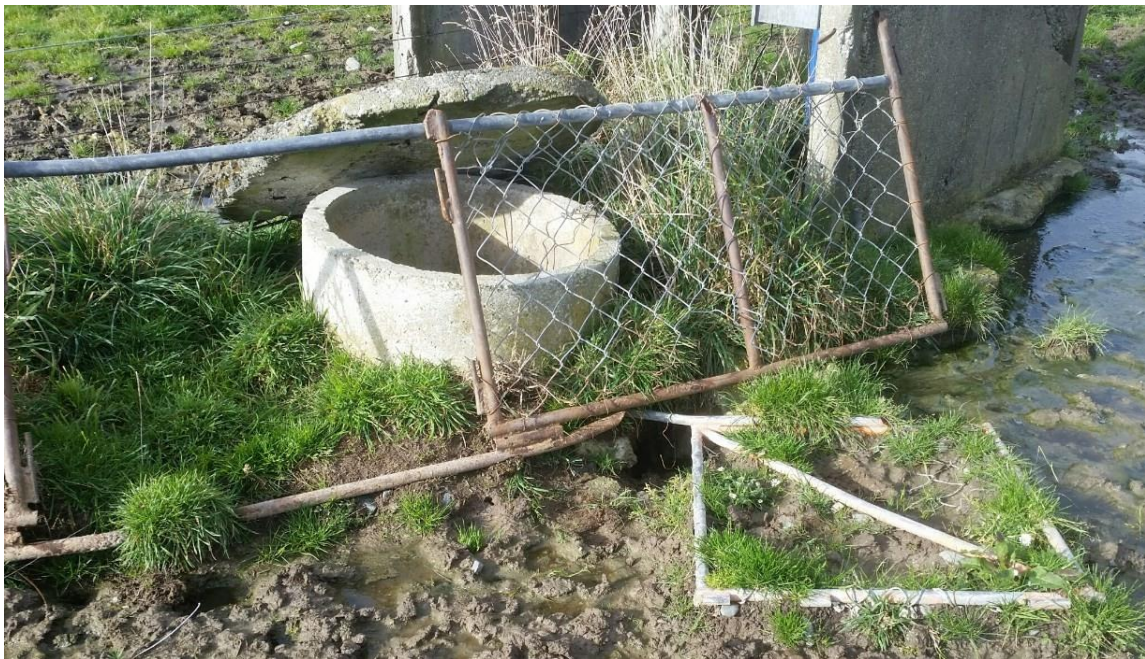
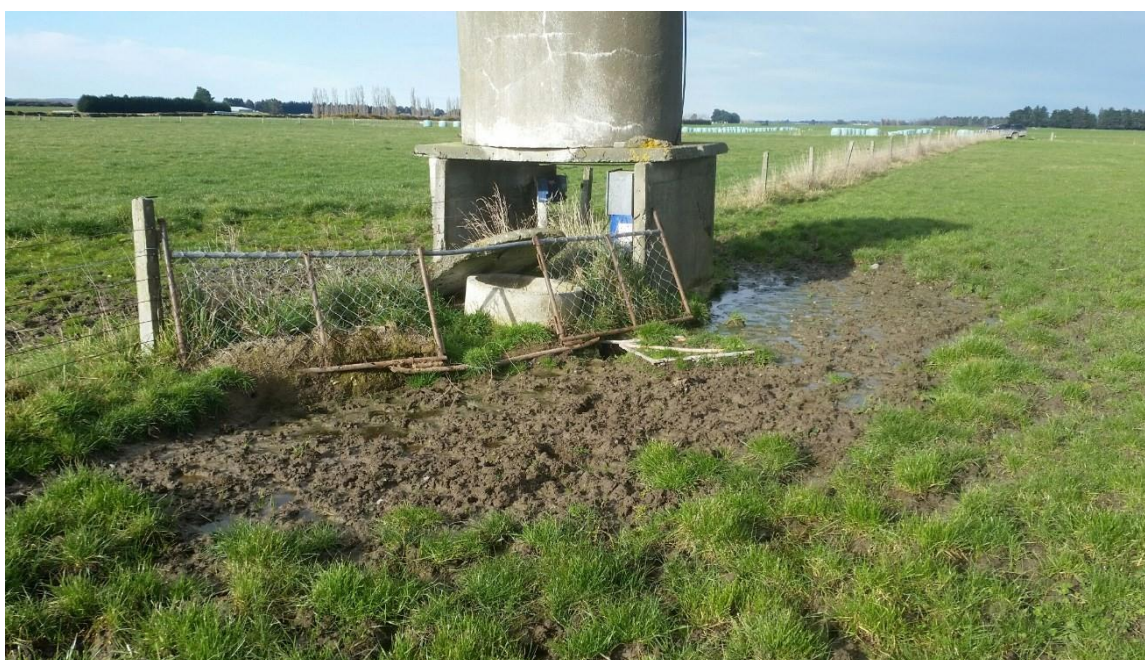
Well E45/XXXX: A well adjacent to a water tank within a paddock

- Primary Use; Environment Southland Ground Water Monitoring
- Well head protection; Poor
- Proximity to contaminate sources; Close <200 m – Stock Camp, Silage Pits
- Surface water flow path; Clear route to well (clear route to inside well pipe due to a hole at ground level)
- Stock access; Yes
- Distance to surface water way; Moderate 100 m - 500 m
- Suitability for groundwater monitoring; Low

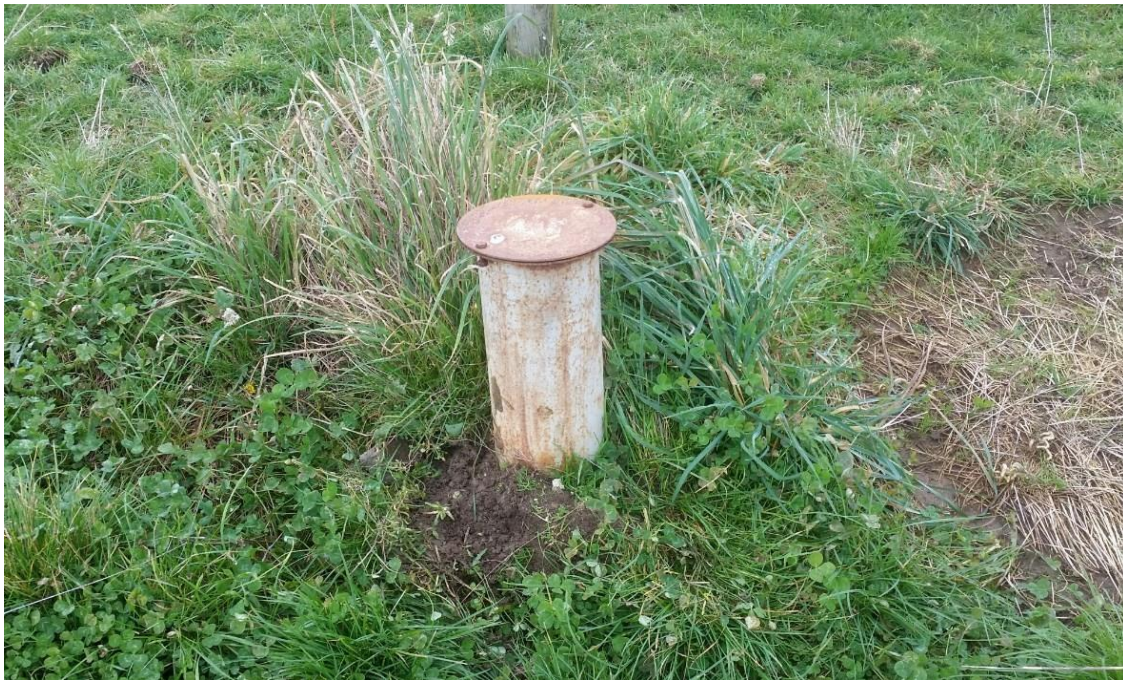
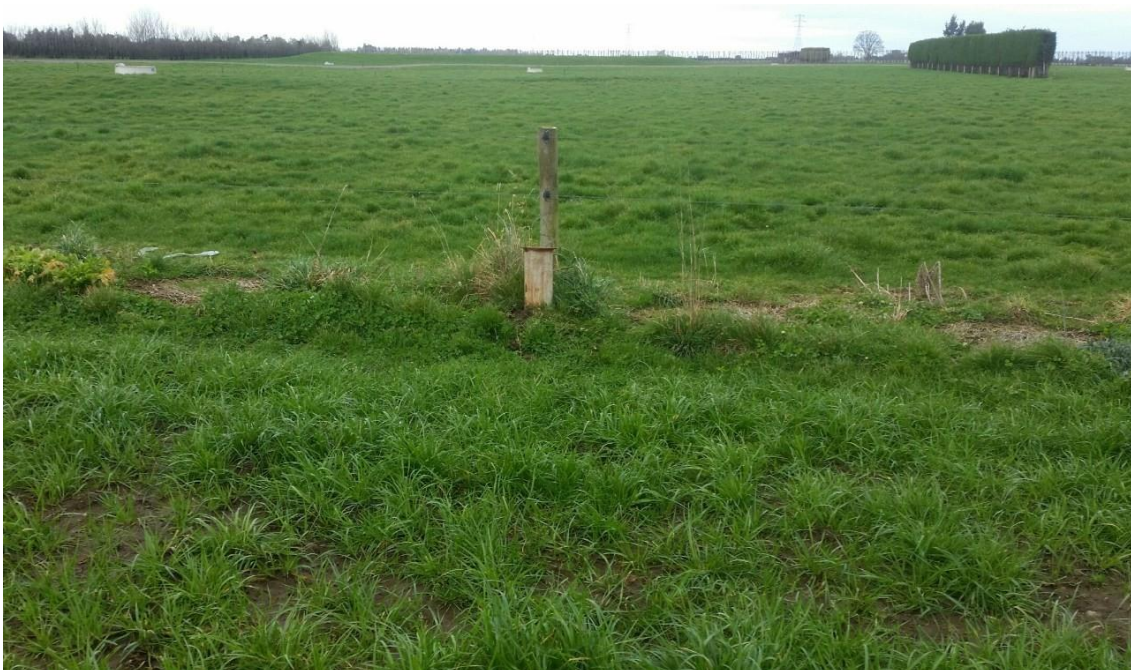
Well E45/XXXX: A bore adjacent to a fence line within a paddock

- Primary Use; Environment Southland Ground Water Monitoring
- Well head protection; Poor
- Proximity to contaminate sources; Close <200 m – Intensive winter grazing, stock lane
- Surface water flow path; No likely route to bore
- Stock access; Yes
- Distance to surface water way; Moderate 100 m - 500 m
- Suitability for groundwater monitoring; Medium

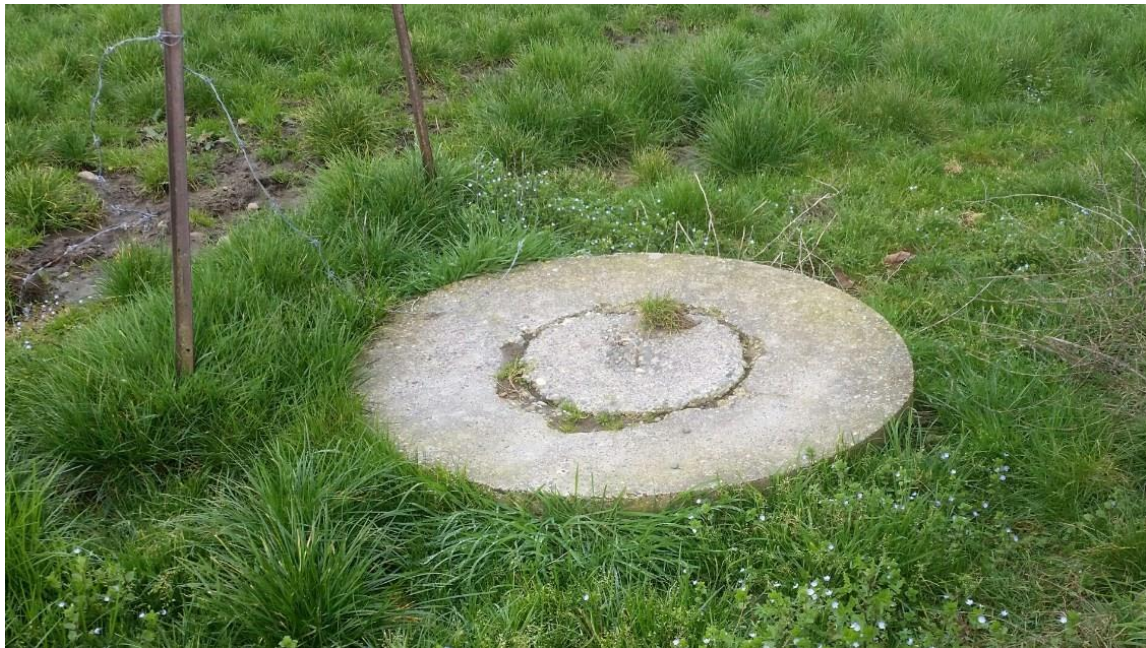
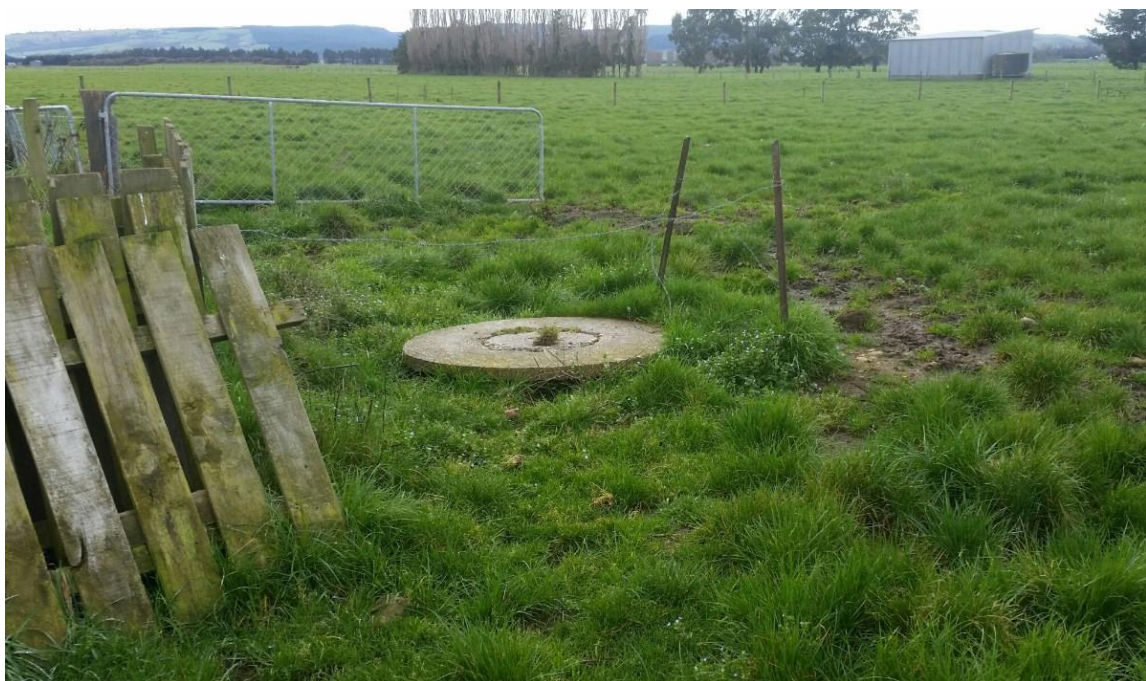
Well E45/XXXX: A well adjacent to a fence within a paddock (close to a house)

- Primary Use; Environment Southland Ground Water Monitoring
- Well head protection; Poor
- Proximity to contaminate sources; Close <200 m – Stock camp, Calf Sheds, Gateway, Septic Tank System
- Surface water flow path; Clear route to bore
- Stock access; Yes
- Distance to surface water way; Moderate 100 m - 500 m
- Suitability for groundwater monitoring; Low
