# PHOSPHORUS MITIGATION PLAN

**Woldwile Runoff**

**20 Gill Road & 1711 Otautau-  
Tuatapere Road**

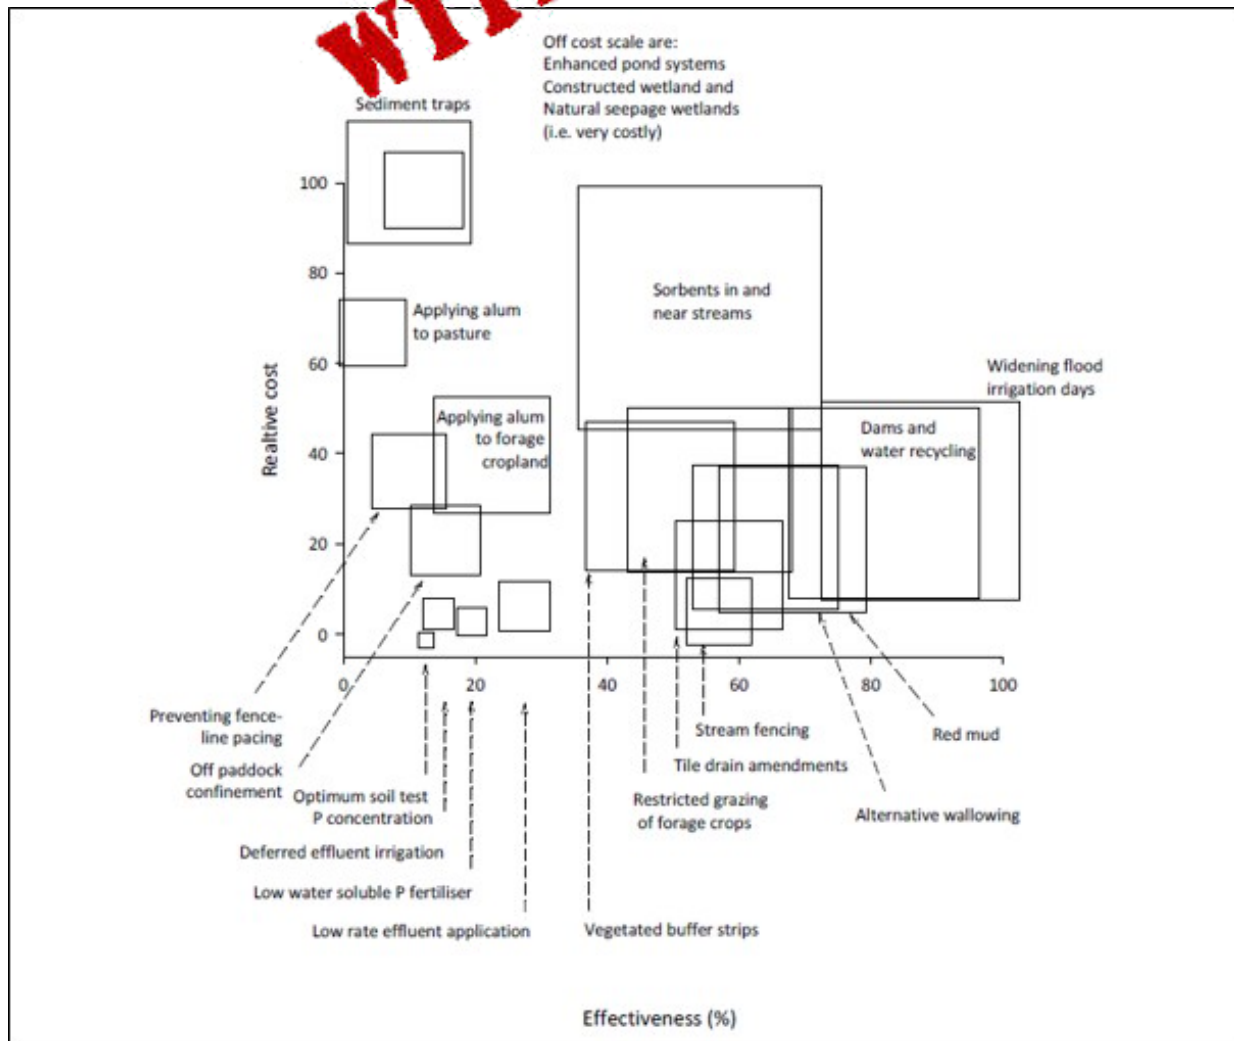
Figure 1 - Cost and effectiveness of strategies to mitigate phosphorus losses (McDowell et al, 2013)

The 40% reduction is based on research that shows management of critical source areas and vegetated buffers can reduce phosphorus loss by 38-59% (Figure 1). A lower range reduction figure of 40% has been used to try and ensure the impact of the proposed mitigations is not over estimated.

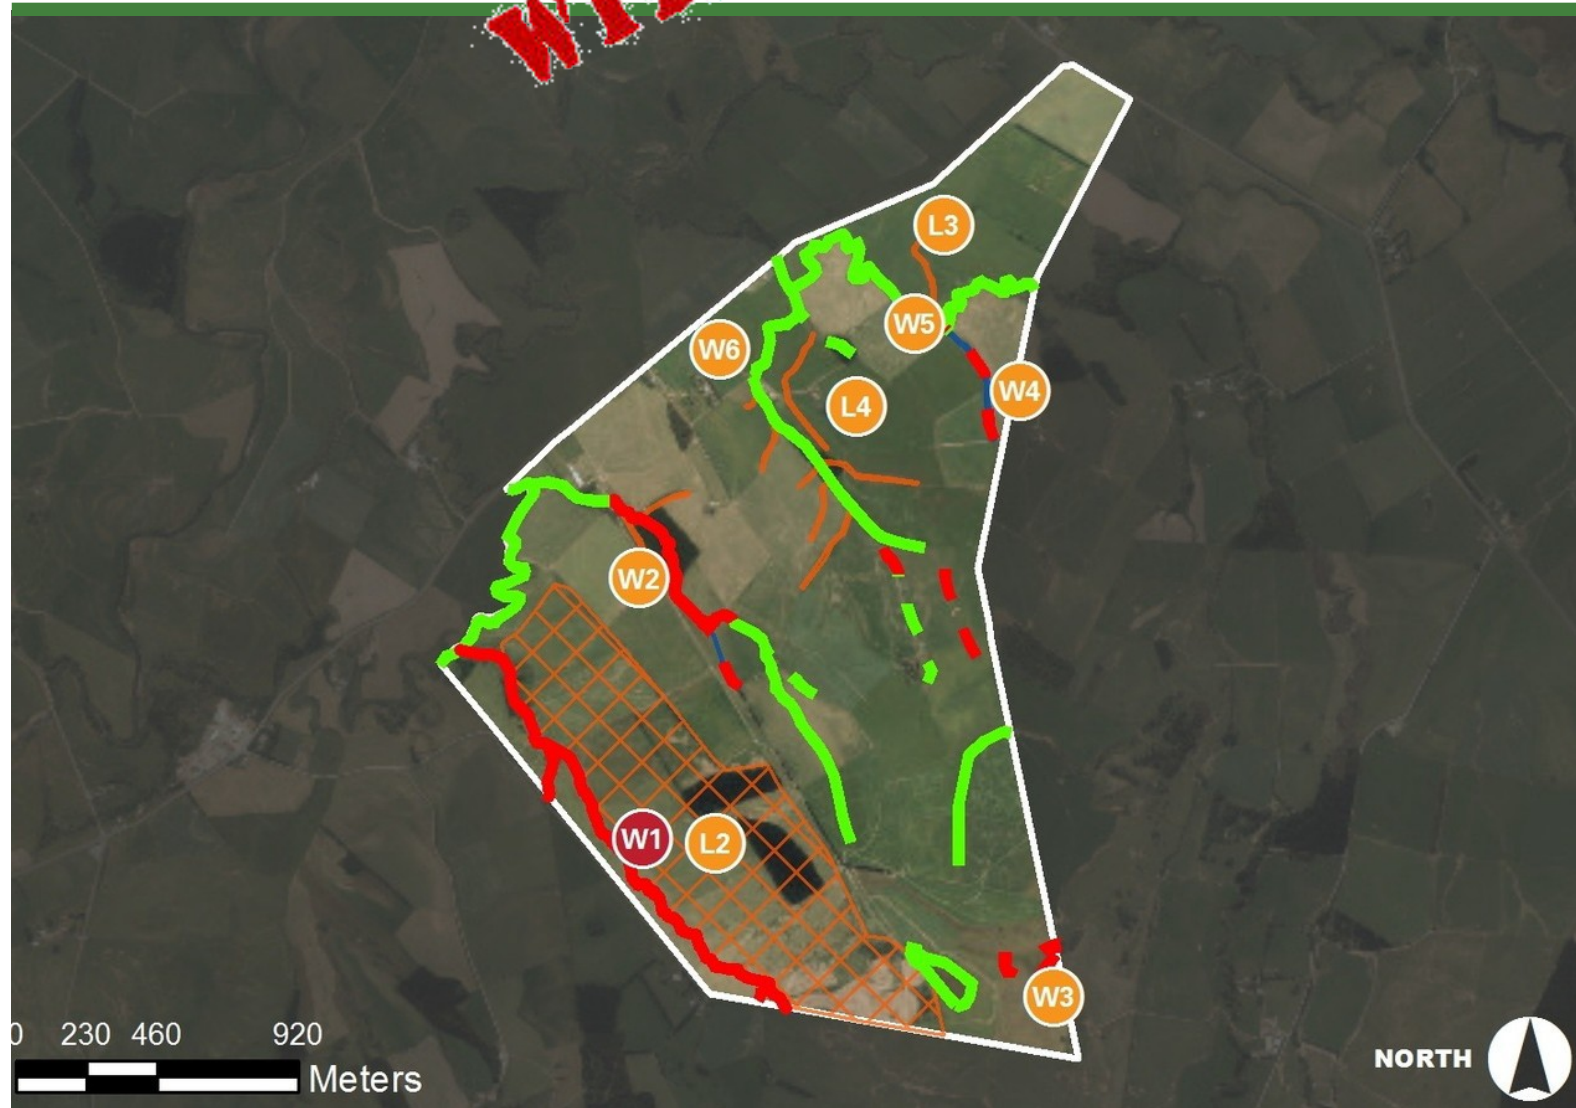
- L2 Critical Source Area - Western Hill Face - Critical Source Areas
- L3 Critical Source Area - Critical Source Areas - Overland Flow Paths
- L4 Race Maintenance & Management - Lane Run-off - Paddock 12
- W1 Waterway Fencing - Foats Stream– Fencing
- W6 Critical Source Area - Culvert - Lane Between Paddocks 11 & 19

- W2 Waterway Fencing - Fenham Creek Tributary Fencing
- W3 Waterway Fencing - Waterway Fencing - Other Areas
- W4 Waterway Fencing - Buckton Creek Tributary Fencing
- W5 Critical Source Area - Stock Ford

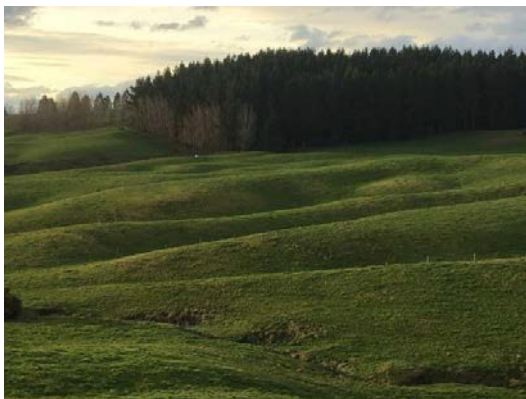
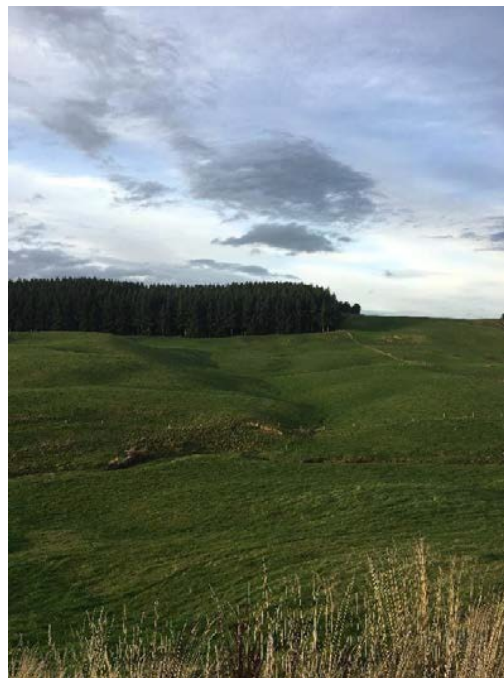
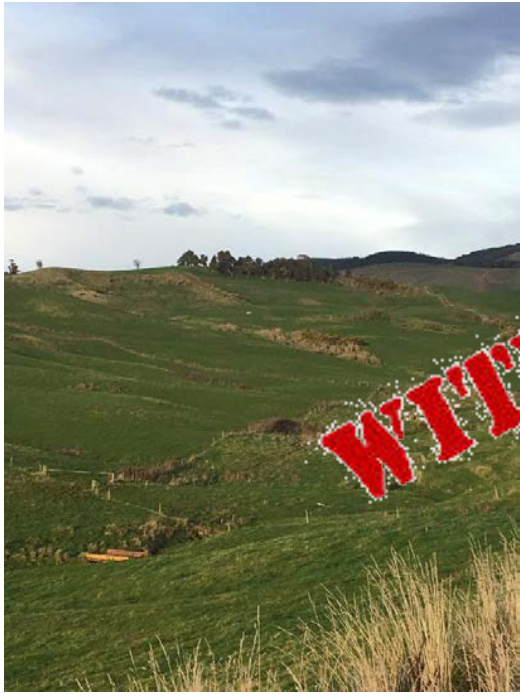
# Western Hill Face - Critical Source Areas

The western hill face slopes down from the top of the farm into Foats Stream. There are a multitude of critical source areas along the hill face that will collect overland flow (and associated contaminants) from surrounding paddocks and direct it down to Foats Creek. Mitigations have already been discussed as part of the actions to fence Foats Creek and include having a wider riparian buffer where critical source areas enter Foats Stream. In addition to this, some of the steeper gullies where land is marginal for production purposes could be fenced off and planted in native vegetation.

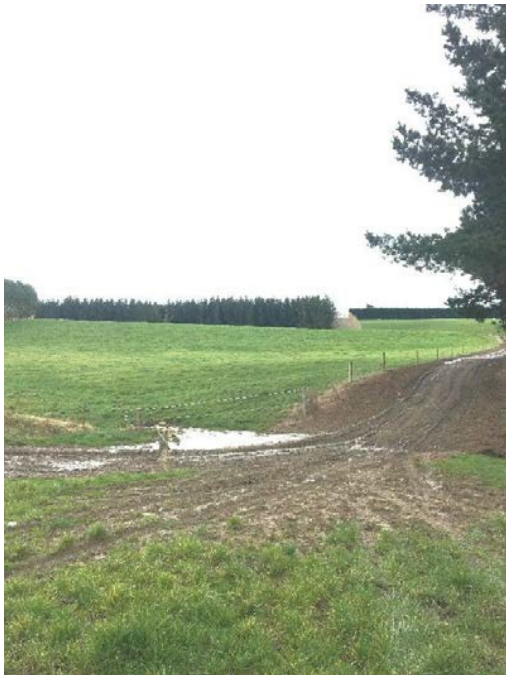
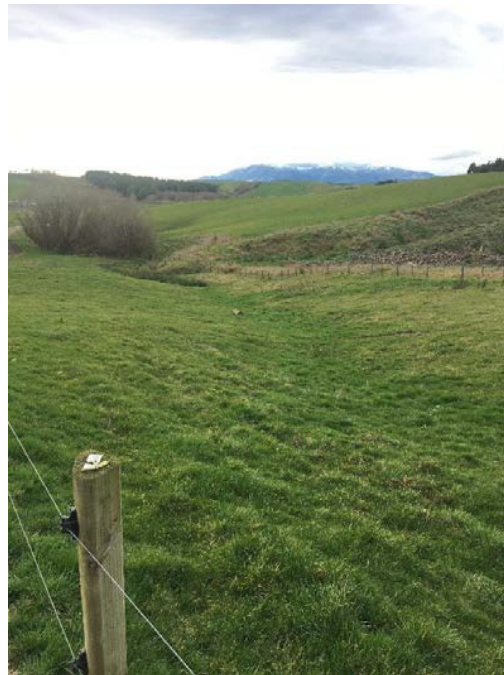
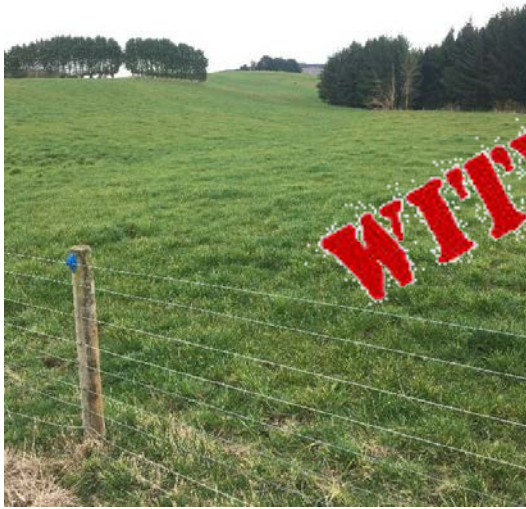
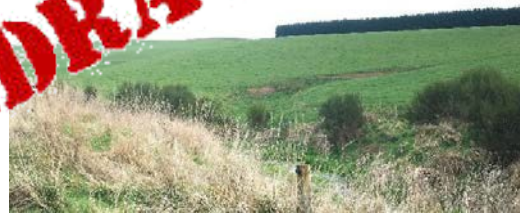
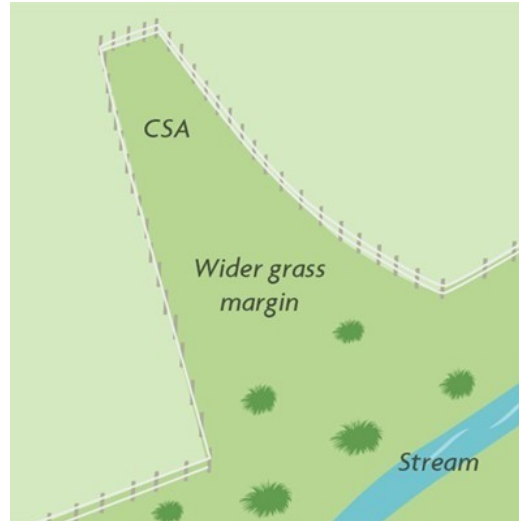
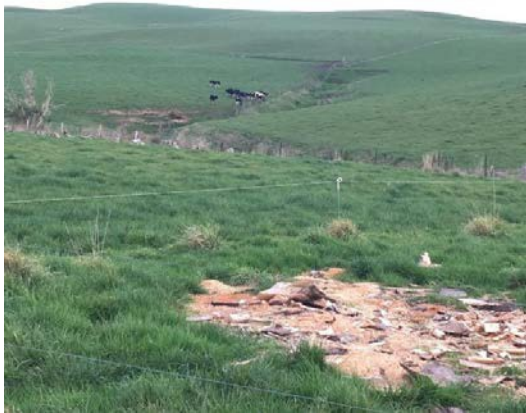
# Critical Source Areas - Overland Flow Paths

There are a number of critical source areas (overland flow paths) on the farm as identified on the map at the start of this section. Those shown are not an exhaustive list but form a guide to the areas that should be investigated further. Critical source areas are areas where water and contaminants off surrounding paddocks are concentrated and transported over the land surface to nearby waterways. Where these areas enter waterways a larger riparian buffer should be provided to filter sediment and associated contaminants (such as phosphorus). Buffers should be appropriately sized for the catchment area of the critical source area (normally 5m minimum). The approximate catchment area of the critical source areas identified (not including the western hill face) is 42.3ha.

**Extend Riparian Buffers - Critical Source Areas**

Extend the riparian buffers where critical source areas such as gullies and swales enter waterways. Buffers should generally be a minimum of 5m or larger depending on the size of the critical source area catchment. Buffer areas should be left in rank grass or planted in native grasses such as carex secta, red tussock and toetoe.

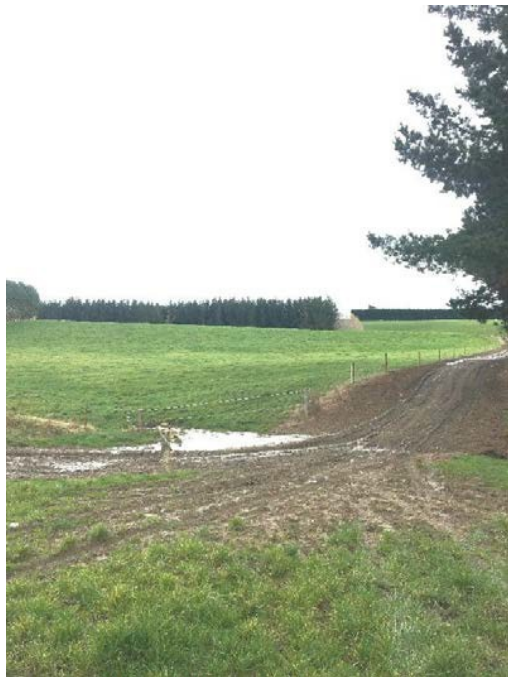
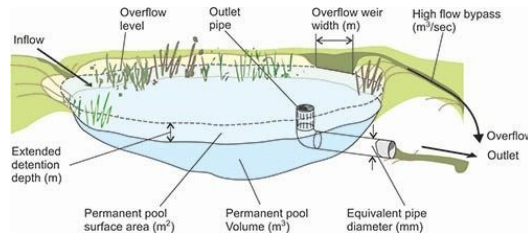
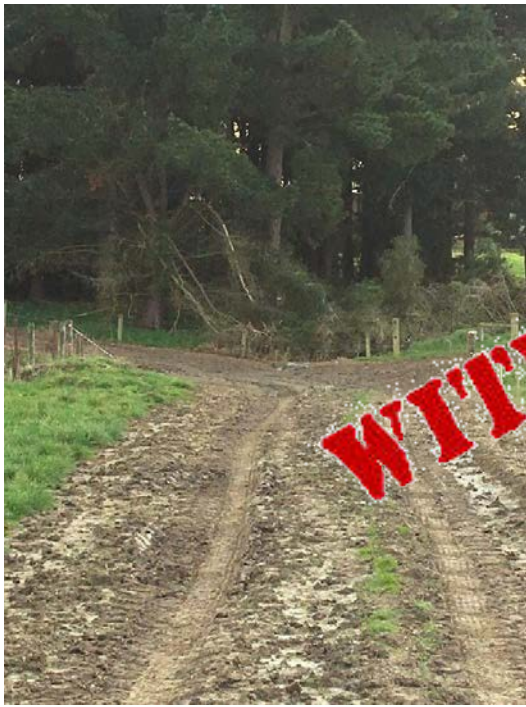
# Lane Run-off - Paddock 12

Lane passing between paddocks 12 and 9. The lane slopes down to a stand of pine trees that has a small waterway running through it. Run-off from the lane and paddock 12 flow down to this point. The lane should be built up in this area to avoid run-off flowing into the adjacent creek. The gateway into paddock 12 could be moved out of the low lying area to a location further up the lane and a small bund installed in the low area with a riser and pipe under the lane into the creek. The bund will allow a small amount of water to pond, settling out sediment before discharging into the creek. This will avoid run-off from the paddock flowing across the lane, causing damage and picking up more contaminants.

**Modify Lane / Move Gateway / Install riser**

Build up the lane so it slopes away from the creek and run-off flows into adjacent paddocks. The gateway into paddock 12 could be moved out of the low lying area to a location further up the lane and a small bund installed in the low area with a riser and pipe under the lane into the creek. The bund will allow a small amount of water to pond, settling out sediment before discharging into the creek.

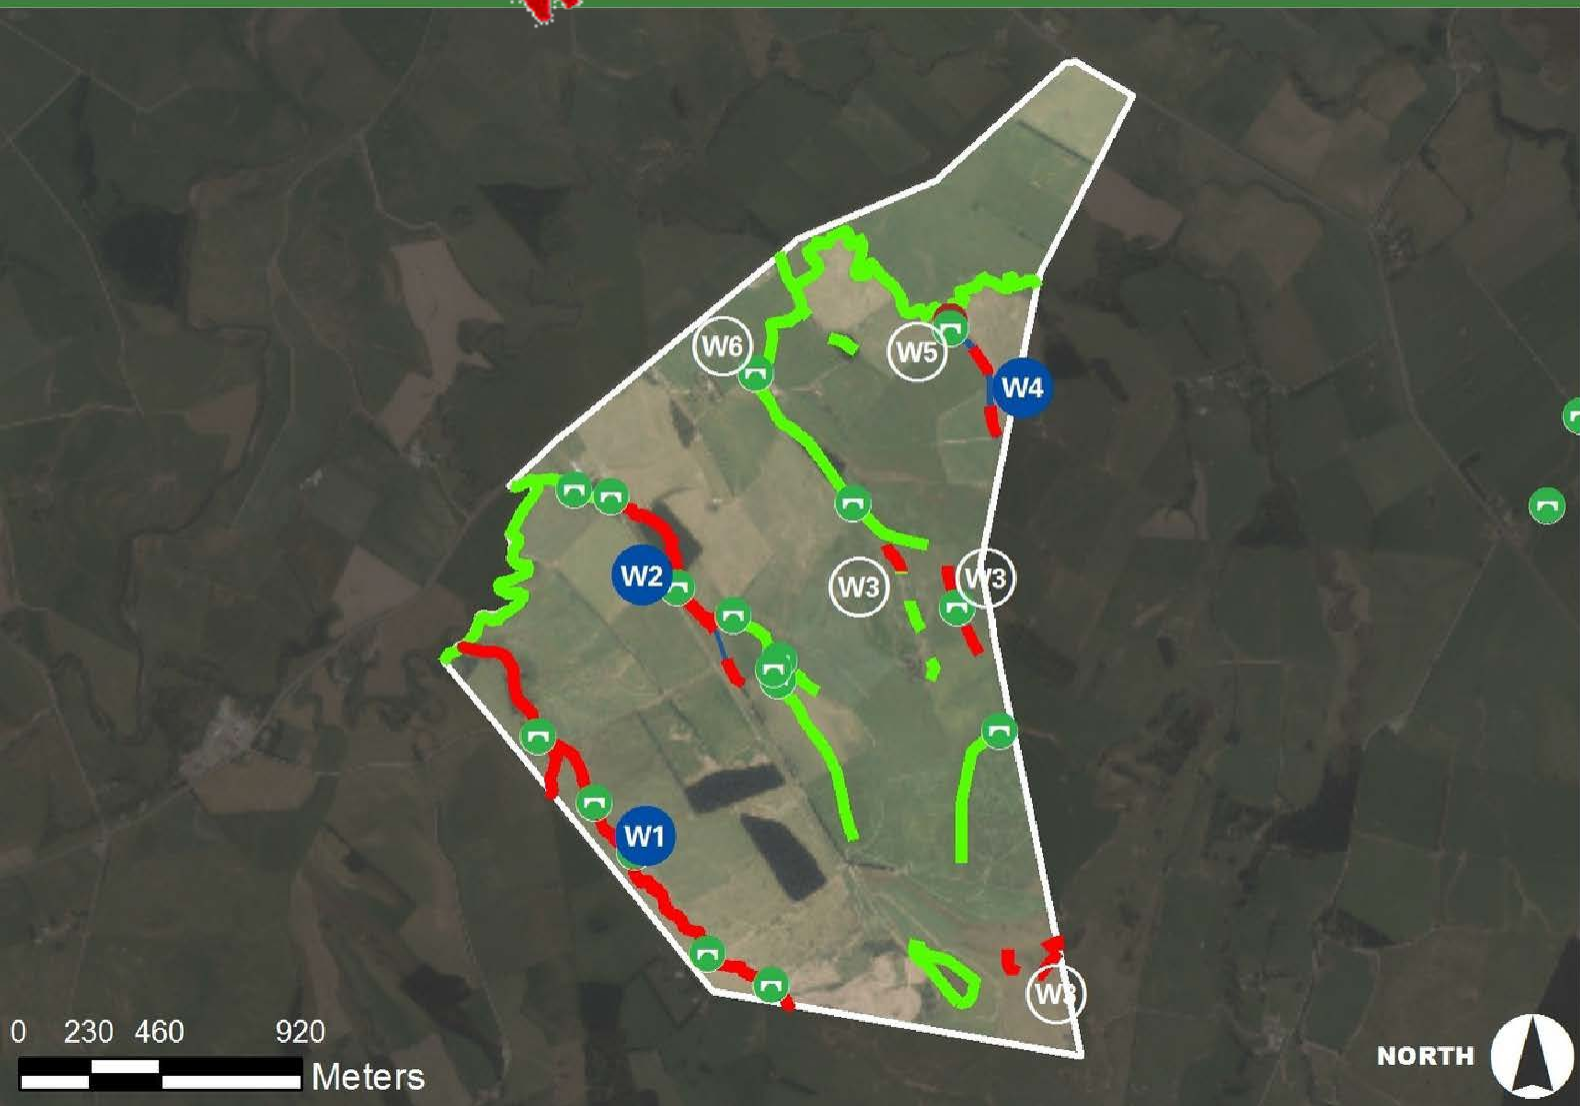
# WATERWAYS MANAGEMENT

- W1 Waterway Fencing - Foats Stream - Fencing
- W2 Waterway Fencing - Fenham Creek Tributary Fencing
- W3 Waterway Fencing - Waterway Fencing - Other Areas
- W4 Waterway Fencing - Buckton Creek Tributary Fencing

- W5 Critical Source Area - Stock Ford
- W6 Critical Source Area - Culvert - Lane Between Paddocks 11 & 19
- Accord Defined Stock Excluded Waterway
- Accord Defined Stock Not Excluded Waterway
- Non-Accord Defined Stock Excluded Waterway

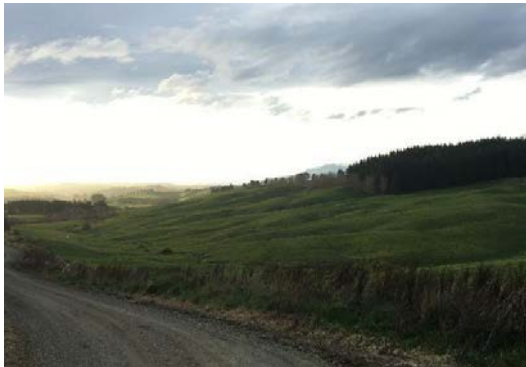
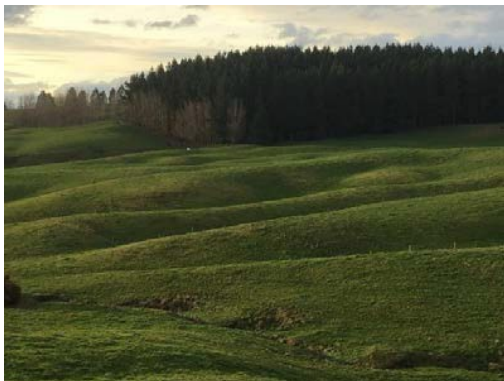
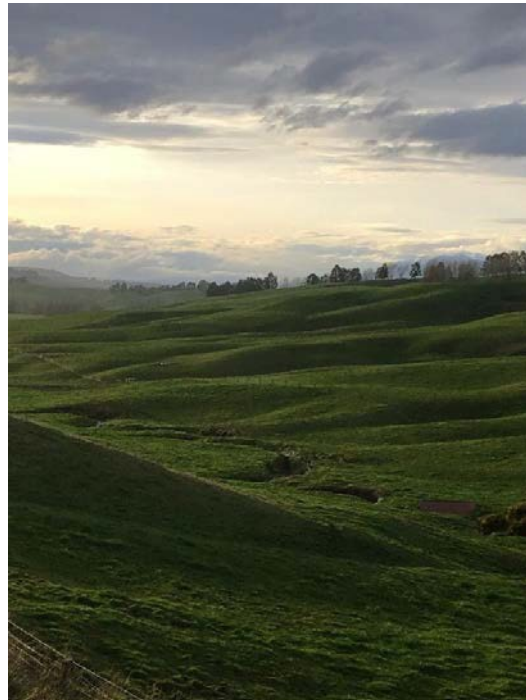
W1 Waterway Fencing  
**Foats Stream - Fencing**

A tributary of Foats Stream flows along the western side of the Merriburn Lease Block adjacent to Sim Road. Run-off from the steeper hill country to the east all flows down into the stream via a multitude of critical source areas. The stream is currently not fenced to exclude stock and there is no vegetated riparian margin. Fencing of the waterway will reduce phosphorus losses from the farm by preventing direct deposition into the stream by stock and filtering run-off from surrounding paddocks. Where critical source areas enter the stream it is recommended the riparian margin is maintained at 5m with a 2m rank grass margin maintained outside of these areas. Foats Stream Tributary has a catchment of approximately 78ha (located on the farm).

**▶ Fence Foats Stream - 2m Buffer**

Fence off the Foats Stream tributary running along the western side of the farm. A 2m riparian buffer should be established on both sides of the creek with the buffer extended to 5m in locations where swales or gullies (critical source areas) enter the stream.

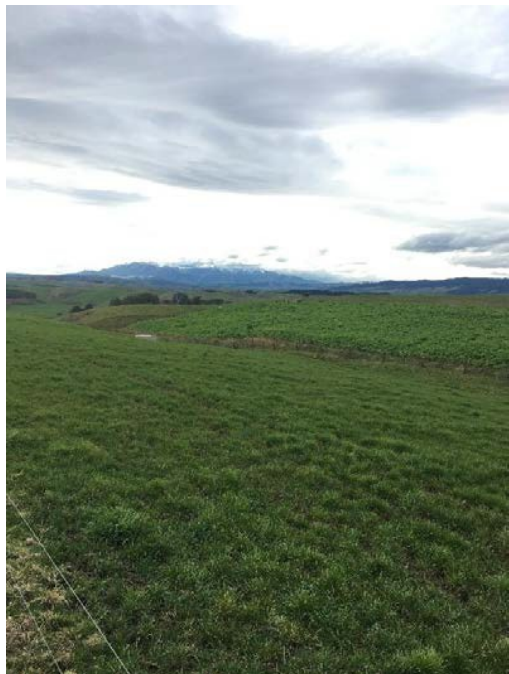
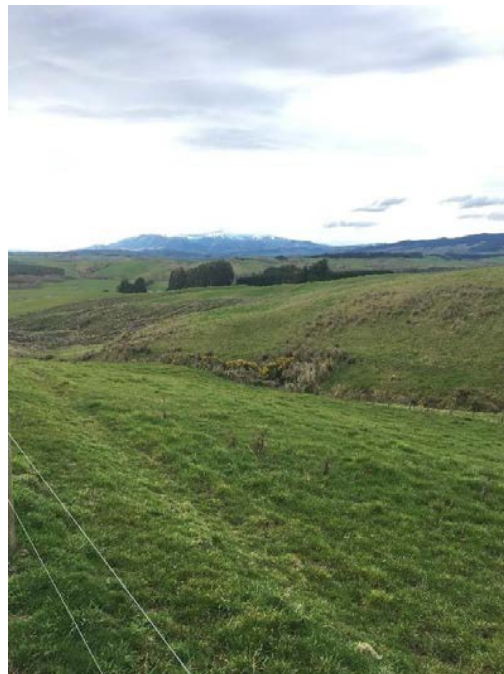
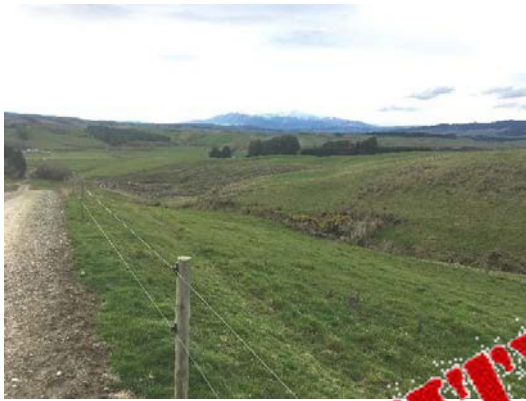
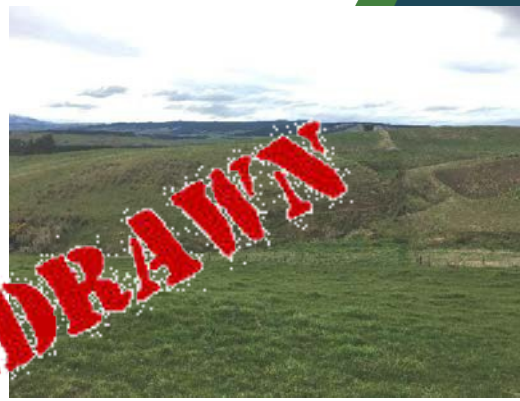
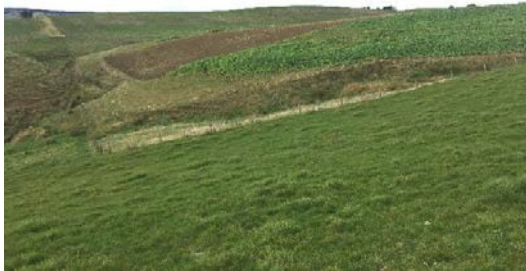
# Fenham Creek Tributary Fencing

A tributary of Fenham Creek flows down from the higher elevations of the farm out to Otautau-Tuatapere Road. The upper and lower reaches of the Creek are permanently fenced to exclude stock (although the riparian buffers should be extended when adjacent paddocks are being winter grazed). In the middle section a small forestry block has recently been removed and the creek flows down through a gully to the bottom of the farm. Run-off from surrounding paddocks flows down into the stream via the general topography of the land and critical source areas.

Fencing of the central section of the waterway will reduce phosphorus losses from the farm by preventing direct deposition into the stream by stock and filtering run-off from surrounding paddocks. Where critical source areas enter the stream it is recommended the riparian margin is increased to 5m with a 3m rank grass margin maintained outside of these areas. The steeper sections of the hill could also be fenced off as these have minimal productive value. These areas could be planted in natives such as red tussock, toetoe, cabbage trees, broadleaf, etc to prevent erosion and add to the aesthetic and biodiversity values of the farm.

**Fence off Fenham Creek (Central Section)**

Fence off the central section of the waterway. Where critical source areas enter the stream increase the riparian margin to a minimum of 5m with a 3m rank grass margin maintained outside of these areas. The steeper sections of the hill could also be fenced off as these have minimal productive value.

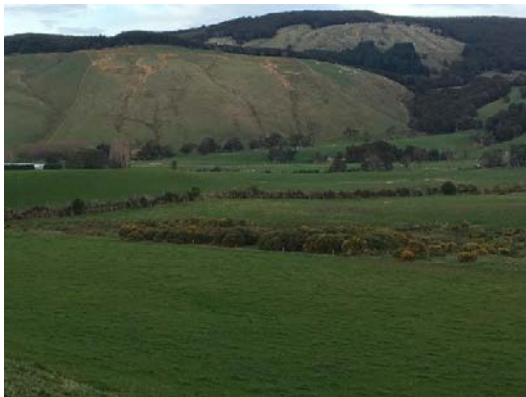
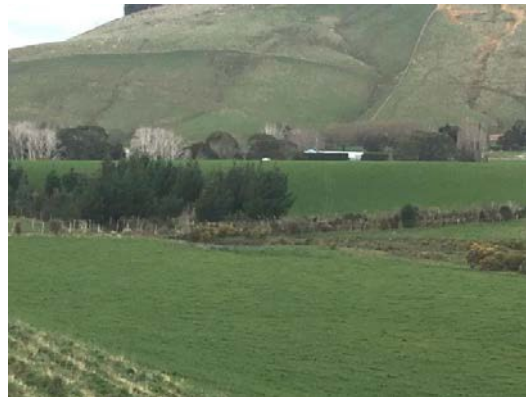
# Waterway Fencing - Other Areas

Three additional areas have been identified as requiring fencing to exclude stock. Two of these areas have not been photographed and have been identified from aerial photography. These are small ephemeral waterways or gullies in paddocks 15, 16 and 17. Fencing these areas and maintaining a minimum 2m rank grass buffer will assist with the filtering of run-off from surrounding paddocks, including phosphorus. In addition to this there is a pond and wetland area in paddock 38 that should also be fenced to achieve similar benefits (see photos).

<b>Fence Waterways - Other Areas</b>
Permanently fence off the waterways/gullies in paddocks 15, 16 and 17 as well as the wetland/pond area in paddock 38. A minimum 2m rank grass riparian margin should be established.
<b>TARGET DATE:</b> 1 Aug 2021

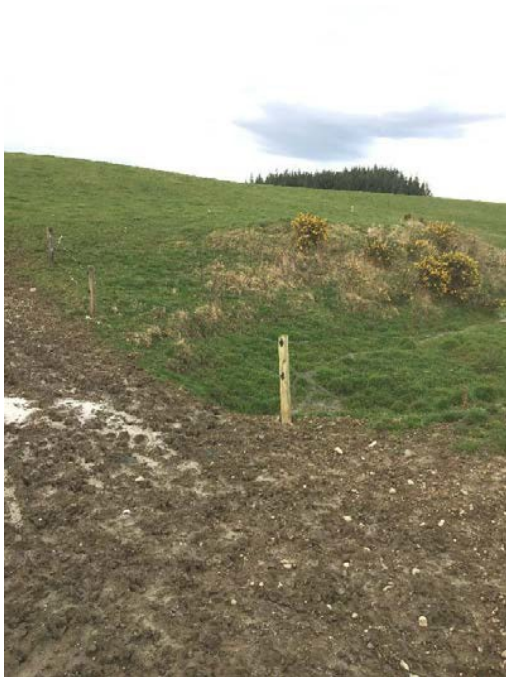
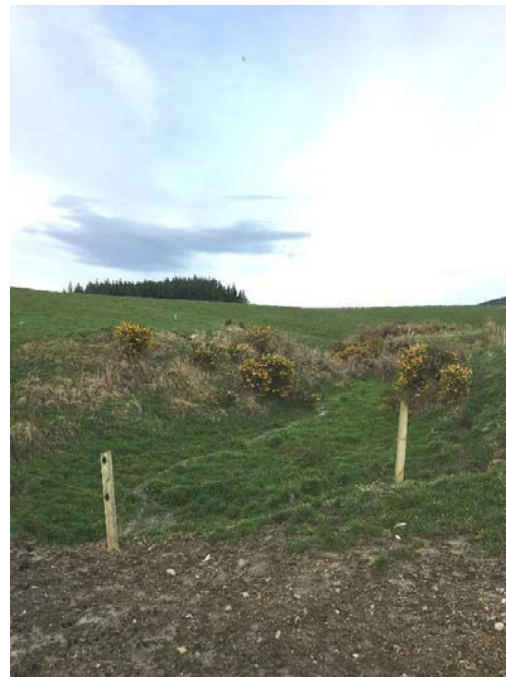
Waterway Fencing  
**Buckton Creek Tributary Fencing**

Small ephemeral waterway that runs between paddocks 6, 7 and 8. The waterway is not currently permanently fenced, however there is a variable riparian margin due to the slope of the bank and the fact the stream flows through a gully. Fencing will prevent stock access and allow rank grass to better establish within the riparian margin, assisting with filtering of run-off. It is recommended a permanent fence be installed at the top of the bank/gully.

**Fence off Buckton Creek Tributary**

Permanently fence off the waterway that runs between paddocks 7 and 8. There is a natural riparian buffer due to the topography of the land of approximately 2m. It is recommended the fence line follows this natural contour.

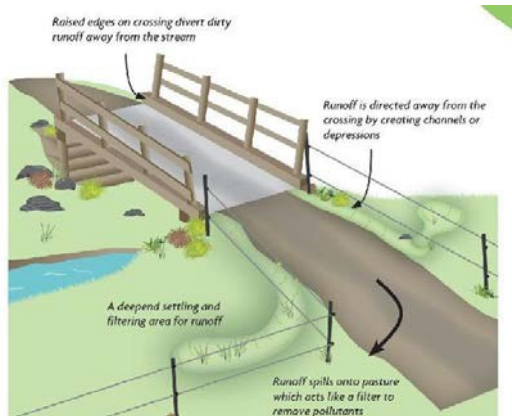
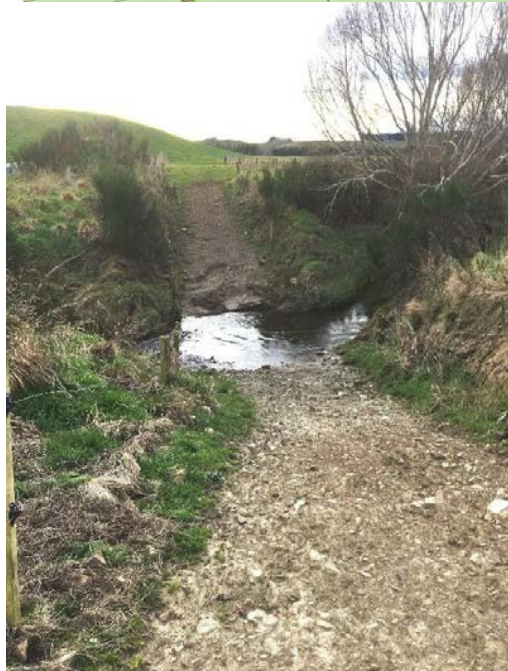
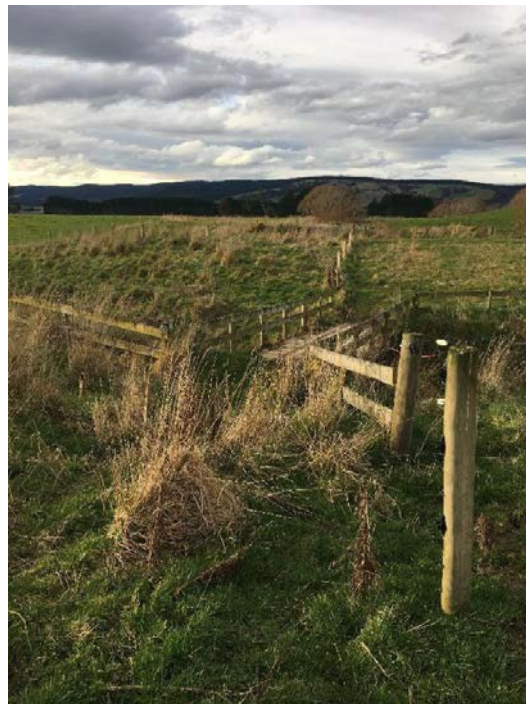
Critical Source Area  
**Stock Ford**

Stock ford between paddocks 5 and 6. The ford is used to access paddocks to the east of the farm and replaces an unsafe bridge. Long term the use of the ford should be discontinued (due to the direct deposition of contaminants into the waterway) and a bridge reinstated.

**Re-instate Bridge between Paddocks 5 and 6**

Long term the use of the ford should be discontinued (to prevent the direct deposition of contaminants into the waterway) and a bridge re-instated.

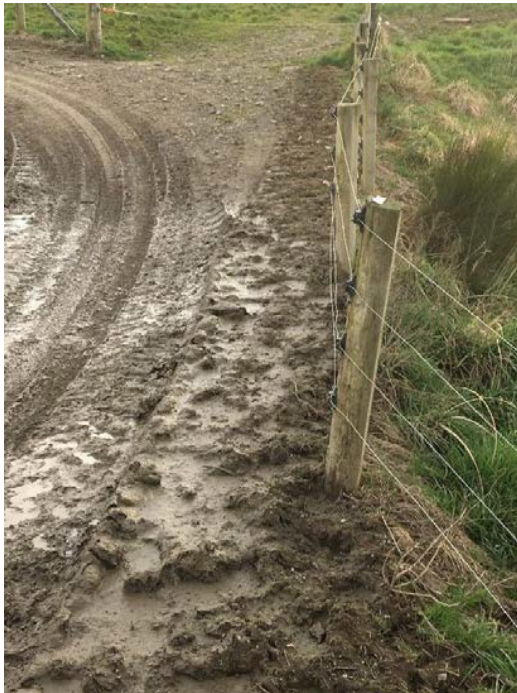
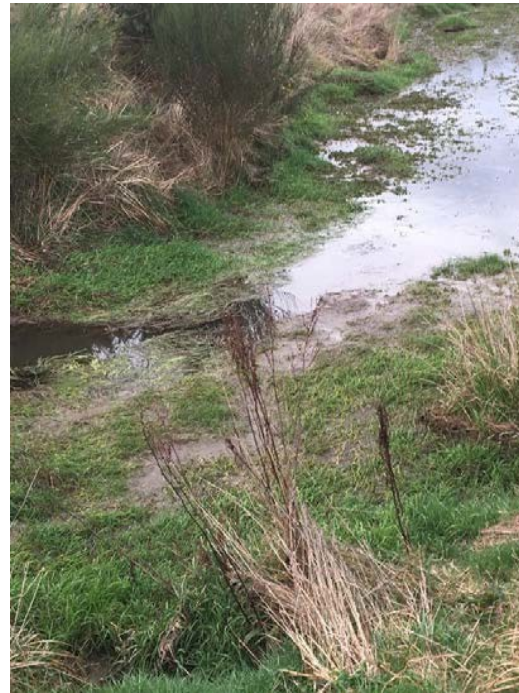
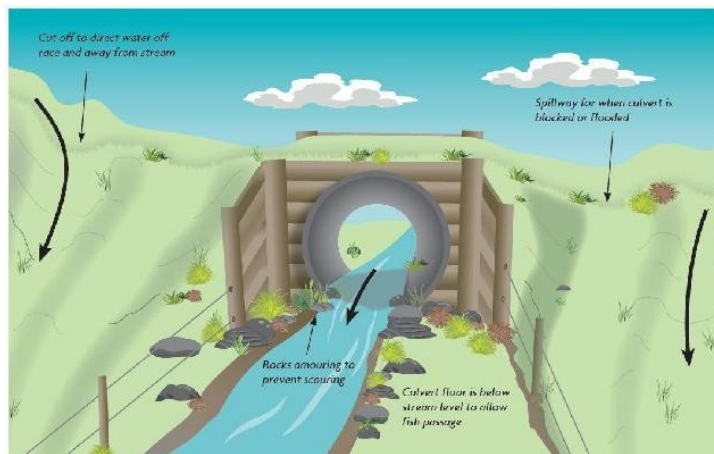
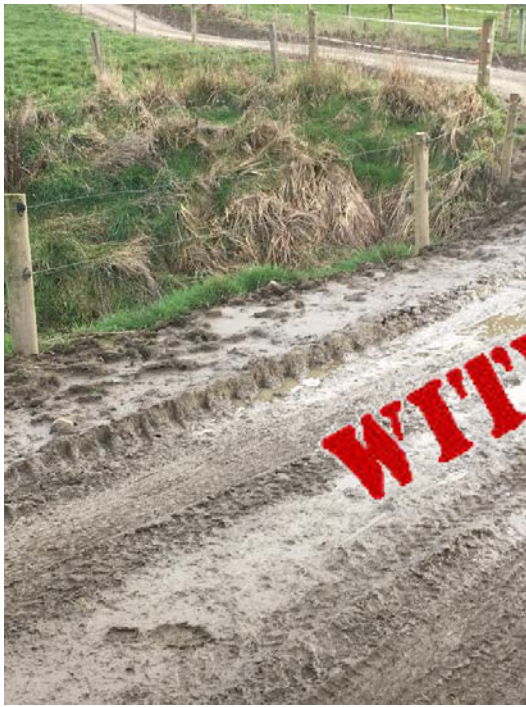
# Culvert - Lane between Paddocks 11 & 19

Lane crossing the waterway to the south of paddock 11. The culvert has no raised sides which allows any runoff to flow off the side into the underlying water. Building up the sides of the culvert and directing run-off back into the paddock or at a minimum into a grass riparian area will assist with filtering sediment and associated phosphorus.

**Build Up Sides of Culvert (Sth Paddock 11)**

Build up the sides of the lane crossing the waterway to the south of paddock 11. This will prevent the direct deposition of sediment and associated phosphorus into the underlying waterway and allow for filtering via a grass buffer.

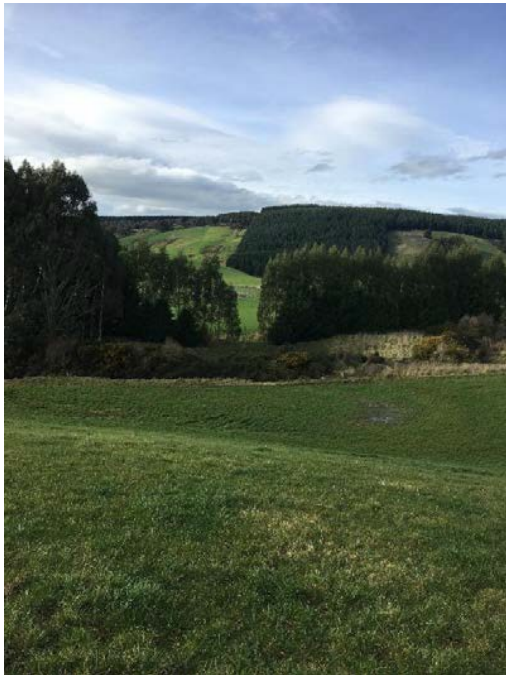
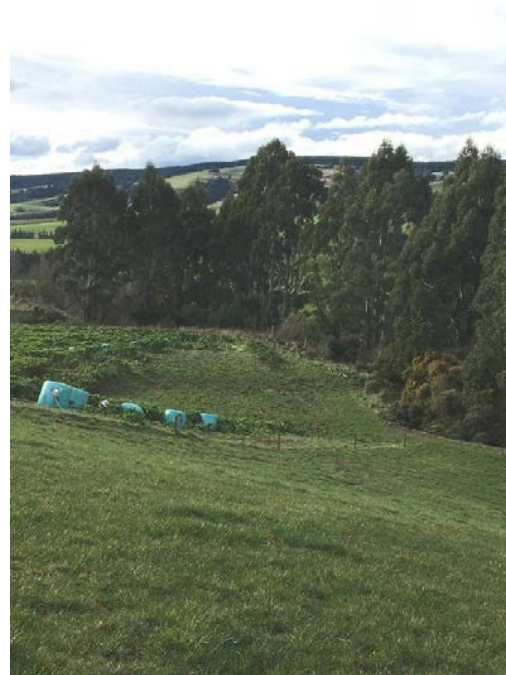
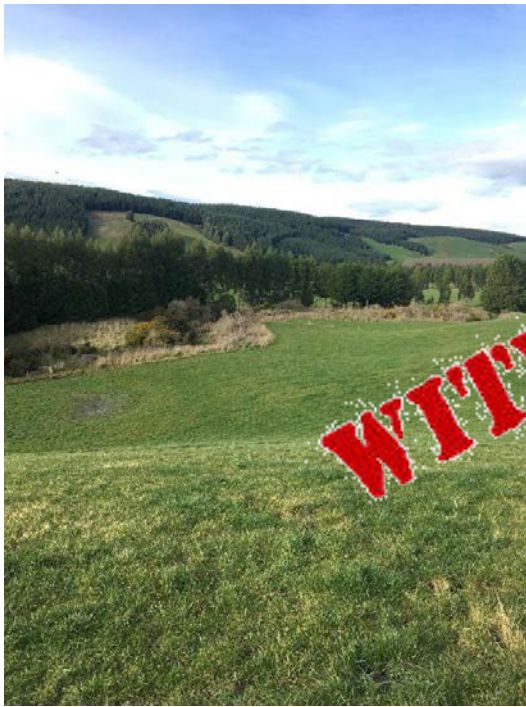
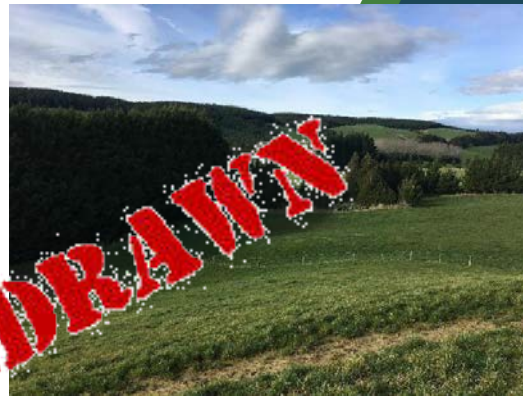
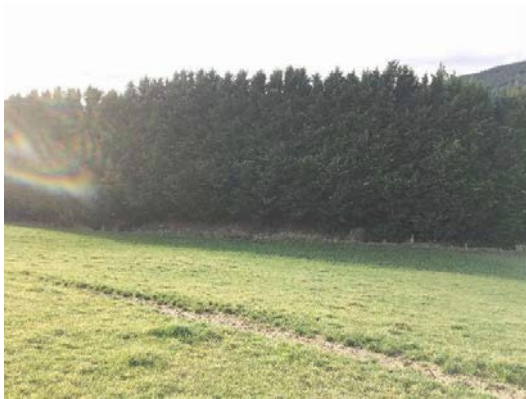
## Fenham Creek Tributary (Northern Section)

Northern end of the Fenham Creek Tributary flowing along the bottom of paddocks 88, 90, 92, 94, 96 and 98. The riparian buffer on the western side is approximately 1-1.5m yet there is a significant slope from the adjoining paddocks down to the creek. It is recommended that a 3m grass buffer is fenced off to allow for filtering of overland flow and associated contaminants off the surrounding paddocks. This is especially important when adjacent paddocks are being winter grazed (buffer should be temporarily extended to at least 5m).

##### Extend Riparian Margin (Fenham Creek North)

It is recommended that the riparian margin of the Fenham Creek Tributary flowing below paddocks 88, 90, 92, 94, 96 and 98 be extended to 3m and maintained in rank grass to.

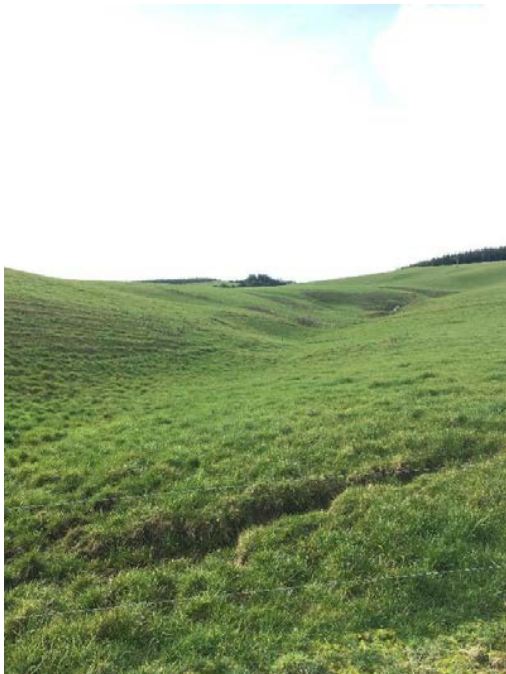
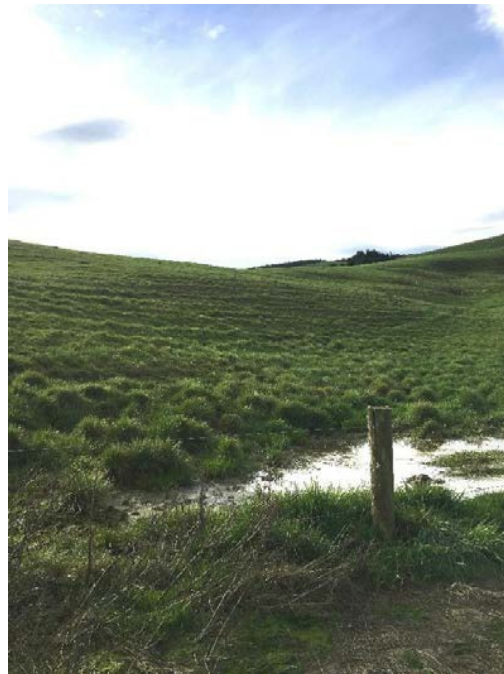
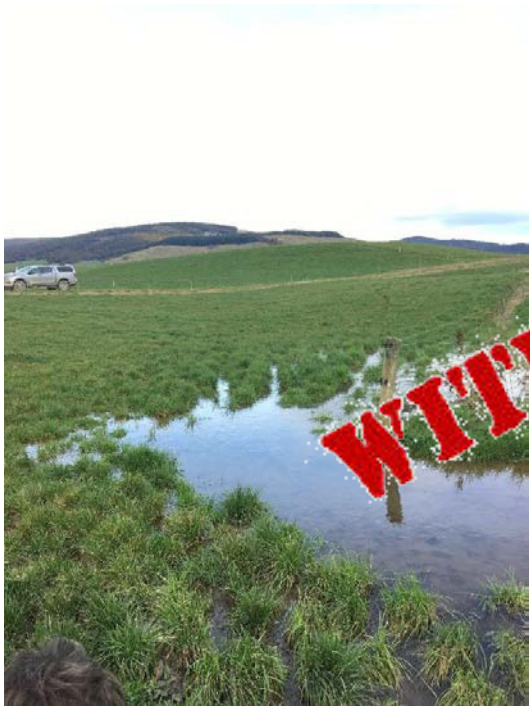
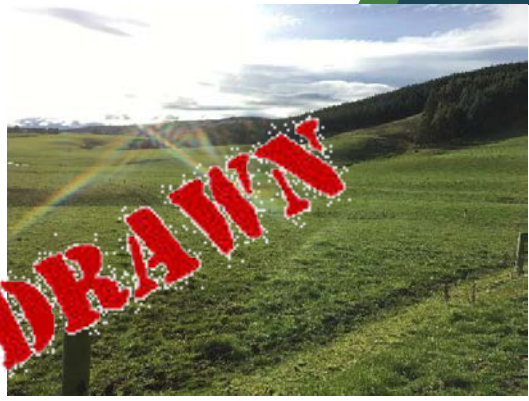
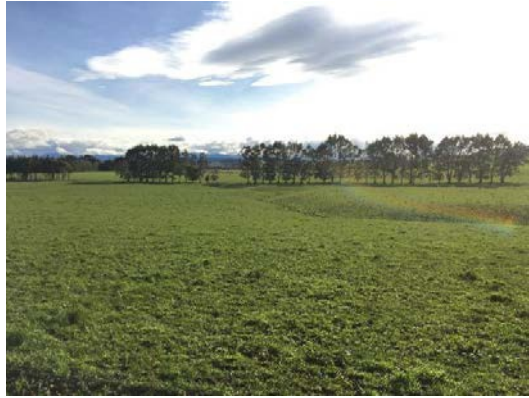
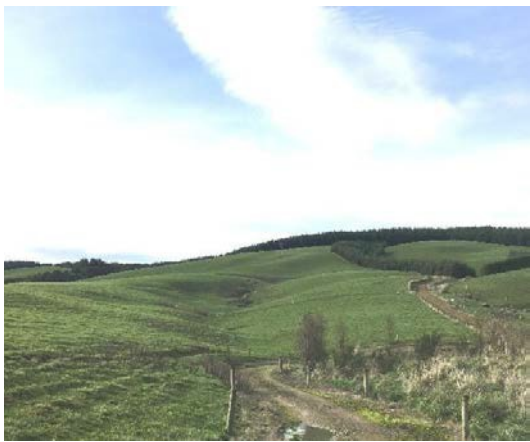
## Critical Source Areas - Overland Flow

There are a number of critical source areas (overland flow paths) on the farm as identified on the map at the start of this section. Those shown are not an exhaustive list but form a guide to the areas that should be investigated further. The critical source areas across the farm are areas where water and contaminants off surrounding paddocks are concentrated and transported over the land surface to nearby waterways. Where these areas enter waterways a larger riparian buffer should be provided to filter sediment and associated contaminants (such as phosphorus). Buffers should be appropriately sized for the catchment area of the critical source area (normally 5m minimum).

**OPEN ACTIONS:****Extend Riparian Buffers - Critical Source Areas**

Extend the riparian buffers where critical source areas such as gullies and swales enter waterways. Buffers should generally be a minimum of 5m or larger depending on the size of the critical source area catchment. Buffer areas should be left in rank grass or planted in native grasses such as carex secta, red tussock and toetoe.

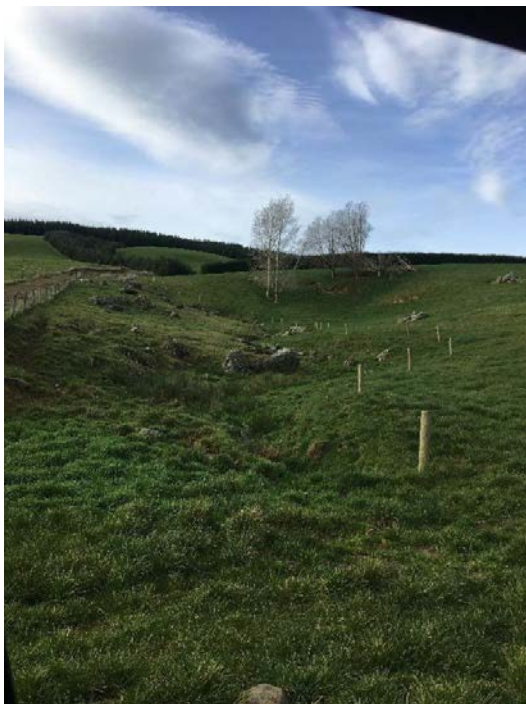
The gully through paddock 9 has previously been fenced off (posts in place). This should be re-fenced to exclude stock. The area is of low production potential and having stock in this area is likely to cause pugging and sediment (and associated phosphorus) loss to the nearby waterway.

**Re-fence Gully - Paddock 10**

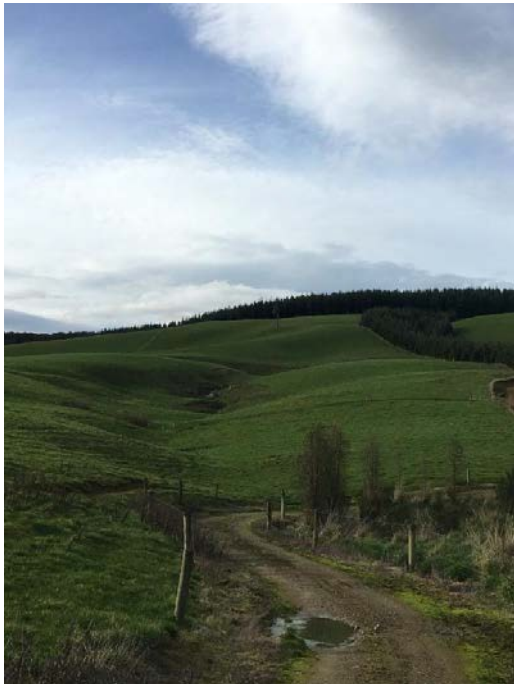
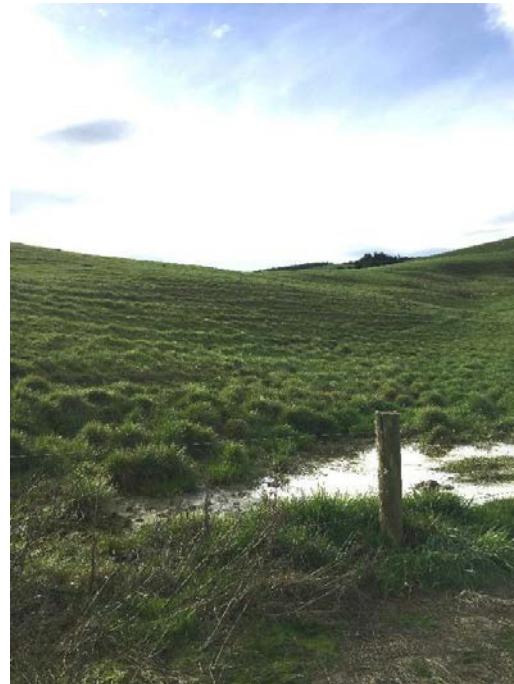
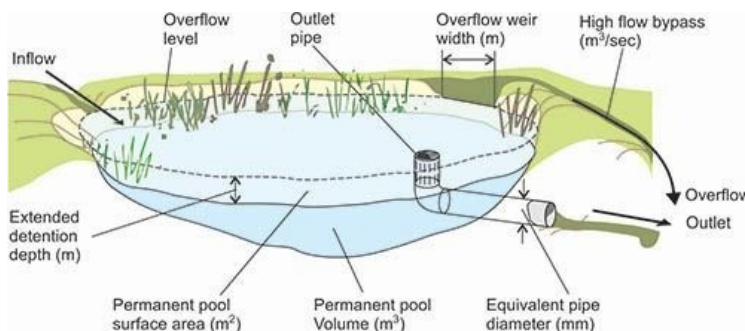
Gully through the center of paddocks 10 and 15. In some places erosion is occurring. These areas should be fenced off to avoid further damage (consider planting with natives to stabilise). In addition to this, the gully is a conduit for overland flow down to the waterway at the bottom. Due to the location of the lane there is minimal opportunity to extend the riparian margin, however long term there is an opportunity to install a sediment trap at the bottom of the gully with an overflow into the creek.

**Exclude Stock from Erosion Areas (Pad 10 & 15)**
