WAIKAWA ESTUARY: SEDIMENTATION RATE MONITORING SUMMARY, JANUARY 2012

Prepared by for Environment Southland by Leigh Stevens and Barry Robertson, Wriggle Coastal Management.

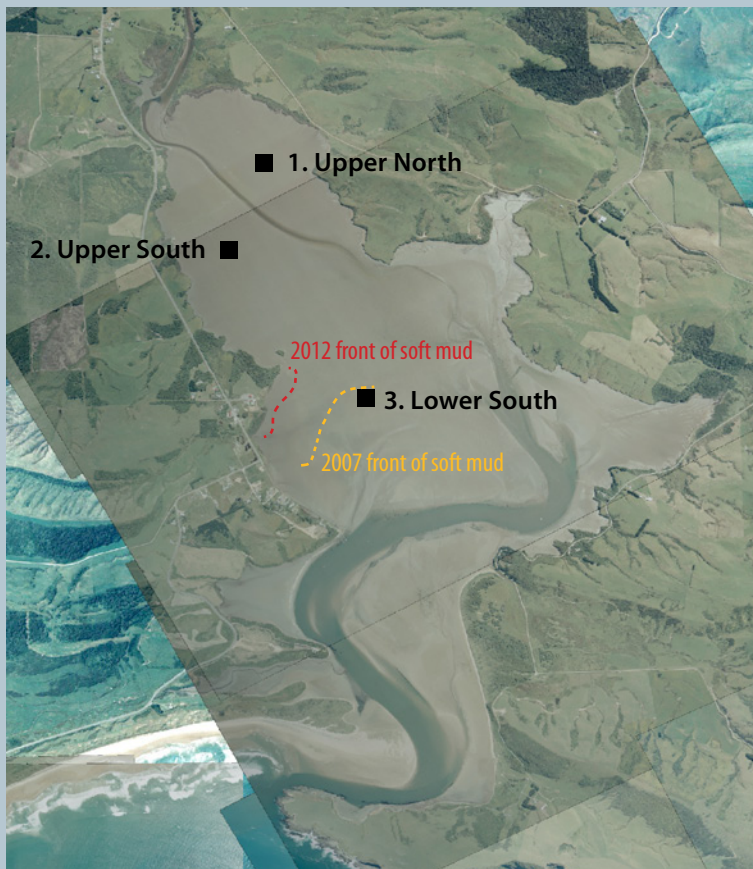
Figure 1. Location of sediment rate monitoring sites in Waikawa Estuary and the position of the soft mud front in the middle estuary.

To monitor ongoing sedimentation rates, 4 concrete plates were buried at each of 3 sites in the estuary in 2007 (Figure 1 - see Stevens and Robertson 2009 for further details) and have been monitored annually since that time. To account for spatial and temporal variation in sedimentation rates from natural processes such as wind generated waves, tidal flows, and river inputs, site averages are used to estimate mean annual sedimentation rates for the estuary.

The greatest mean annual decline in mud has been at the Lower South site. This site was established at the leading edge of soft mud in the middle estuary in 2007. Since then, the front of overlying surface mud has progressively moved up the estuary (Figure 1). In 2012, this trend continued with parts of the intertidal flats previously covered in soft mud now noticeably sandier.

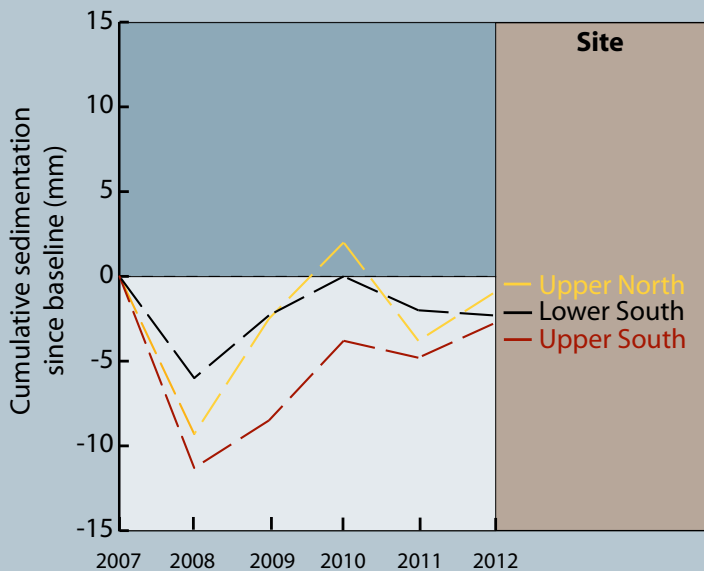
Figure 2. Cumulative change in sediment levels over buried plates in Waikawa Estuary, 2007 to 2012.

Table 1 presents the 2012 sedimentation rate results for the 12 plates buried in Waikawa Estuary, with summary data from 2007-2012 presented in Figures 2 and 3.

The mean annual rate of sedimentation indicates a slight overall loss of sediment at all sites since 2007 (-0.3mm/yr to -2.4mm/yr), a condition rating of "Very Low". This has been punctuated by variable increases and decreases within this period (Figure 2).

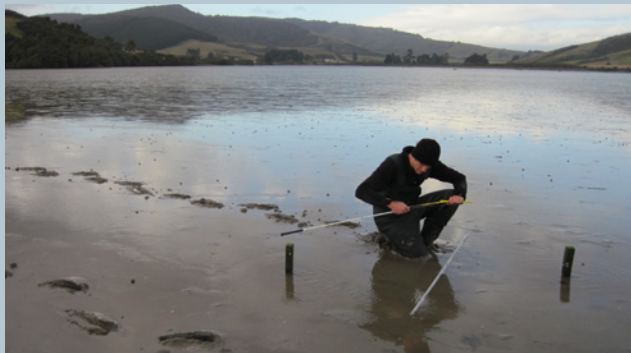
While surface mud deposits are currently being flushed from the middle part of the estuary, the underlying sediments are still relatively muddy. This is reflected in a shallow RPD (1-3cm), infilling of interstitial spaces with fine muds (10% mud in 2007), and rapid re-suspension of muds by wave action making estuary waters turbid.

Despite the low mean annual deposition evident over the past 5 years, Waikawa Estuary remains excessively muddy (42% soft and very soft mud - Stevens and Robertson 2009), with the vast majority of the mud located in the extensive intertidal flats in the upper and middle estuary (see photo).
