A guide to improving fish access through culverts

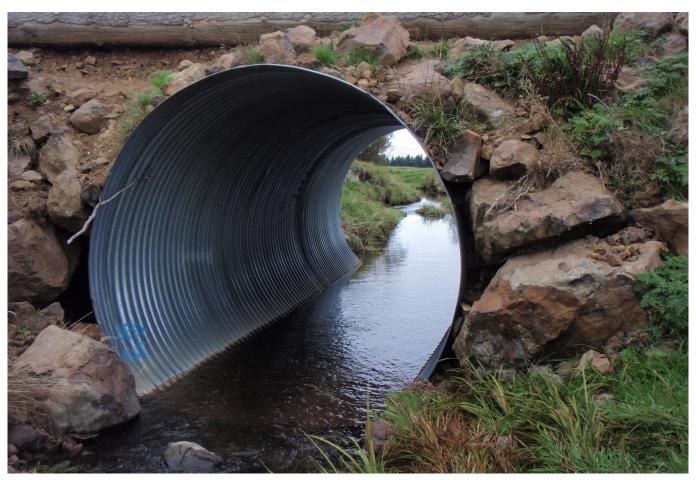
Excellent culvert design providing year round fish access

The best practice to ensure fish access is to not alter the waterway channel alignment and gradient. Install an open bottom culvert or invert 25% – 50% of a round culvert into the bed so the natural bed is present through the culvert. Do not use box culverts or install concrete steps as these create shallow water, reducing fish access.

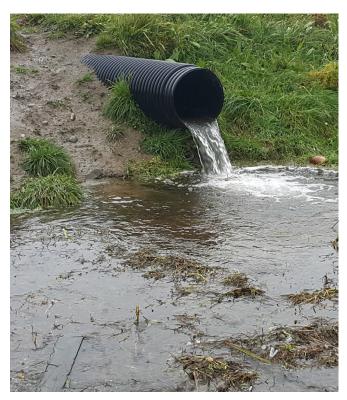
A perched culvert preventing fish access

1. Perched culverts

Perching is caused by a culvert installed on top of the waterway bed. This prevents bed materials from naturally moving downstream building them up, creating a waterfall.

This depends on the species needing access, and the culvert design. Ramps can be added to the downstream end to bridge a waterfall from a perched culvert. Ropes or baffles can be

added to the inside culvert surface to help fish climb or swim through high velocity water. Rocks, sandbags or boards can be placed in the waterway below the culvert to create a series of small pools to increase water depth and reduce velocity, allowing fish to swim through. For large high culverts, a fish ladder featuring a number of pools maybe required.
